HOME INSPECTION REPORT

On November 19, 2016 The HomeTeam Inspection Service made a visual inspection of 123 Sample Road, Charlton, MA 01507. Enclosed please find a written, narrative report of our findings in accordance with the terms of our Inspection Agreement.

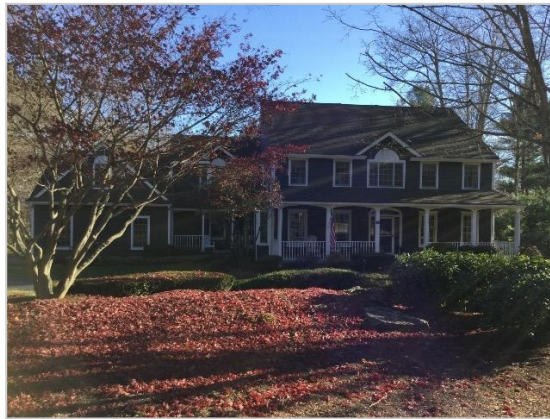
Photo 1

The structure was situated on a moderately sloped lot. The general grade around the structure appeared to be adequate to direct rain water away from the foundation, assuming normal drainage and downspout, gutter, and other systems are functioning properly.

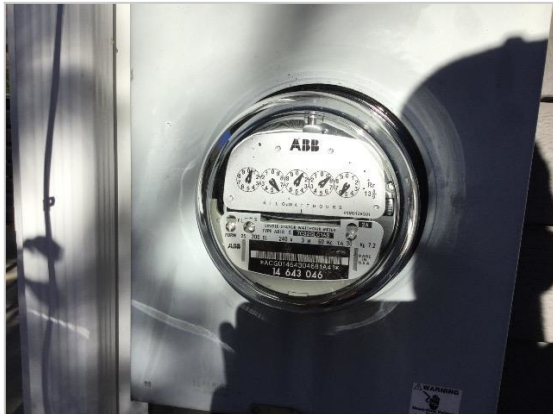
Photo 15

The underground electric service wire entered the structure on the right wall. The electric meter was located on the exterior wall.

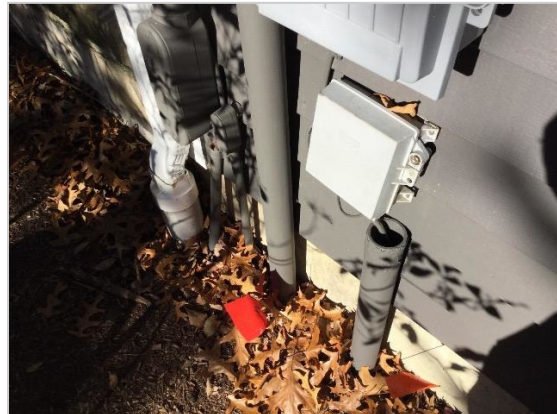
Photo 16

The service wire appeared to be 120/240 volt and 200 amp and entered a Square D service panel, located on the right basement wall. The main service disconnect was 200-amp rated and was located in the main panel. The branch circuits within the panel were copper and aluminum. These branch circuits and the circuit breaker to which they were attached appeared to be appropriately matched. The internal components of the service panel, i.e. main lugs, bus bars, etc were in good condition.

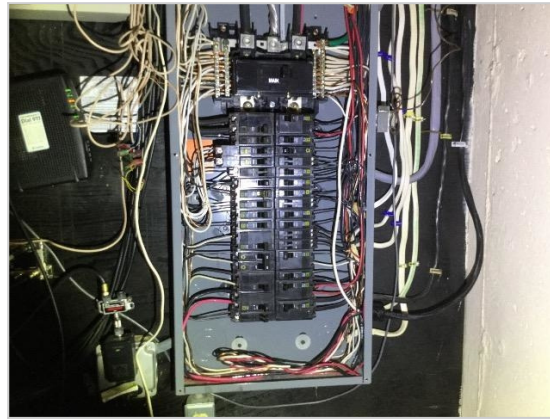
Photo 17

A circuit breaker in the electric panel had two attached circuits (wires). Each circuit should have its own dedicated breaker to prevent nuisance tripping and ensure good terminal contact, which may help prevent overheating. This situation is commonly referred to as a "double-tap". An electrician should repair this condition and further assess the panel for any additional required repairs.
