HOME INSPECTION REPORT

The HomeTeam Inspection Service made a visual inspection of 123 Anywhere St., City, ST 12345. Enclosed please find a written, narrative report of our findings in accordance with the terms of our Inspection Agreement.

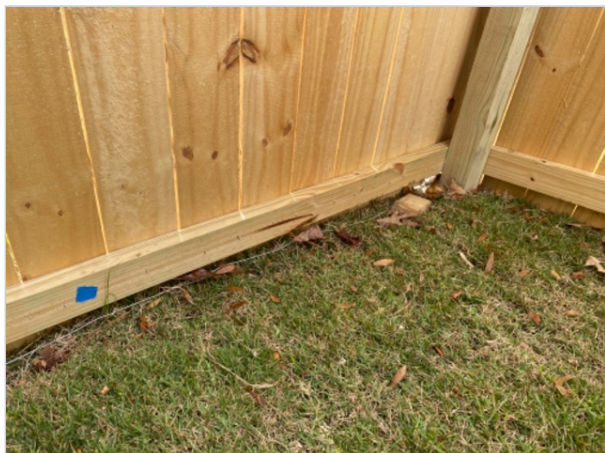
Photo 9

The screws securing the bottom trim board on the right side privacy fence are sharp and longer than what is needed. Resulting in a safety hazard. They should be replaced with shorter screws.

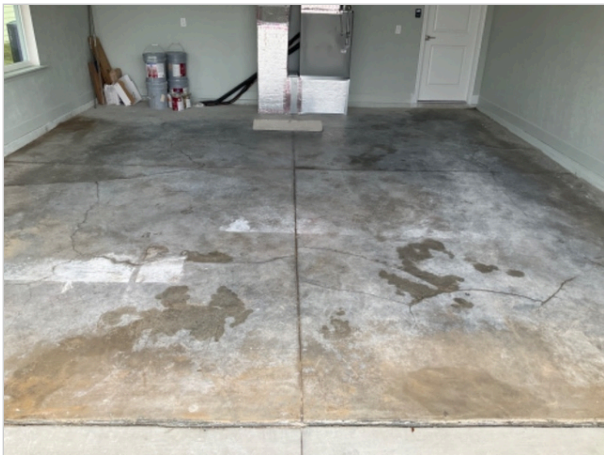
The garage floor had minor spider cracks observed. These cracks did not appear to be a structural issue. These cracks should be sealed and monitored.

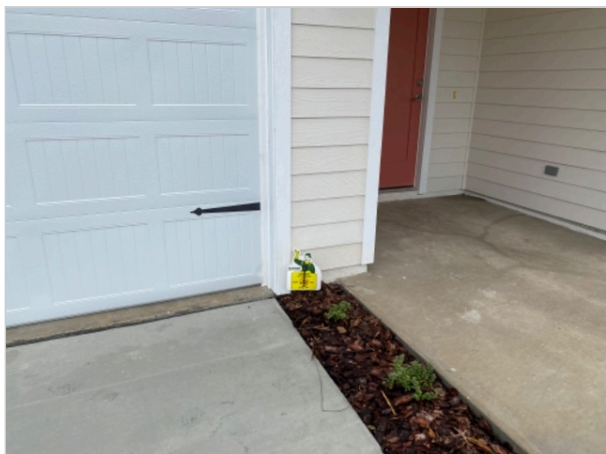
Photo 24

The garage door is dented from what appears to be impact. The door was operating correctly at the time of the inspection. Care should be exercised to ensure that the door is not subjected to further impact, as the door may crack or fail.

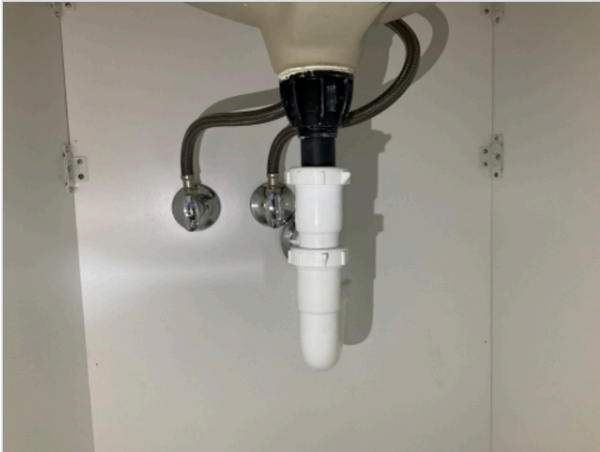
Photo 42

Jack and Jill bathroom

Leaks were observed at the toilet shut off in the Jack and Jill bathroom when in use. The tub and sink in the hall bathroom drain slowly. A licensed plumbing company should be called to evaluate the system and make any repairs.

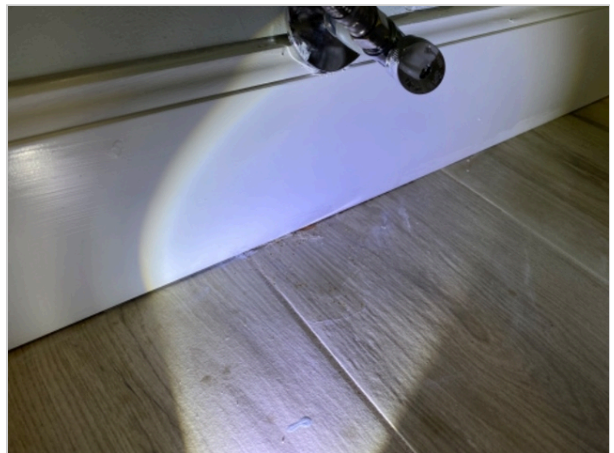
Photo 44

The Jack and Jill toilet shut off is leaking.

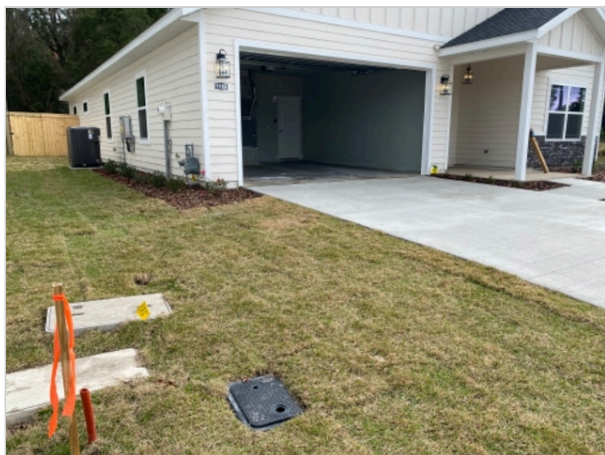
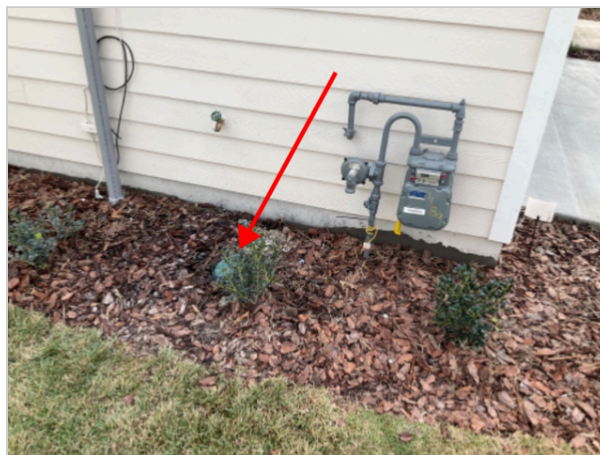
Water shut off

The water meter was located in the front left yard. The main water shutoff valve for the structure was located adjacent to the water service entry point on the left side of the house. Water shutoff valves are visually inspected only. No attempt is made to operate the main or any other water supply shutoff valves during the inspection. These valves are infrequently used and could leak after being operated. The only exception to this policy is made when the main water supply valve is off upon arrival at the inspection. Since it is the buyers right to have all utilities operable for the home inspection, we will attempt to turn the main water valve on for the inspection. The HomeTeam is not responsible for leaks caused by operating the valve.

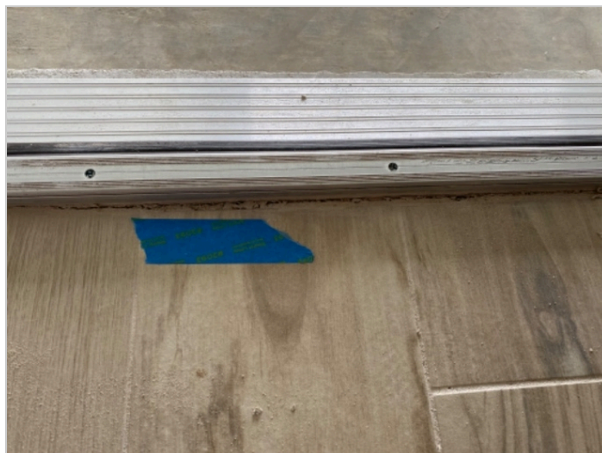
The home was in the final stages of construction. There were blemishes and nicks observed in areas of the home, which is normal. Many areas were marked with blue tape, to help the builder and contractors identify said issues.

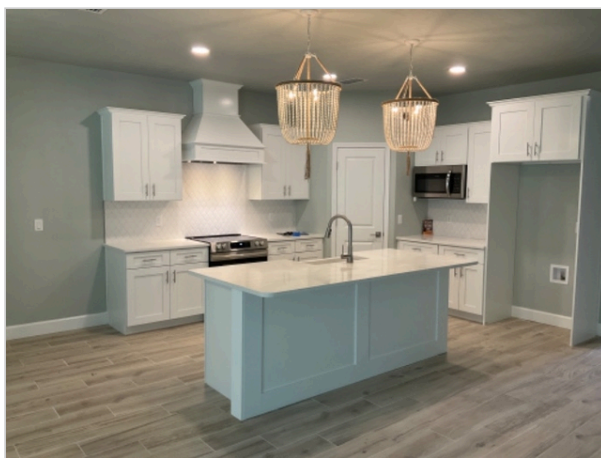
Photo 70

Portions of the kitchens cabinets were not completely secure to the wall. The cabinets should be secured to prevent them from falling.

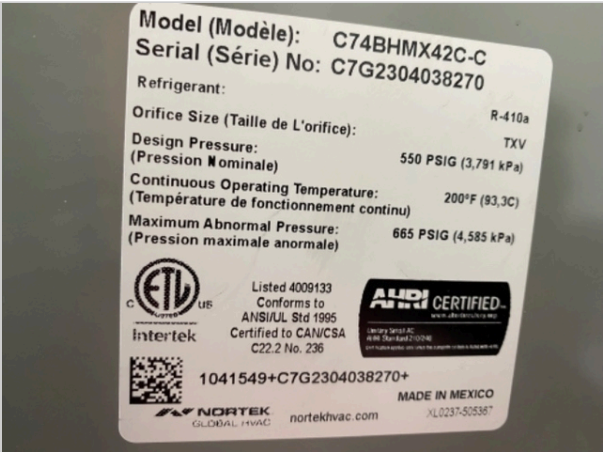
The HVAC condensate line was raised above the floor drain or drain inlet. The condensate line was trapped. The HVAC condensate line must be trapped and not in contact with wet drain inlets to prevent the possible migration of bacteria and mold into the air-handling system. The heating system was found to be functional.
