### *HOME INSPECTION REPORT*

The HomeTeam Inspection Service made a visual inspection of 123 Anywhere St., City, ST 12345. Enclosed please find a written, narrative report of our findings in accordance with the terms of our Inspection Agreement.

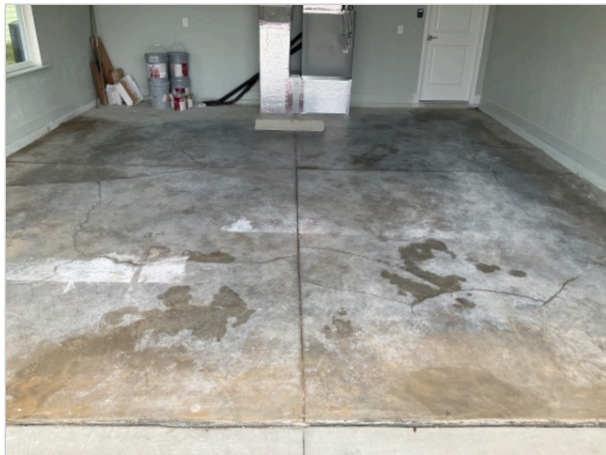
**Photo 18**

Garage

The garage floor had minor spider cracks observed. These cracks did not appear to be a structural issue. These cracks should be sealed and monitored.

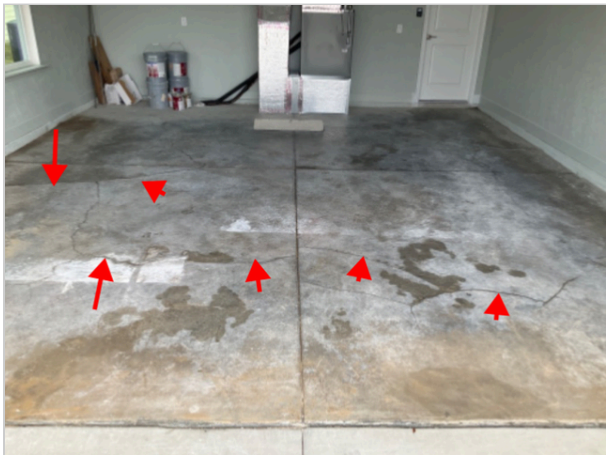
**Photo 19**

Garage

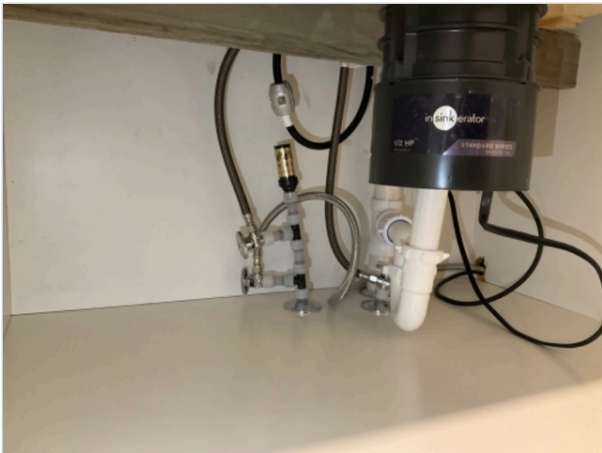
**Photo 38**

Kitchen

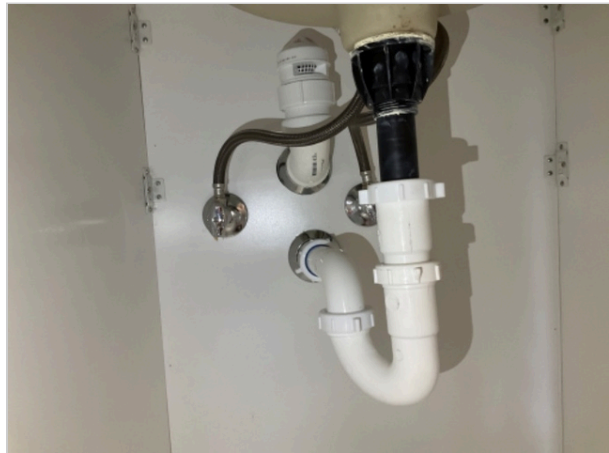
**Photo 39**

Guest bathroom

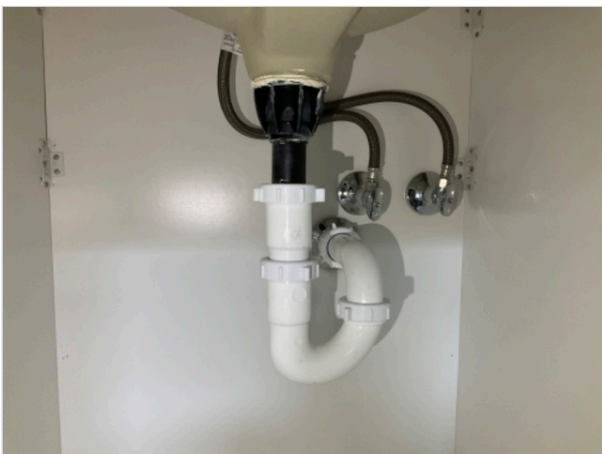
**Photo 40**

Master left

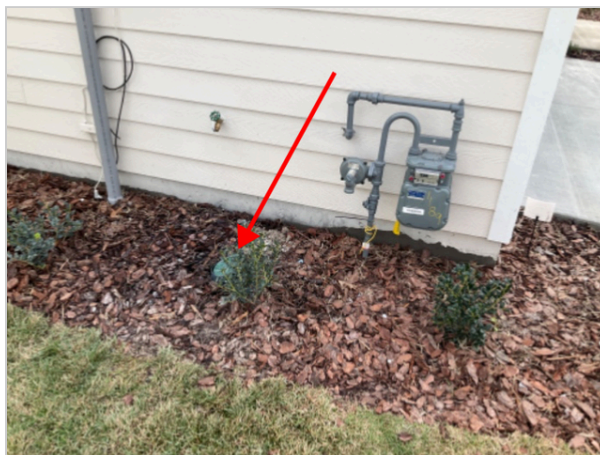
**Photo 52**

The water meter was located in the front left yard. The main water shutoff valve for the structure was located adjacent to the water service entry point on the left side of the house. Water shutoff valves are visually inspected only. No attempt is made to operate the main or any other water supply shutoff valves during the inspection. These valves are infrequently used and could leak after being operated. The only exception to this policy is made when the main water supply valve is off upon arrival at the inspection. Since it is the buyers right to have all utilities operable for the home inspection, we will attempt to turn the main water valve on for the inspection. The HomeTeam is not responsible for leaks caused by operating the valve.

Water shut off

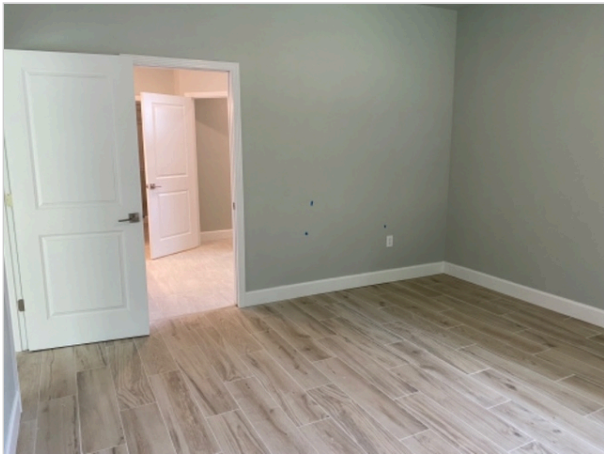
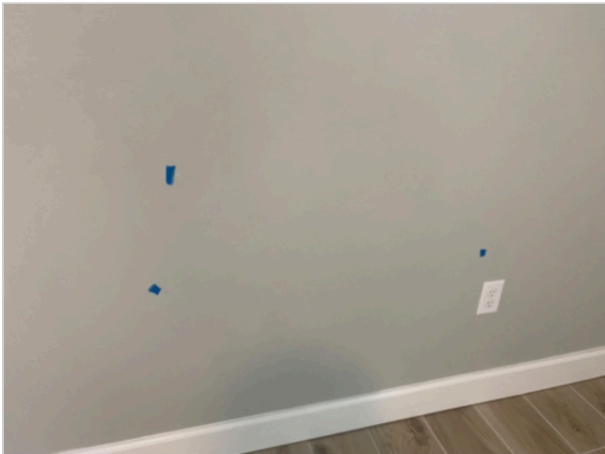
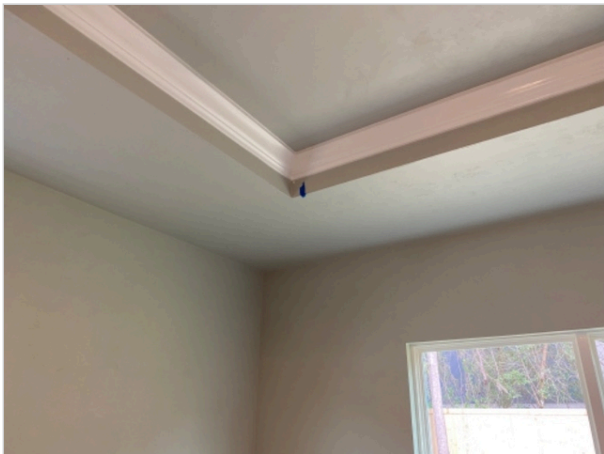
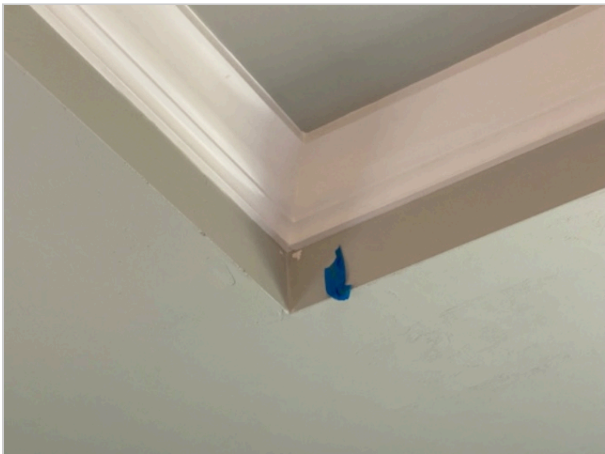
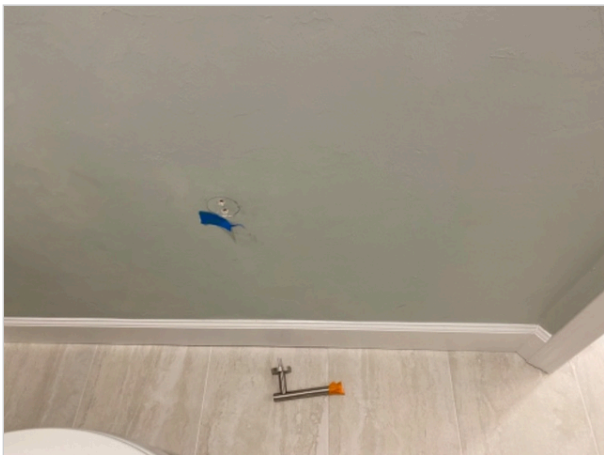
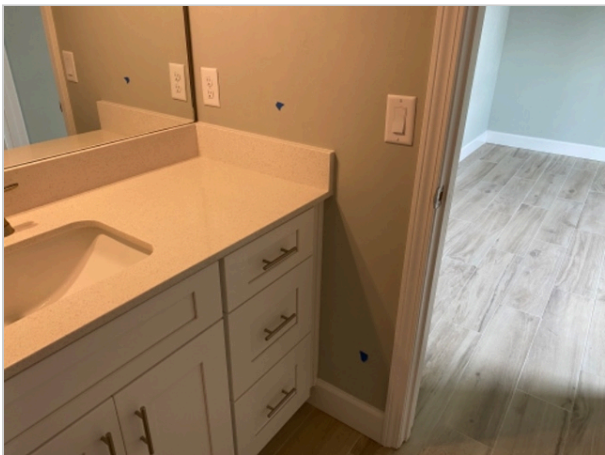
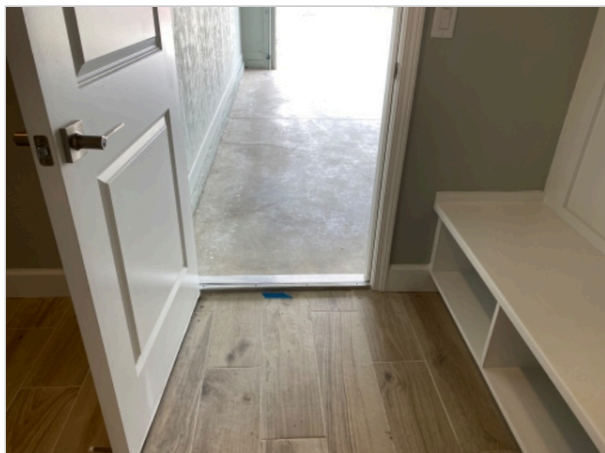
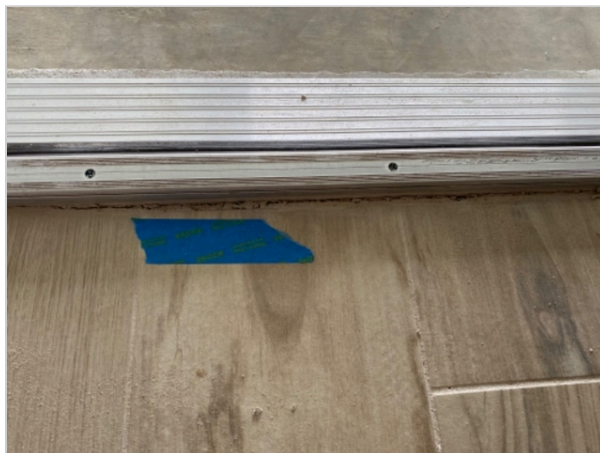
**The home was in the final stages of construction. There were blemishes and nicks observed in areas of the home, which is normal. Many areas were marked with blue tape, to help the builder and contractors identify said issues.**

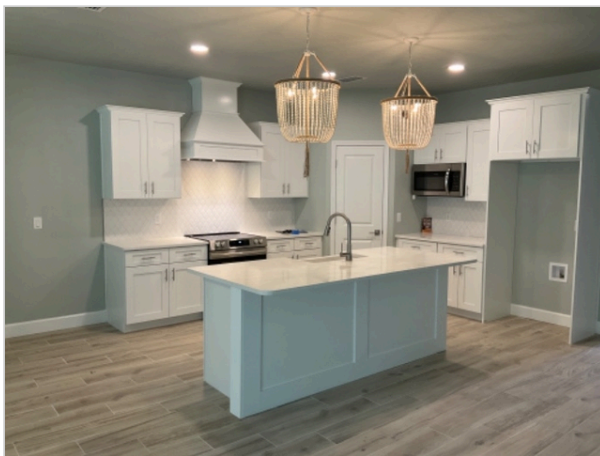
**Photo 70**

**Portions of the kitchens cabinets were not completely secure to the wall.** The cabinets should be secured to prevent them from falling.

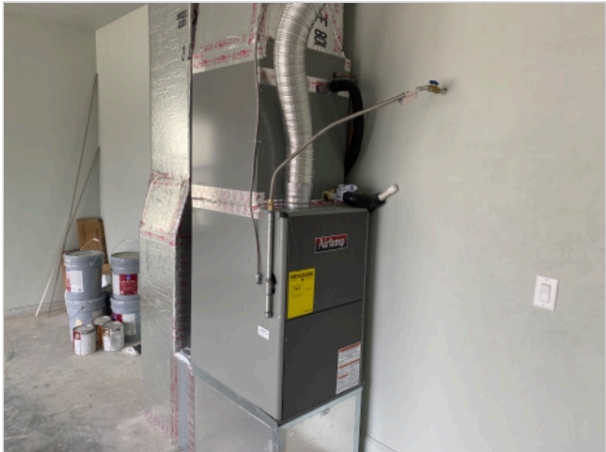
Photo 80

The structure was heated by an AirTemp natural gas air handler, Model Number C74BHMx42C-C and Serial Number C7G2304038270, which is less than one year old. The unit was located in the garage of the structure. The automatic safety controls on the unit were tested and found to be functional at the time of the inspection.

The HVAC condensate line was raised above the floor drain or drain inlet. The condensate line was trapped. The HVAC condensate line must be trapped and not in contact with wet drain inlets to prevent the possible migration of bacteria and mold into the air-handling system. The heating system was found to be functional.

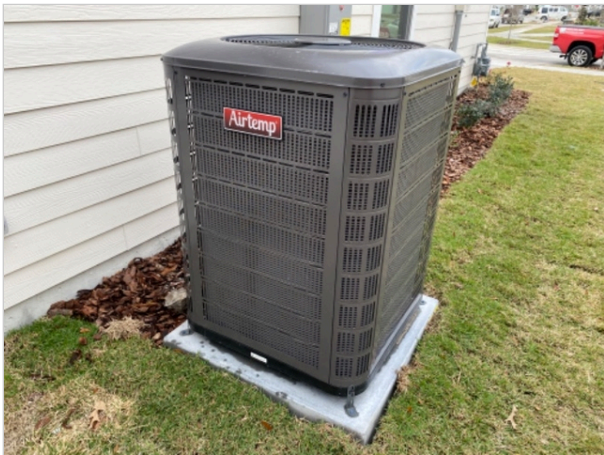
**Photo 82**

The electric outdoor air conditioner condensing unit was an Airtemp, Model Number VSA3BE4M1SN42K and Serial

Number VSG2309006528. The unit is located on the left side of the structure. This unit is approximately less than one years old. Periodic preventive maintenance is recommended to keep this unit in good working condition. The cooling system was functional.

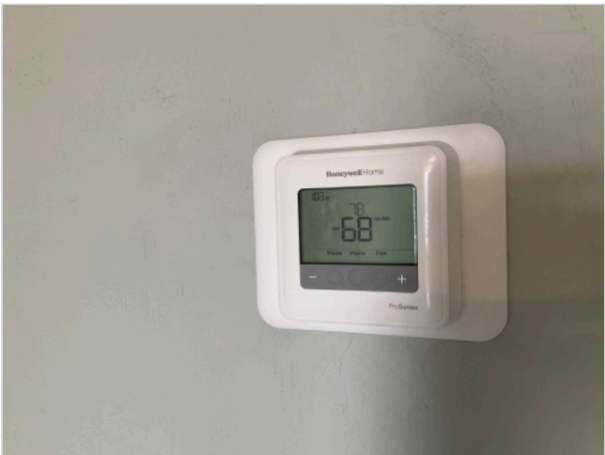
**Photo 84**

The control for the heating and air conditioning system was a 24 volt digital programmable thermostat located on the hallway wall of the home. The thermostat was manufactured by Honeywell and was found to be in working order.
