HOME INSPECTION REPORT

The inspected property consisted of a single story wood-framed structure with brick and wood siding that was vacant at the time of the inspection. There were material defects on the visible portions of the siding. The approximate temperature at the time of the inspection was 30 to 35 degrees Fahrenheit, and the weather was snowy. The utilities were on at the time of the inspection. The buyer and their agent were present during the inspection. The home was situated on a lightly sloped lot. The general grade around the home appeared to be adequate to direct rain water away from the foundation. The age of the home, as reported by the MLS sheet was said to be eighty to ninety years old. There was a concrete walkway leading to a concrete porch in the front of the home. There were material defects observed in the walkway or the porch.

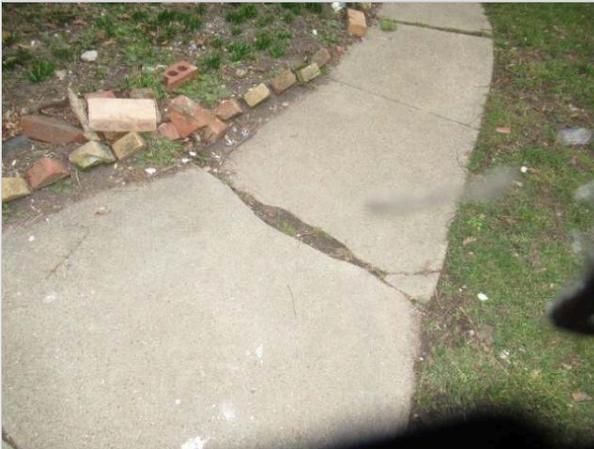
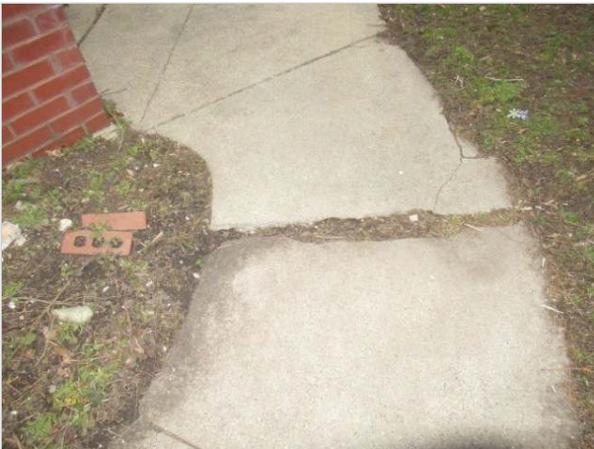
- ***The front and right walkways were cracked and damaged and should be corrected as this is a trip hazard.***

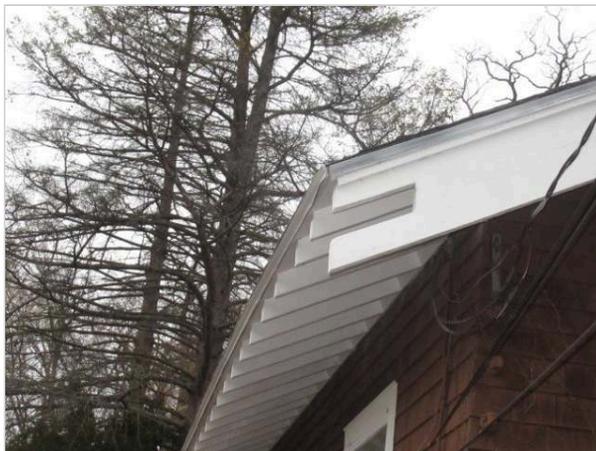
- ***There were gutters and downspouts missing from the left side of the home. Gutters and downspouts help facilitate proper drainage of roof water away from the foundation of the home and we recommend they be installed.***

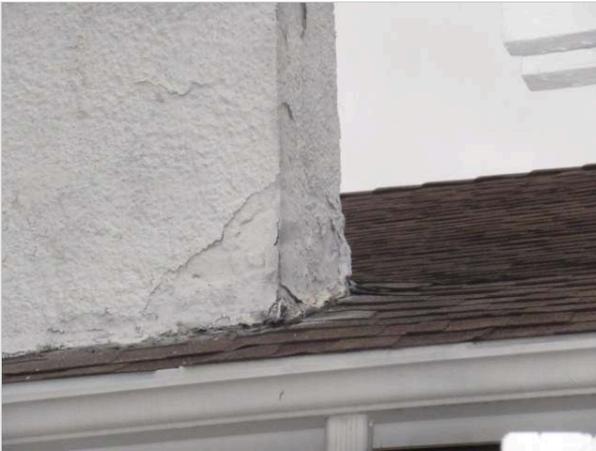
- ***There was damaged brickwork skim-coat at both chimneys that should be repaired.***

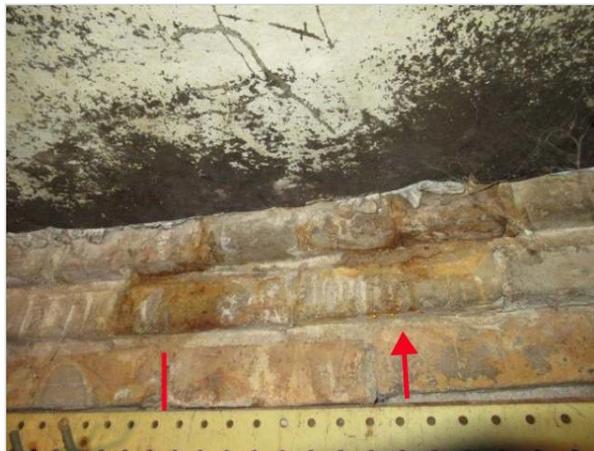
- ***There was active seepage at the front basement brickwork that should be further evaluated by a water proofing company.***

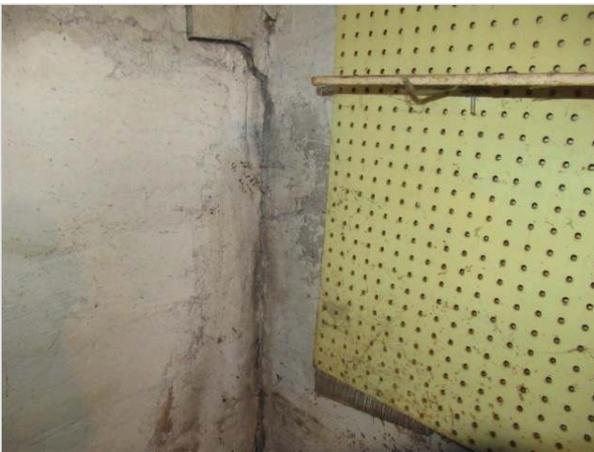
- ***There were a few substantial foundation cracks at the front and left walls that should be further evaluated by a foundation company.***

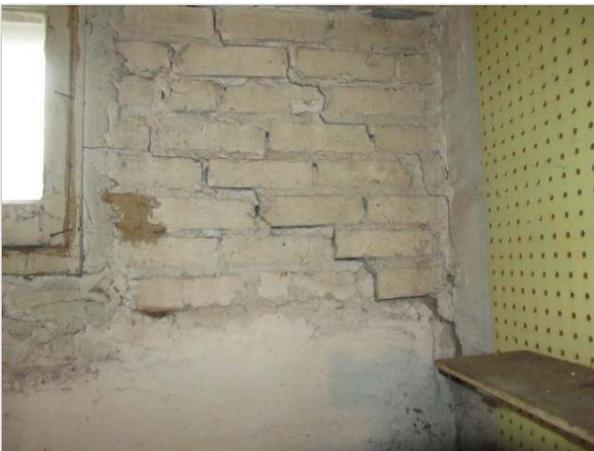
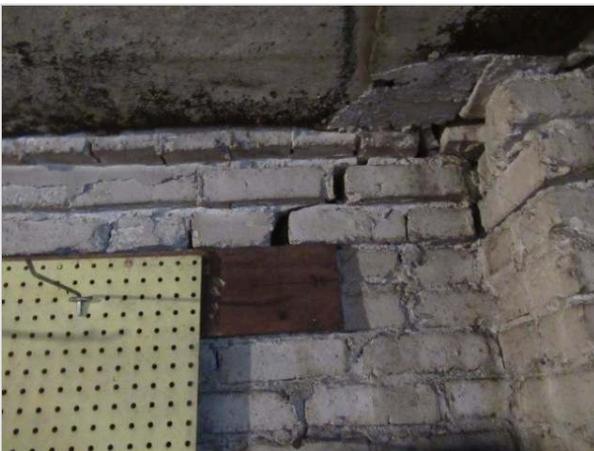
- *There was stair step cracking of the basement brickwork on the front and left sides of the home with shifted bricks that should be further evaluated and repaired by a foundation company.*

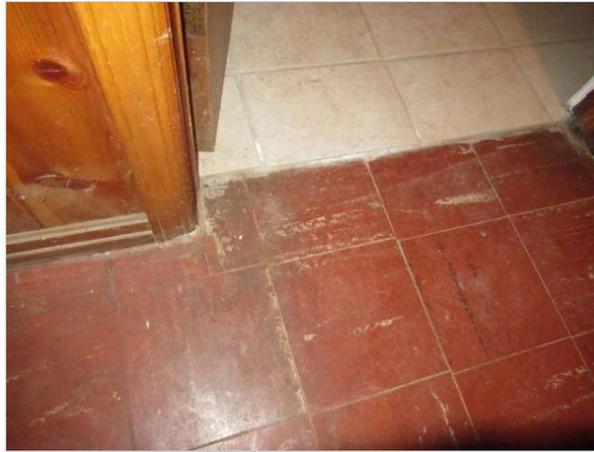
- **The handrail on the staircase leading to the basement was loose and should be secured for safety reasons.**
- **There were 9X9 floor tiles in the basement, which have the characteristics of tile that may contain asbestos. The visible tile appeared to be deteriorating or decaying at the time of the inspection. The only way to confirm the possible asbestos content of this material is to have a sample tested by a qualified laboratory. It is advisable to avoid disturbing the substance prior to any testing. These tiles should be tested and handled with care as they may pose a safety concern.**

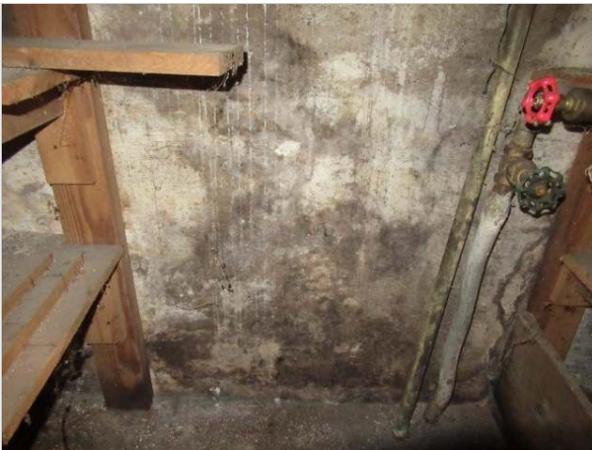
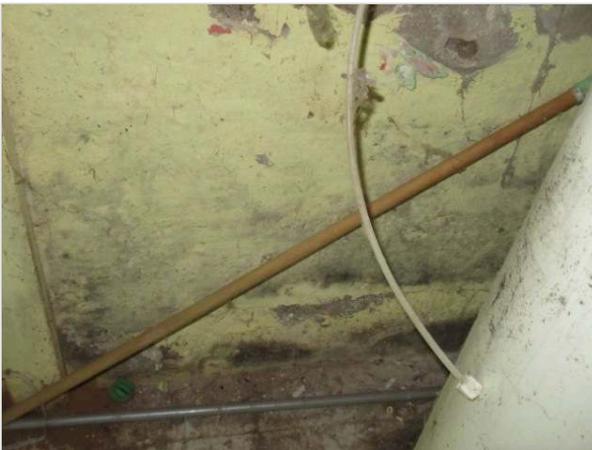
- **There was possible mold growth throughout the basement that should be further evaluated and treated as necessary.**

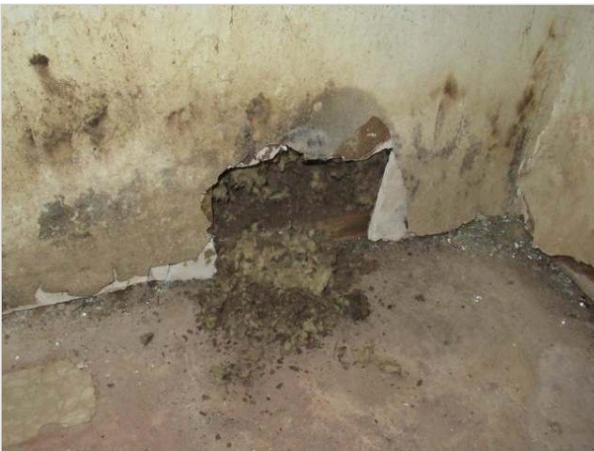
- ***There was water damage with a mold-like substance at the walls in the basement laundry room that should be repaired.***

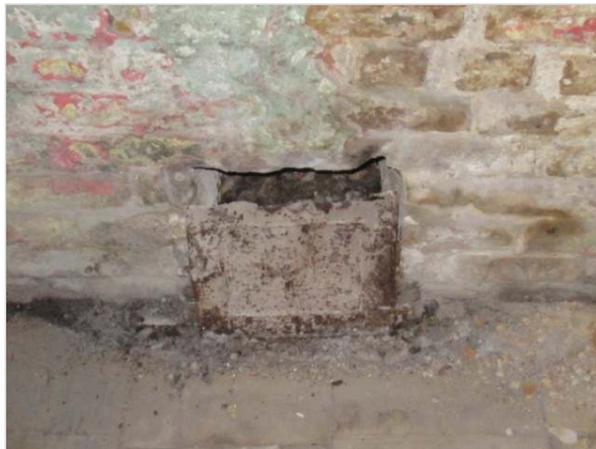
- ***The basement chimney clean-out door was damaged and should be replaced.***

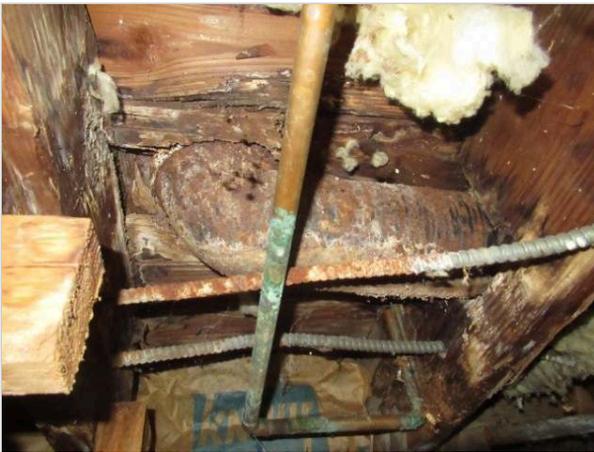
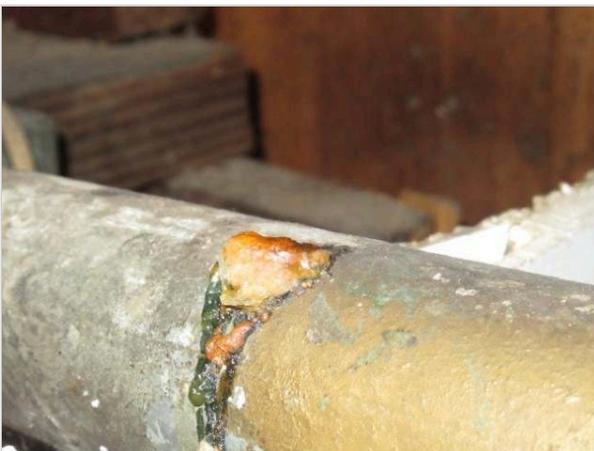
- ***It was too cold to test the outdoor spigots.***
- ***There were rusted and corroded plumbing pipes in the basement that should be further evaluated and corrected as necessary by a plumber.***

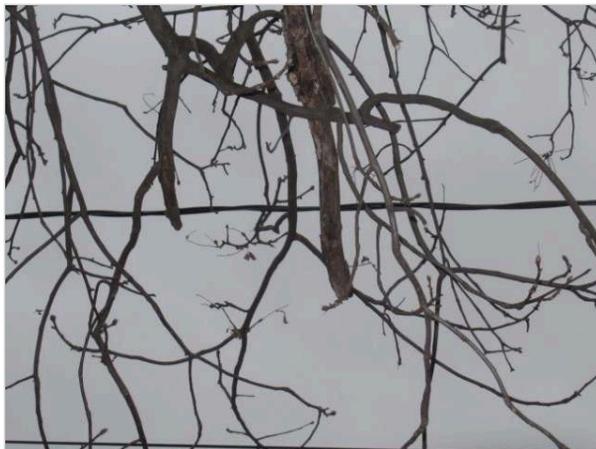
- ***There were tree branches too close or making contact with the main overhead electrical line and should be further evaluated and trimmed back.***

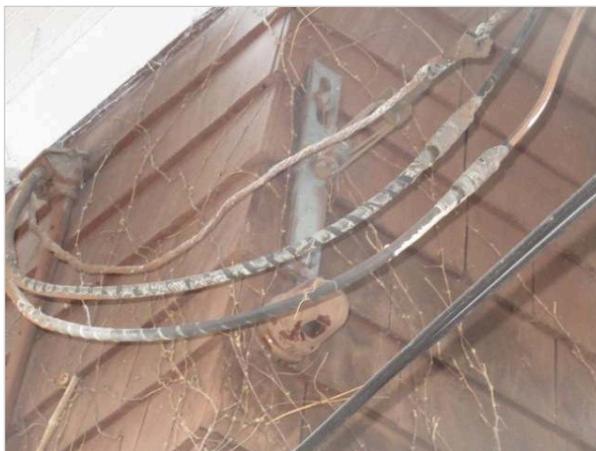
- ***The service entrance cable on the exterior of the home was weathered and may need to be replaced. We recommend further evaluation by a licensed electrician.***

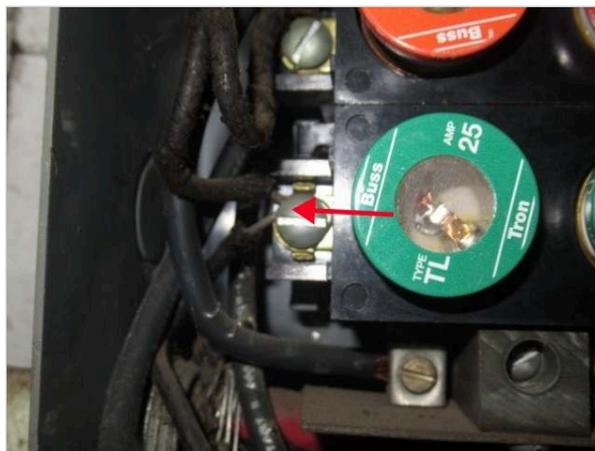
- *There were double taps observed in the main electrical panel that should be further evaluated and corrected by an electrician.*

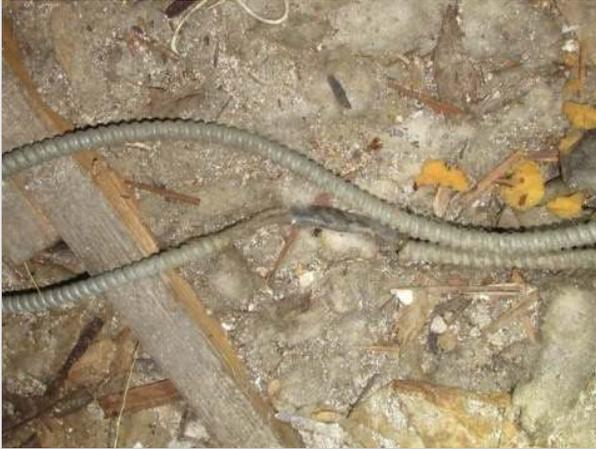
- ***Open electrical splices were noted in the attic. All electrical splices should be enclosed in an approved and covered electrical box.***

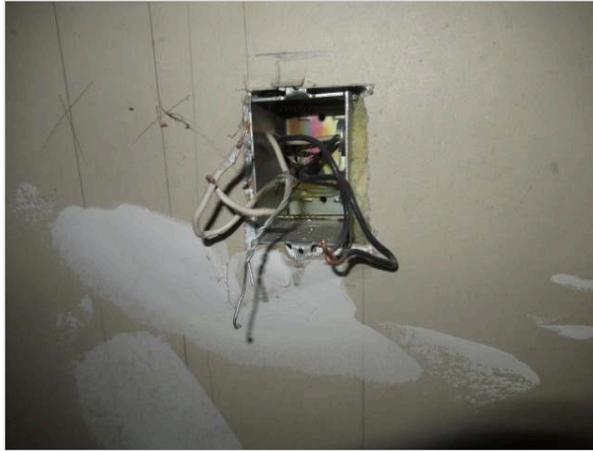
- *Exposed or un-terminated live wires were noted in the basement. The wires should either be disconnected at the source or properly terminated in an approved, covered electrical box.*

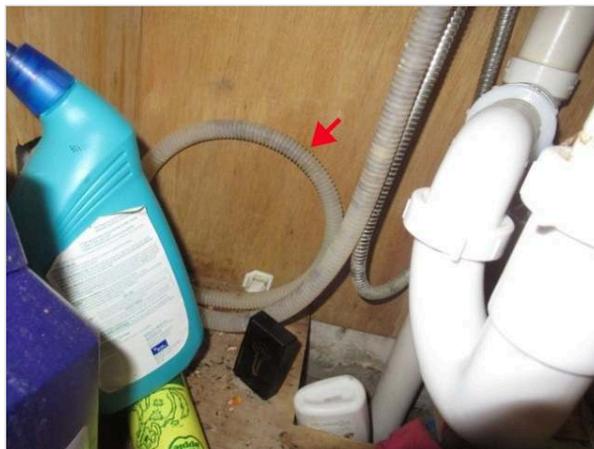
- ***There was no air gap for the dishwasher drain connection and we recommend that this be corrected.***

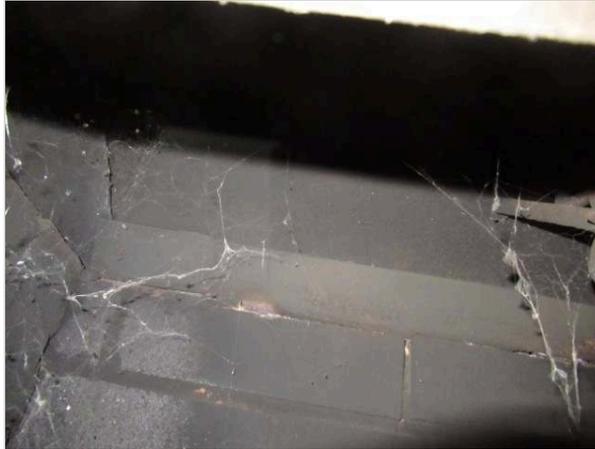
- ***There was creosote build up in the living room fireplace that should be cleaned by a chimney sweep prior to use.***

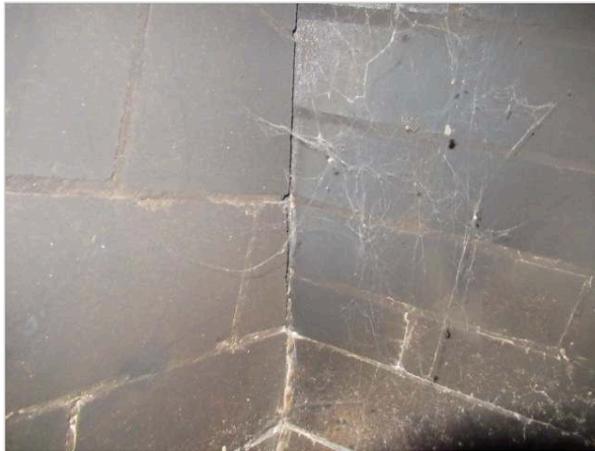
- ***There were cracks in the firebox of the fireplace located in the living room. The bricks and mortar inside the firebox are designed to act as a heat and spark shield and should be free of any voids. The fireplace should be serviced and repaired by a chimney sweep prior to use.***

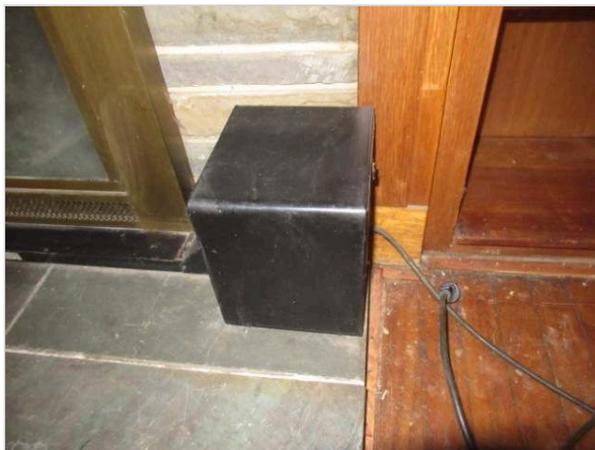
- ***The living room fireplace fan was not functional and should be repaired or replaced.***

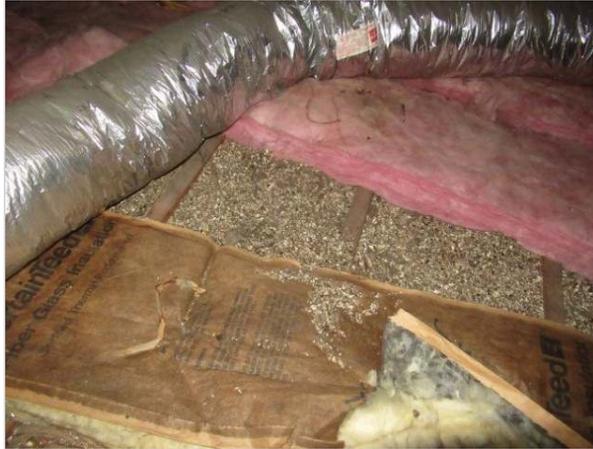
- ***There was some insulation in the attic which appeared to be of a material that may contain a small amount of asbestos. The EPA recommends that homeowners make every effort not to disturb the vermiculite insulation in their attics. If you plan to remodel or conduct renovations that would disturb the vermiculite, hire professionals trained and certified to handle asbestos and safely remove the material. More information on vermiculite can be found on the EPA web site; <http://www.epa.gov/asbestos/pubs/verm.html>***

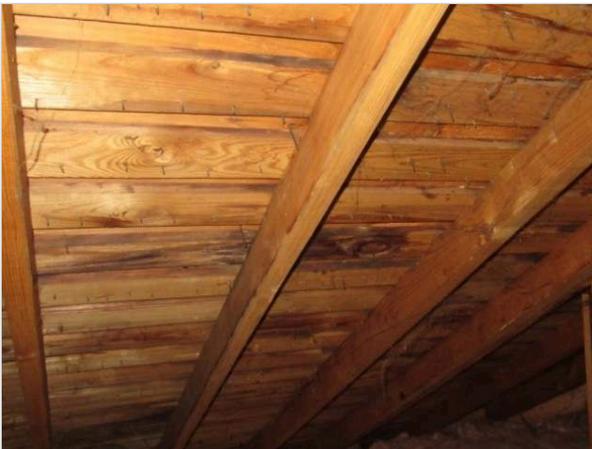
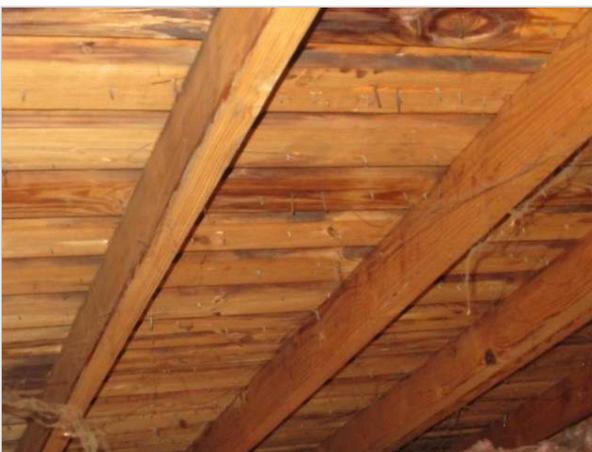
- ***There were signs of previous moisture at the right side of the attic that should be further evaluated and corrected.***

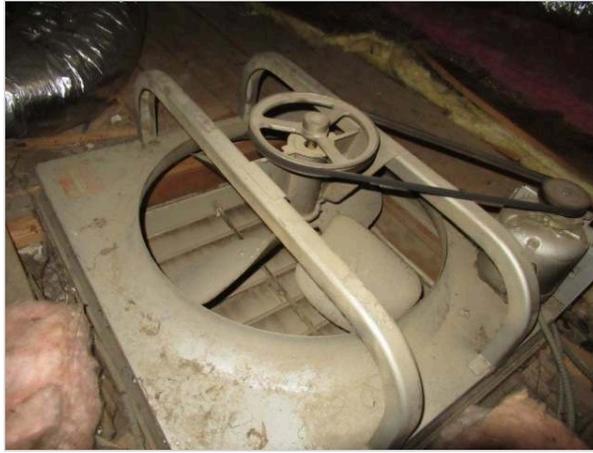
- ***The whole house fan was tested and found to be non-functional and should be repaired or replaced.***

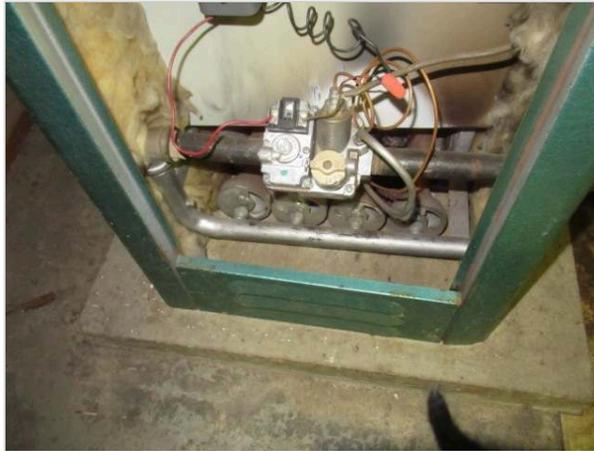
The heating, ventilating and air conditioning systems were inspected by Kooch Heating & Cooling (630) 232-7700. Annual maintenance of the heating and cooling equipment is essential for safe and efficient performance, which will maximize the system's useful life. The results of our visual and operational inspection of the heating and air conditioning system are described below. Periodic preventive maintenance is recommended to keep this unit in good working condition. The home was heated by an Iron Fireman natural gas boiler, model number 21WEN and serial number was not legible which is over 30 years old. The unit was located in the basement of the home. It has an approximate net heating capacity of 180,000 BTUH. NOTE: Without removing the burners to gain complete access, and with the limited viewing area of the heat exchanger, a thorough inspection is not possible. The heating system was found to be functional but poor condition.

- ***There was flame roll-out at the boiler burners at the time of the inspection and should be further evaluated by an HVAC technician. For safety reasons, the boiler was turned off at the thermostat.***
- ***Due to the age and condition of the boiler, we recommend budgeting for replacement.***

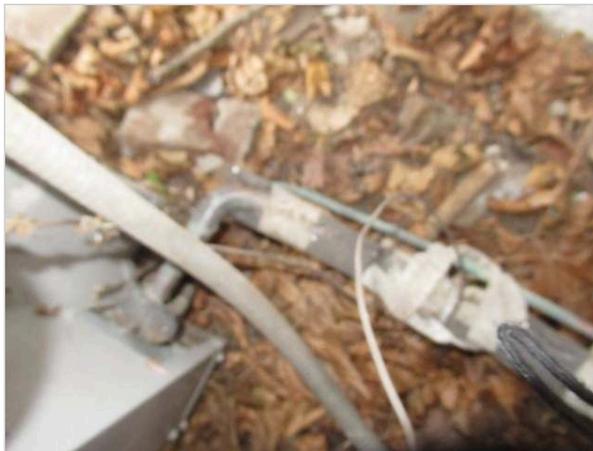
- ***The condenser should be cleaned and serviced by an HVAC technician in the spring.***
- ***Due to the age of the air conditioner, we recommend budgeting for replacement.***
