**HomeTeam**<sup>®</sup>  
INSPECTION SERVICE

### HOME INSPECTION REPORT

*This summary provides a simplified overview of the results of the Friday, April 13, 2018 inspection at 123 Sample Drive, Woodbridge, VA 22191. Be sure to read the full body of the inspection report; it contains much more detail about the property. Any additional evaluations we've recommended must be performed prior to the conclusion of the inspection contingency period.*

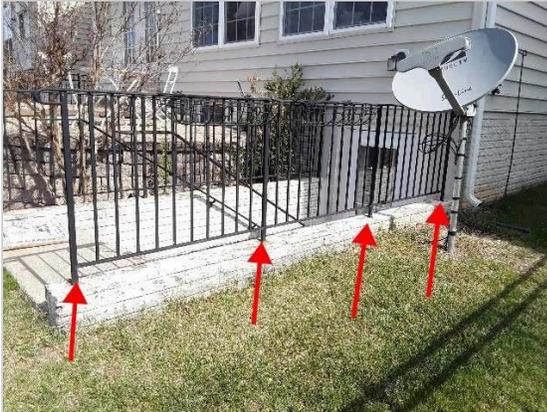
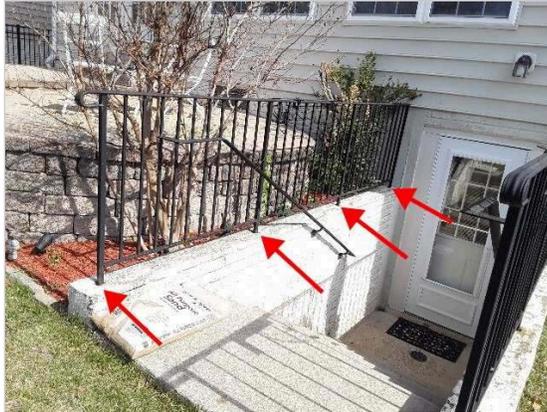
1. There was corrosion noted at the base of the guard rails on the exterior basement stairs. The corrosion should be treated to prevent further corrosion and damage to the rails.

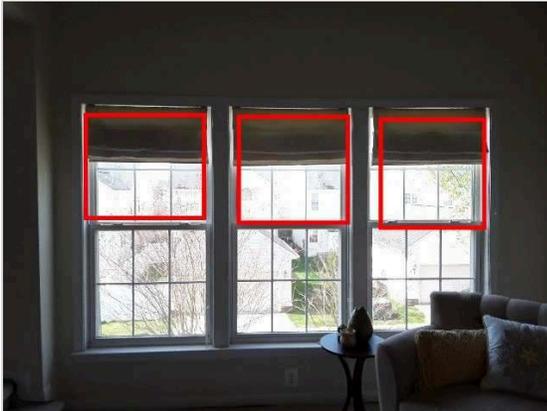
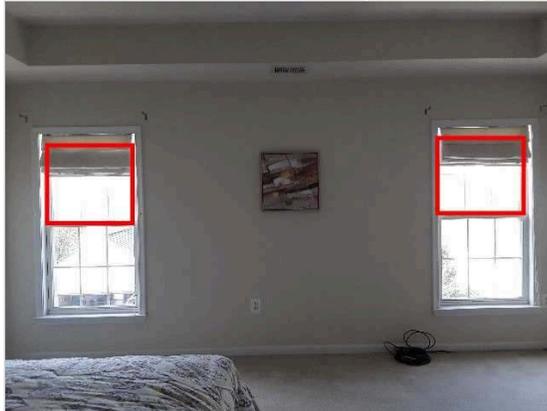
2. One or more of the insulated window panes in the master bedroom had a defective thermal seal. A defective thermal seal can be identified when fogging is observed between the panes of glass. A defective thermal seal does not affect the performance of the window. Repair of the thermal seal can be accomplished by replacing the affected glass panel.

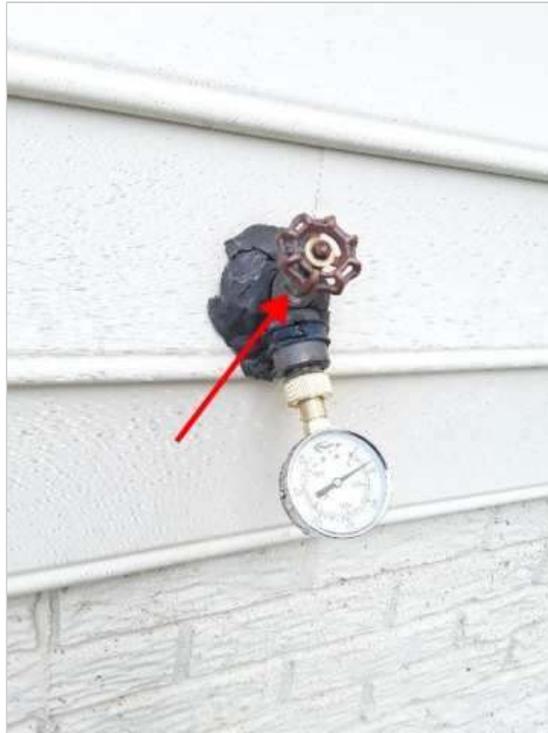
1. The left hose bib and the hose bib in the garage leaked when tested. Consult with a qualified contractor for repair.

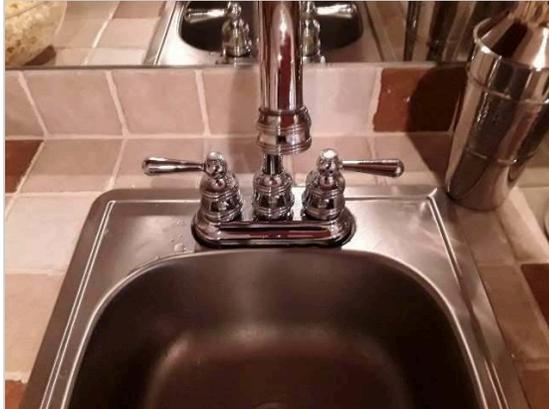
2. The faucet assembly located in the basement wet bar was loose.

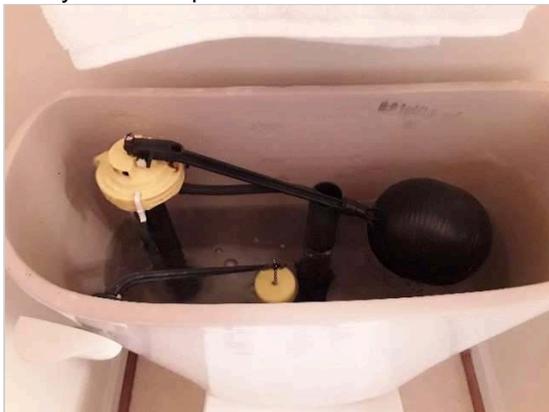
3. There was a leaky fill valve in the toilet located in the 2nd floor hallway bathroom. Consult with a qualified plumber or handyman for repairs.

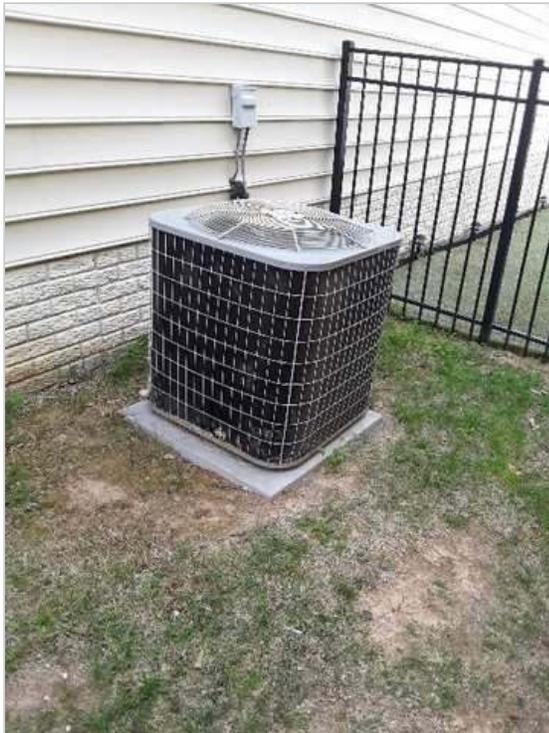
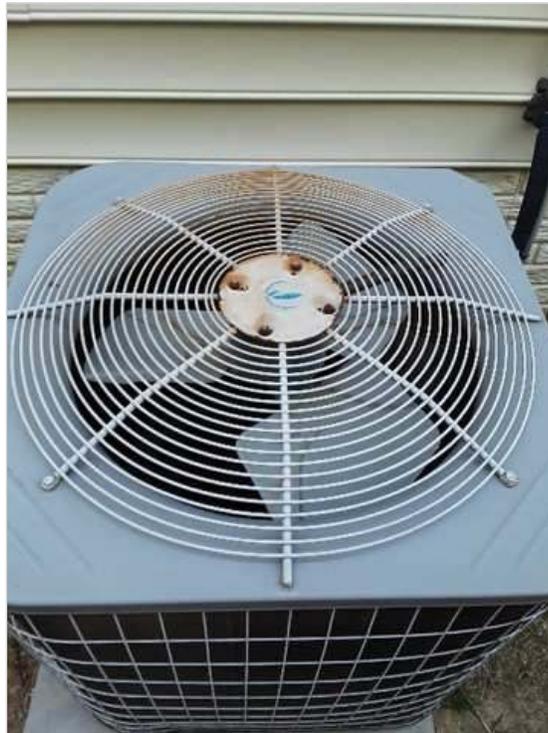
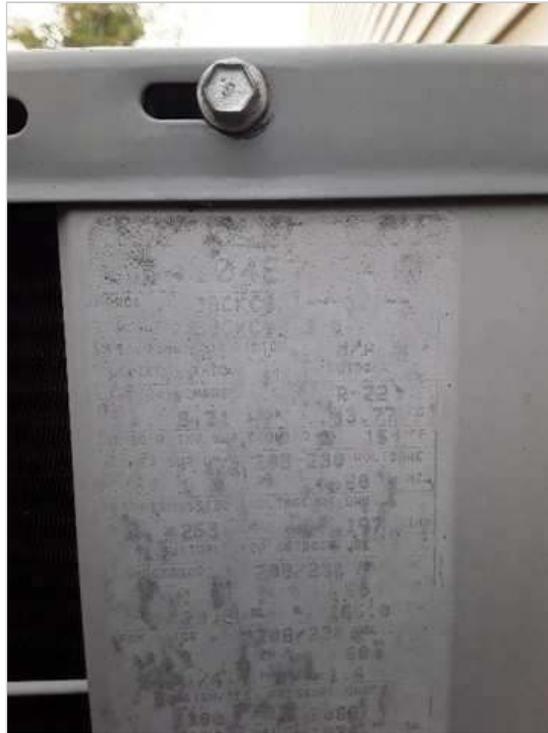
2. Outdoor air conditioner condensing units will typically last approximately 12-15 years before needing to be replaced. An outdoor condensing unit will last longer by doing regular maintenance. The subject condensing unit has been in service for approximately 13 years and was functioning at the time of inspection. The label on the unit was not legible due to wear and therefore the model and serial numbers were not available. The unit may potentially be at or nearing the end of its usable life.

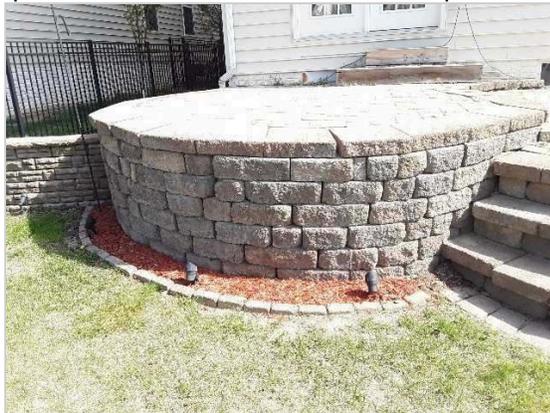
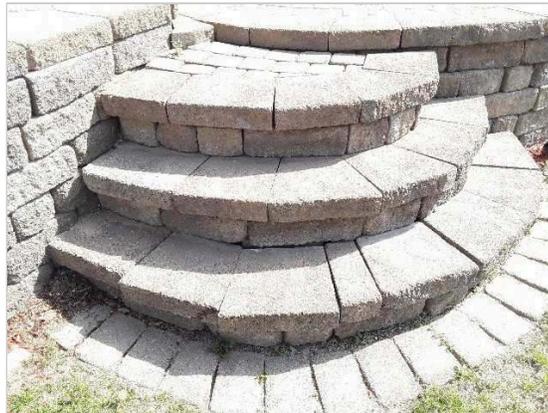
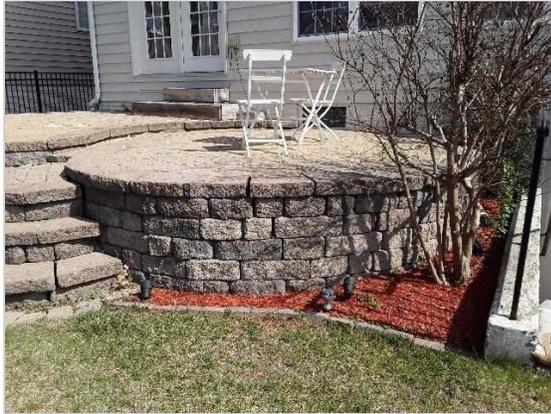
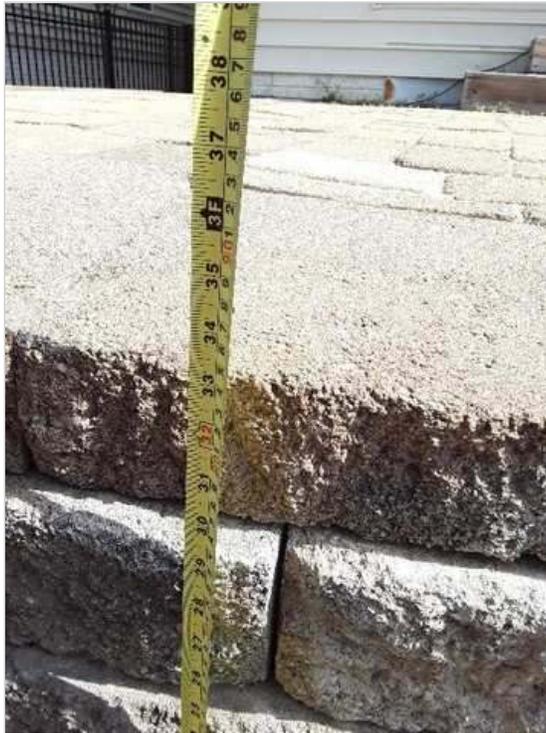
1. The earth beneath the cement paver patio in the rear of the home over time has started to erode away causing the pavers to shift creating several trip hazards found on the walkways around the house. In order to remedy the safety concern it will take extensive landscaping to relevel all of the pavers and the earth beneath them. Consult with a qualified contractor for estimates on repairs.

The earth beneath the cement paver patio in the rear of the home over time has started to erode away causing the pavers to shift creating several trip hazards found on the walkways around the house. In order to remedy the safety concern it will take extensive landscaping to relevel all of the pavers and the earth beneath them. Consult with a qualified contractor for estimates on repairs.

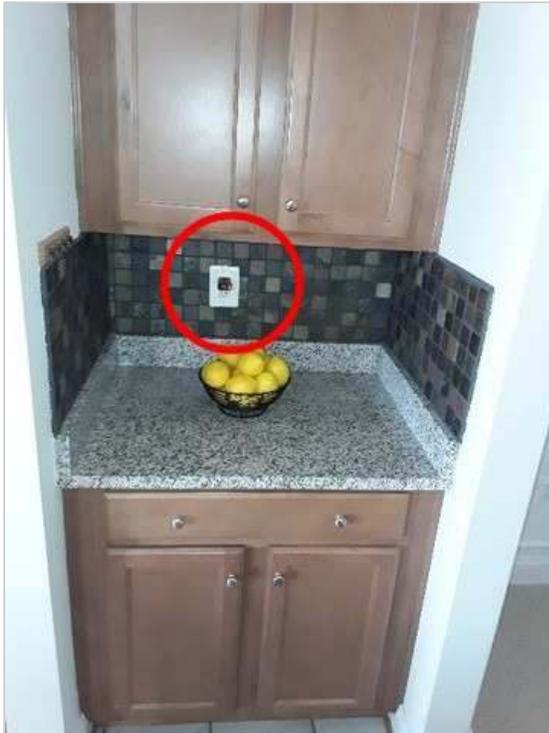
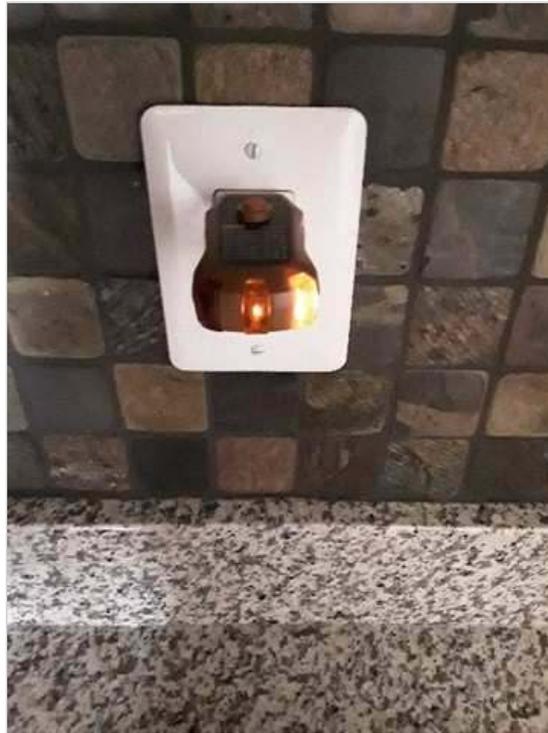
1. The GFCI outlet located in the kitchen is defective and should be replaced by a qualified electrician.

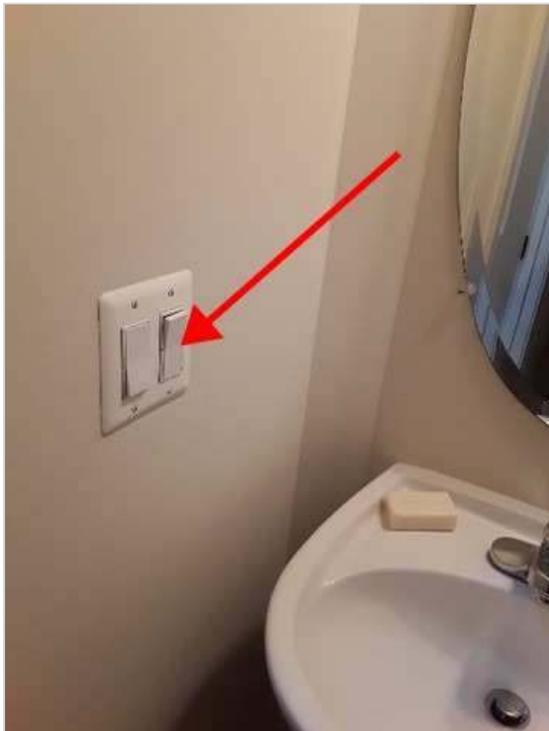
2. A broken switch was noted in the main level half bath. This could be a shock hazard due to exposed electrical contacts. The affected outlet(s) should be replaced by a qualified contractor.

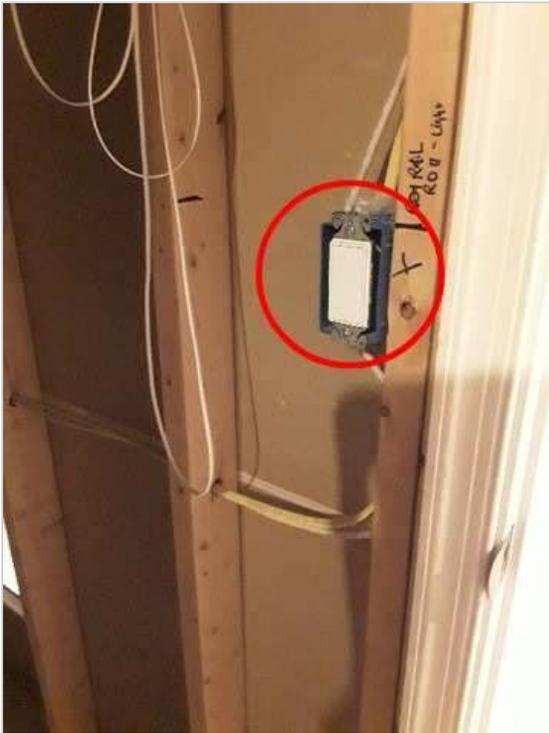
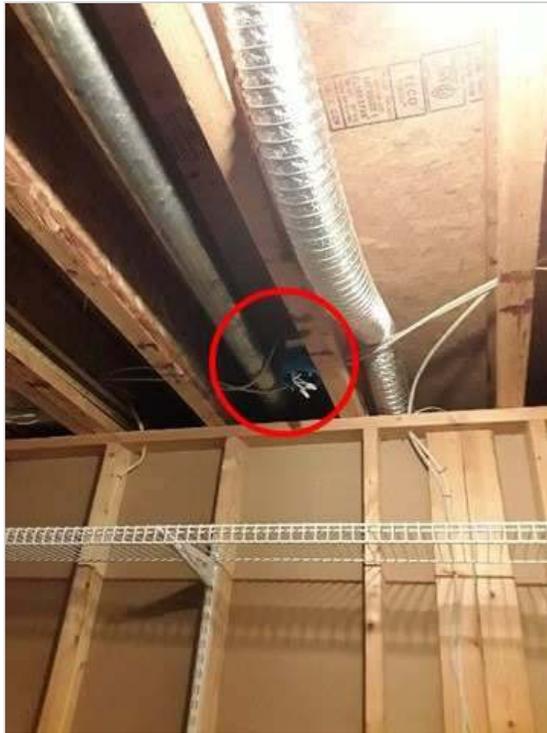
3. One or more devices were missing a switch/junction box/outlet cover in the mechanical/plumbing room. All switch/outlet boxes should be properly covered to avoid a shock hazard. Electrical related repairs should be performed by a qualified electrician.

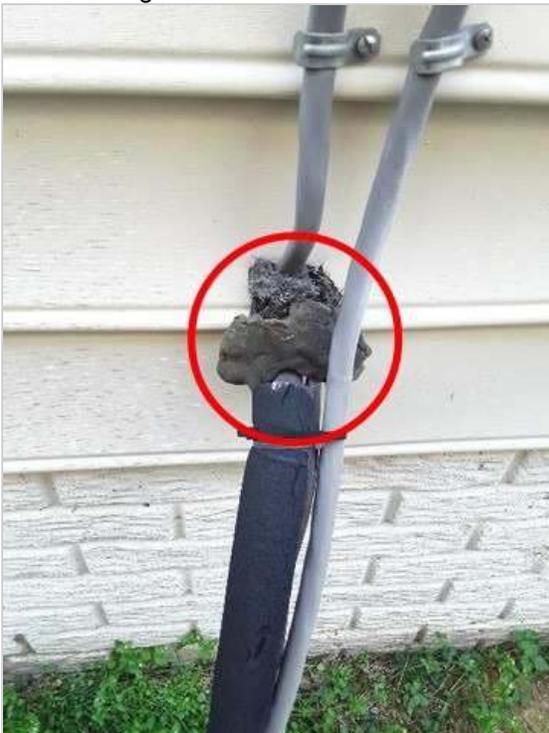
1. The lineset needs to be resealed where it passes through the exterior wall of the home to prevent water and/or insects from entering the home.

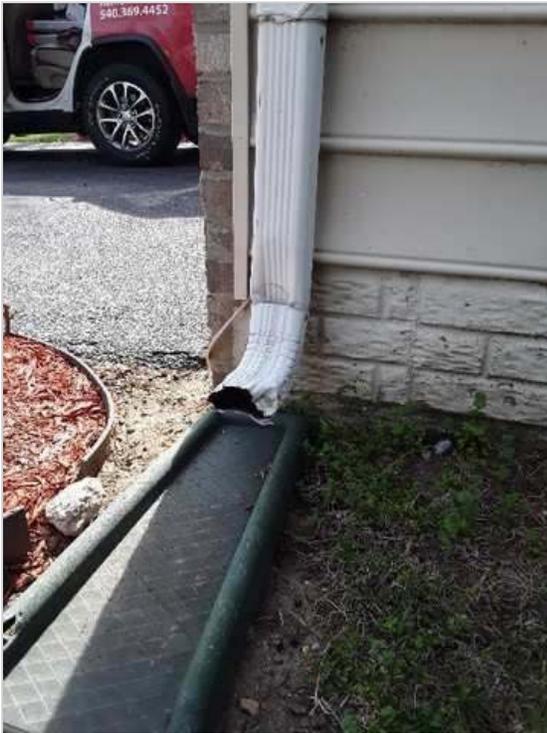
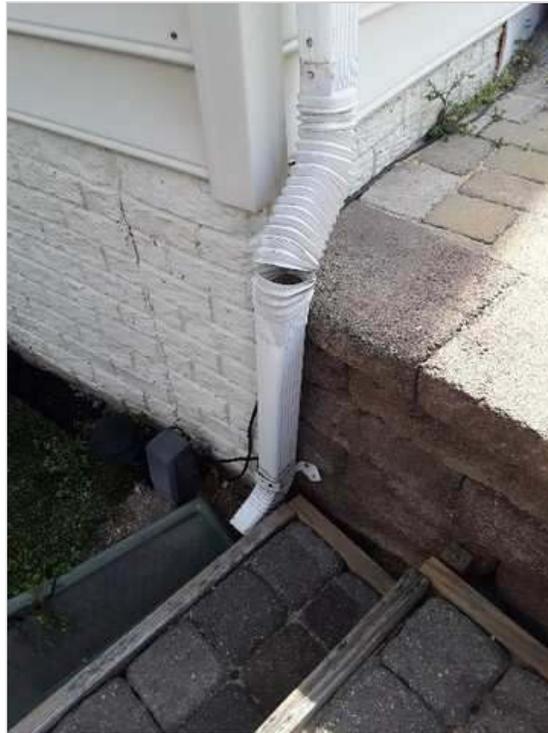
2. The right front and the right rear downspouts were damaged. This may restrict or improperly flow the water away from the foundation and should be corrected.

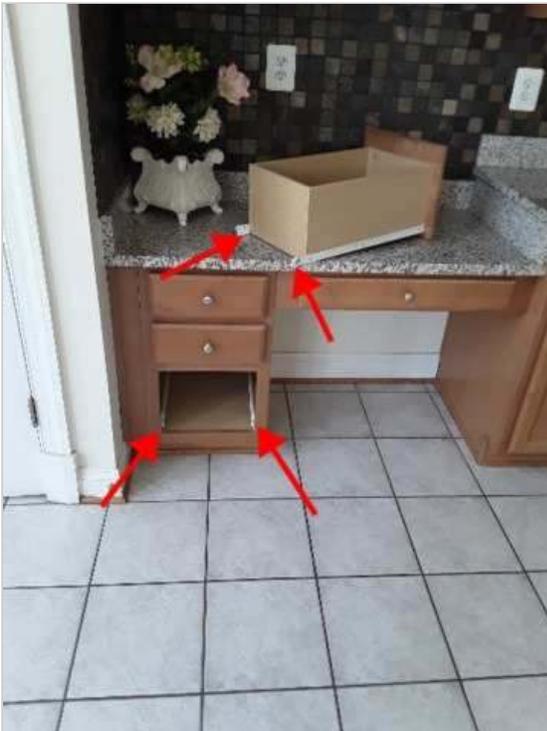
3. The drawer slides were bent on one of the kitchen drawers.

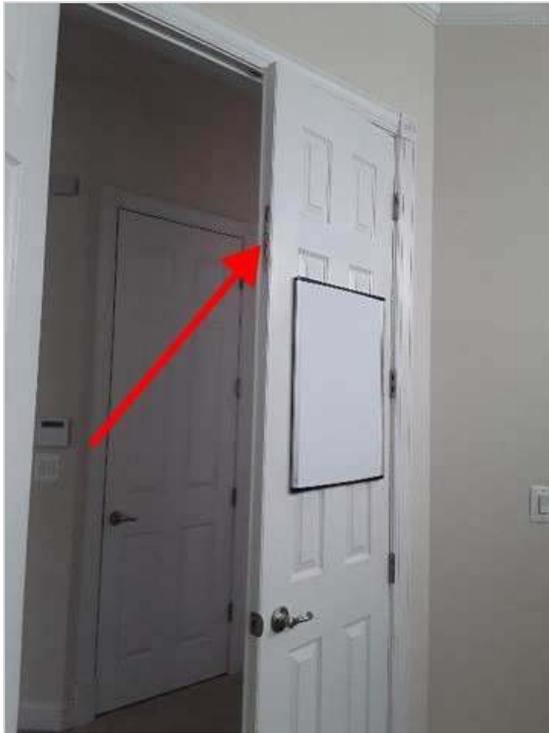
4. The latch was missing hardware on one of the door leading to the office on the main floor.

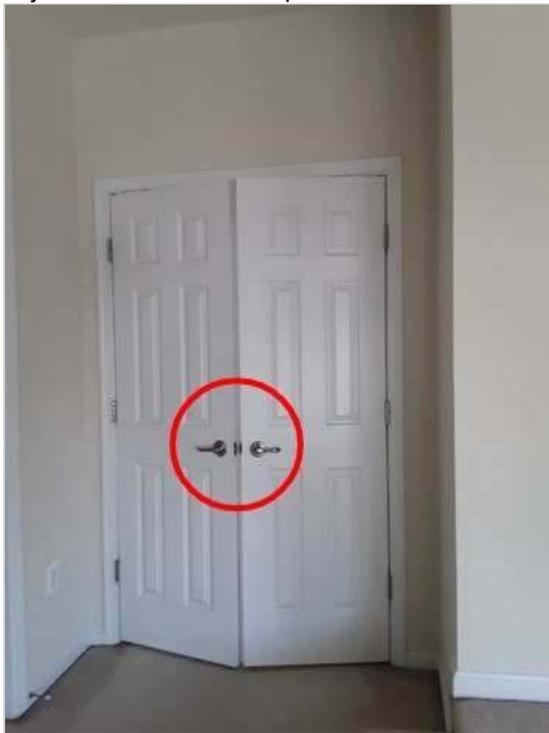
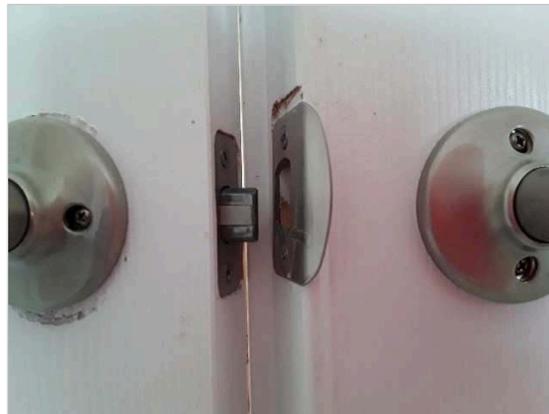
5. The french doors leading to the master bedroom did not latch properly,. This is normally easily corrected by a slight adjustment in the striker plate.

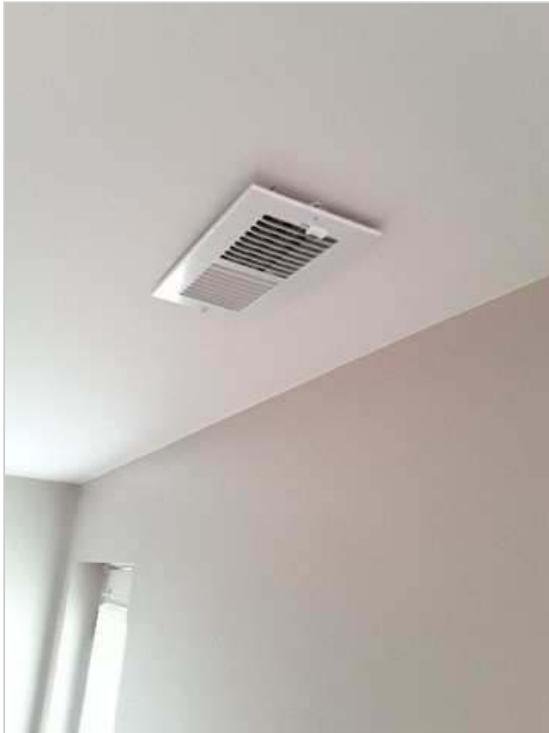
6. The supply grill located in the basement level ceiling was not properly fastened.

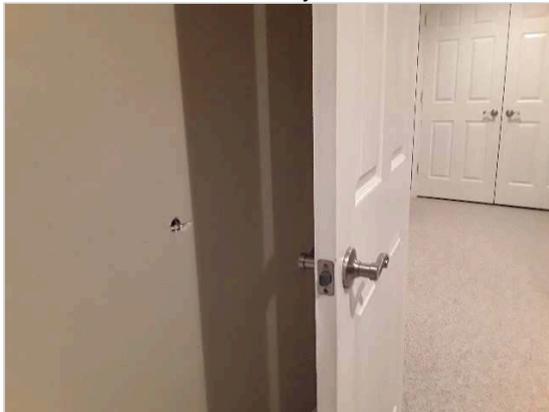
7. There was a hole in the drywall located in the 2nd level bedroom behind the bedroom door.

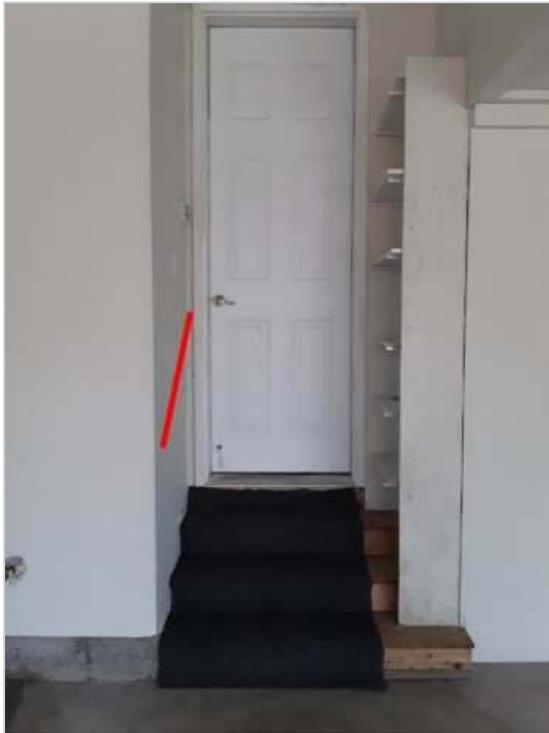
1. There was no handrail on the stairs leading to the garage. This can be a safety concern.

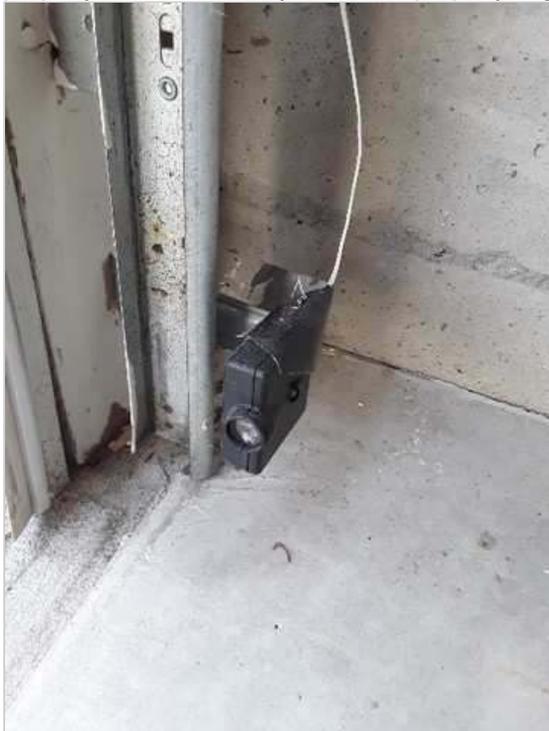
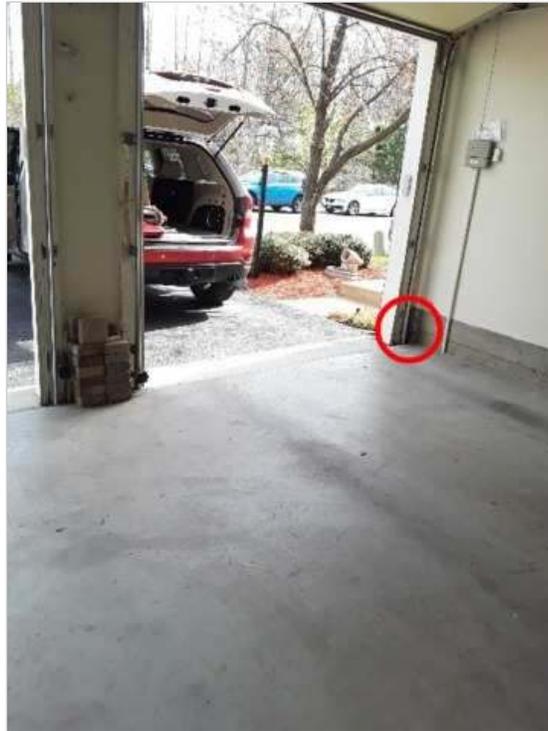
2. One of the laser eyes at the base of the door was not properly secured to the bracket. The safety reverse will not properly function if the eyes are not properly aligned.

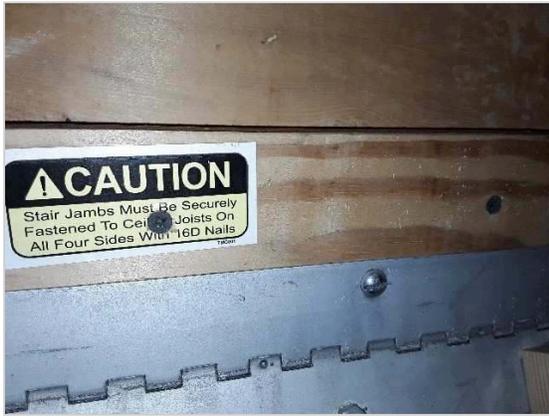
3. The pull-down ladder was not mounted with proper nails. Standard 16d penny nails or 1/4" x 3" lag screws should be used in mounting the ladders. Nails and screws that are intended for other purposes such as drywall or deck screws are not an approved fastener when mounting pull-down ladders because they may have reduced shear strength and may not support the ladders.

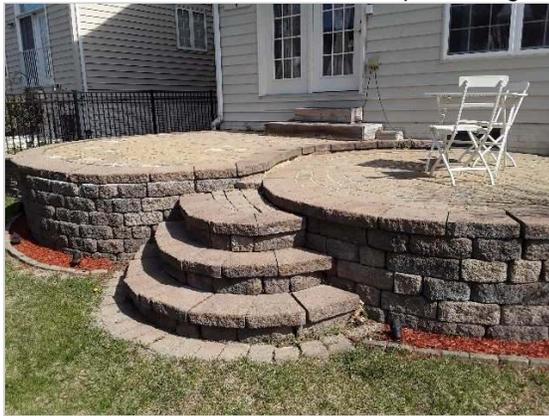
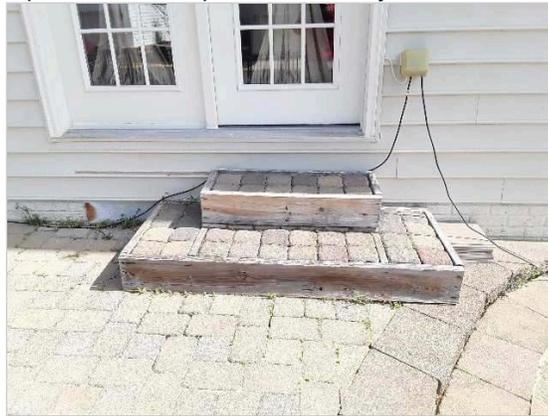
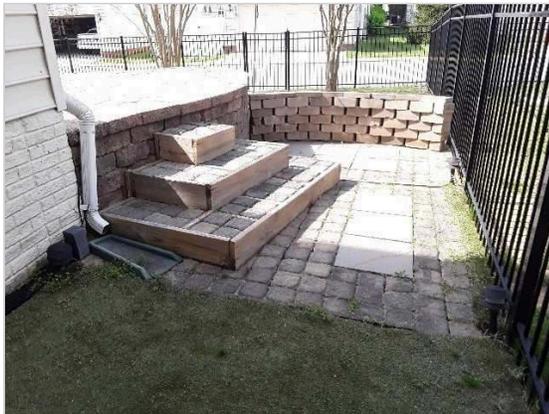
4. There were no handrails on the steps leading to the patio. This can pose as a safety concern for falling.

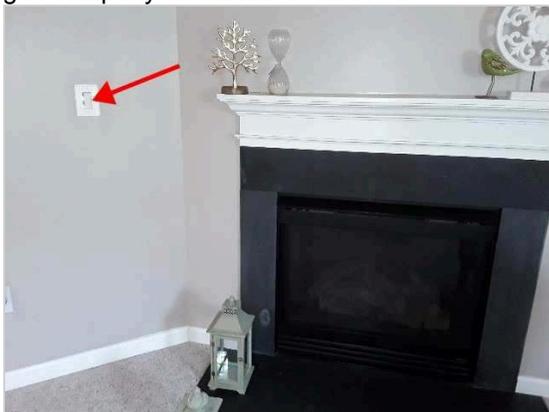
Switch for fireplace

5. The pilot light was tested on the basement fireplace. The fireplace would not light after the pilot was lit. Consult with a gas company for further evaluation.

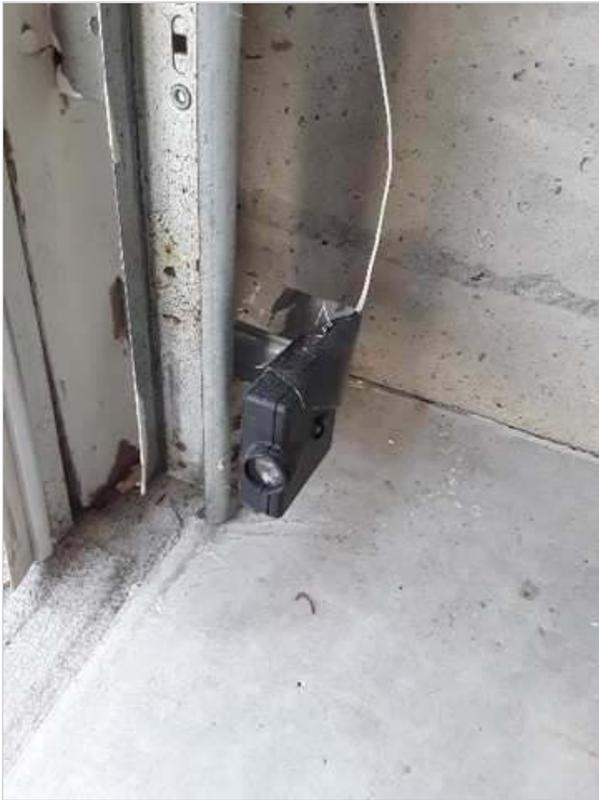
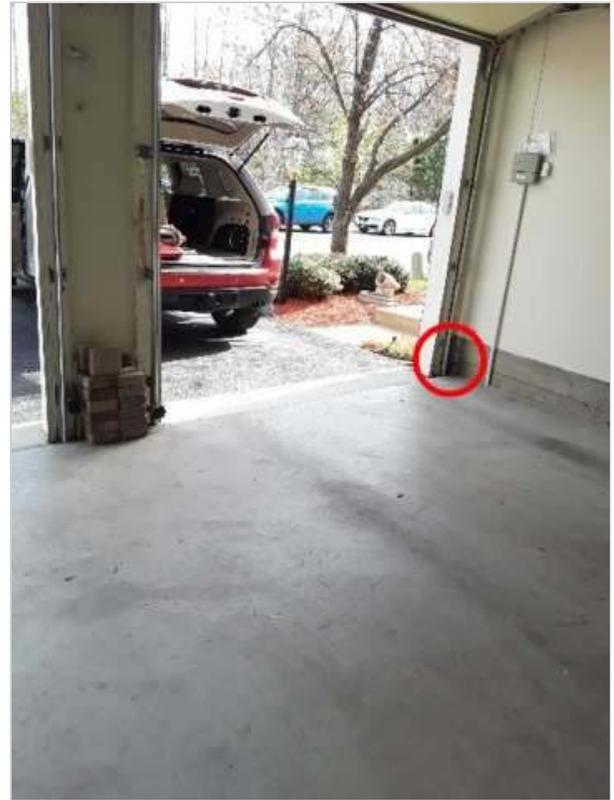
One of the laser eyes at the base of the door was not properly secured to the bracket. The safety reverse will not properly function if the eyes are not properly aligned.

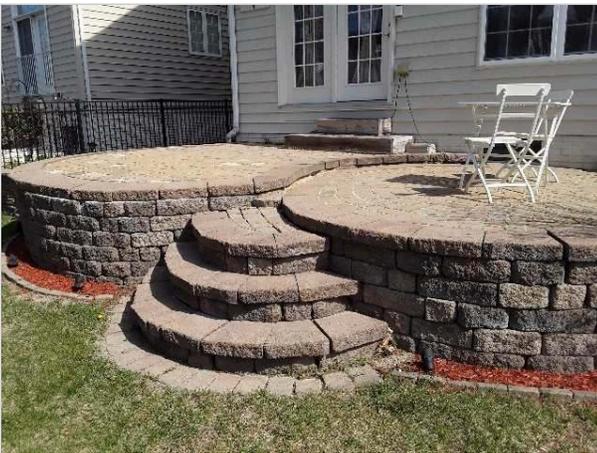
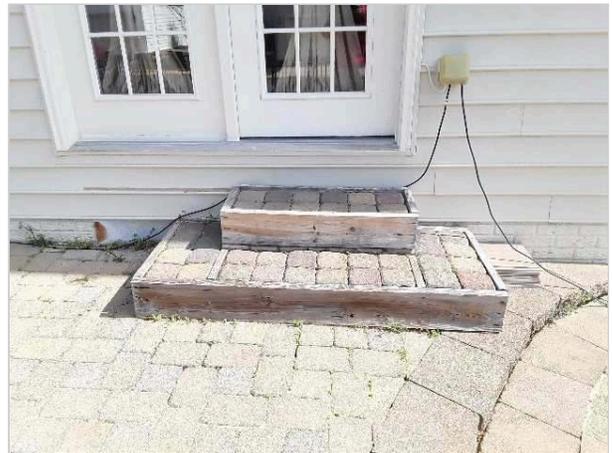
There were no handrails on the steps leading to the patio. This can pose as a safety concern for falling.

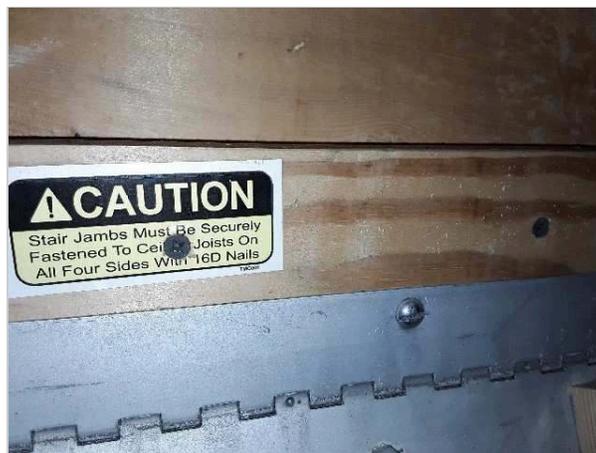
The pull-down ladder was not mounted with proper nails. Standard 16d penny nails or ¼" x 3" lag screws should be used in mounting the ladders. Nails and screws that are intended for other purposes such as drywall or deck screws are not an approved fastener when mounting pull-down ladders because they may have reduced shear strength and may not support the ladders.

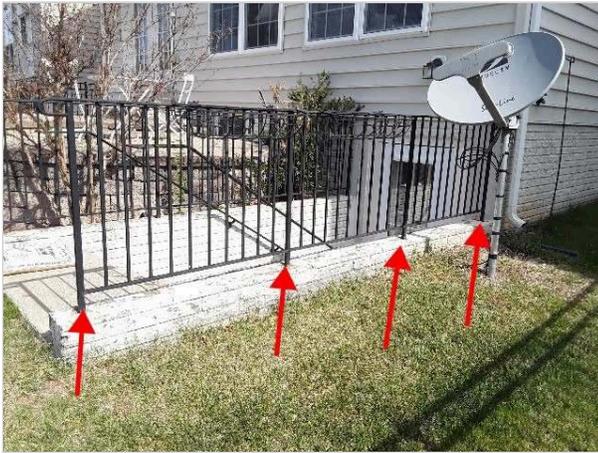
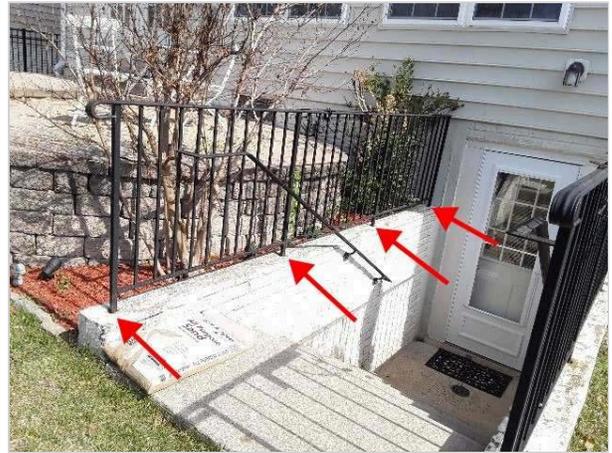
There was corrosion noted at the base of the guard rails on the exterior basement stairs. The corrosion should be treated to prevent further corrosion and damage to the rails.

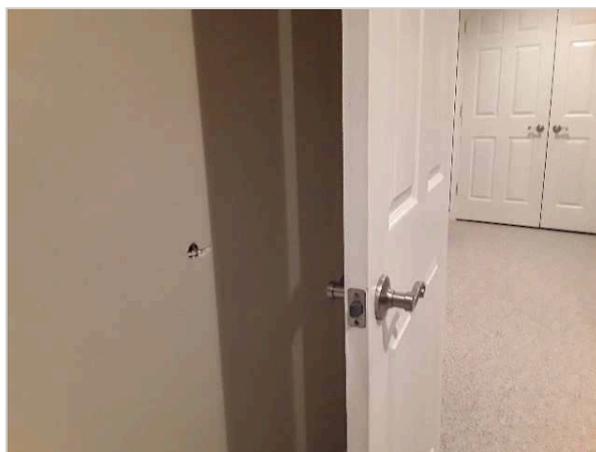
There was a hole in the drywall located in the 2nd level bedroom behind the bedroom door.

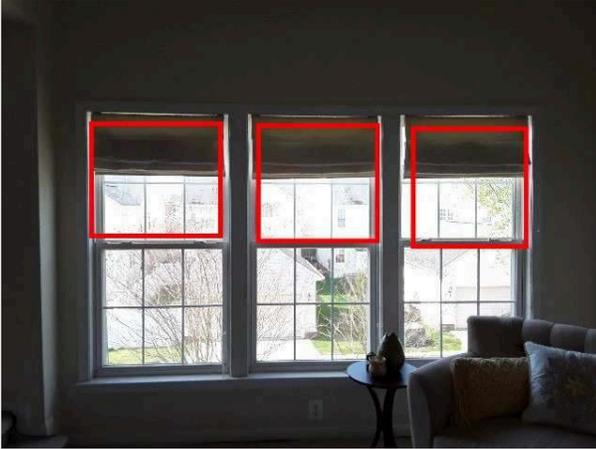
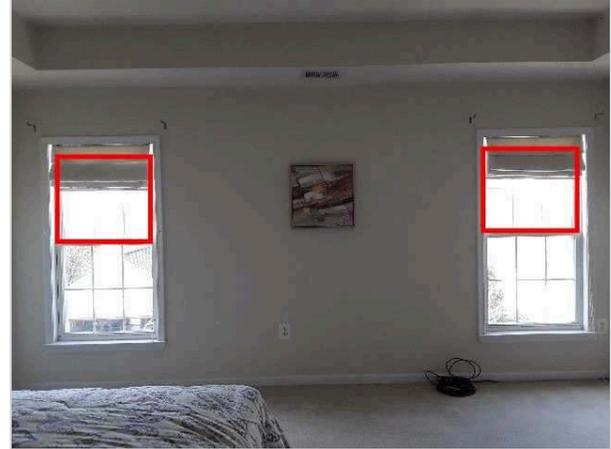
One or more of the insulated window panes in the master bedroom had a defective thermal seal. A defective thermal seal can be identified when fogging is observed between the panes of glass. A defective thermal seal does not affect the performance of the window. Repair of the thermal seal can be accomplished by replacing the affected glass panel.

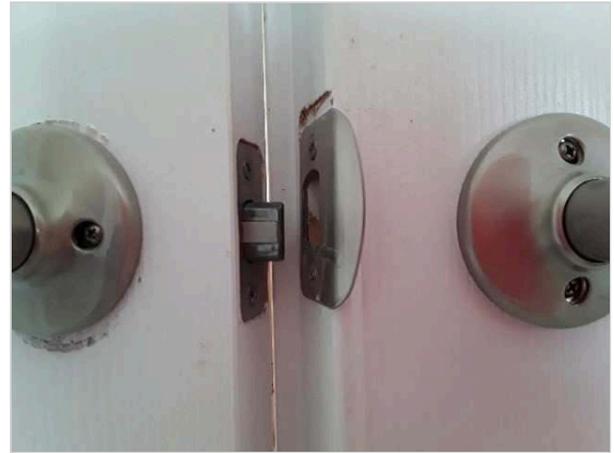
The french doors leading to the master bedroom did not latch properly,. This is normally easily corrected by a slight adjustment in the striker plate.

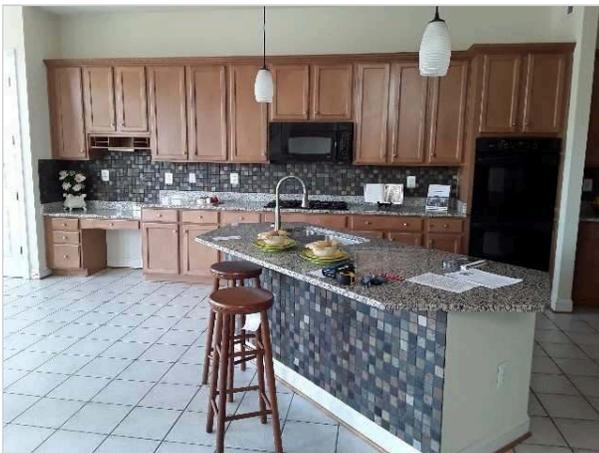
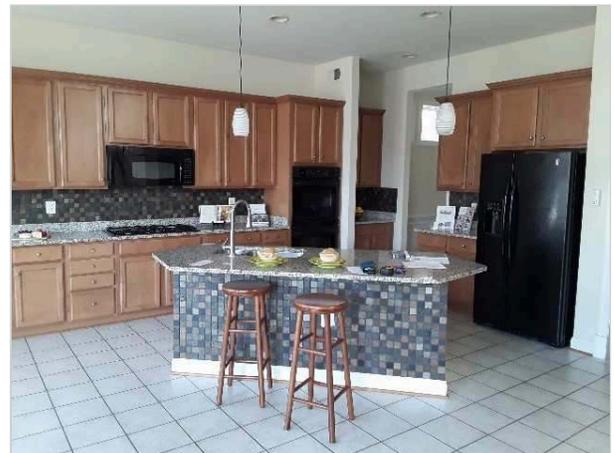
The drawer slides were bent on one of the kitchen drawers.

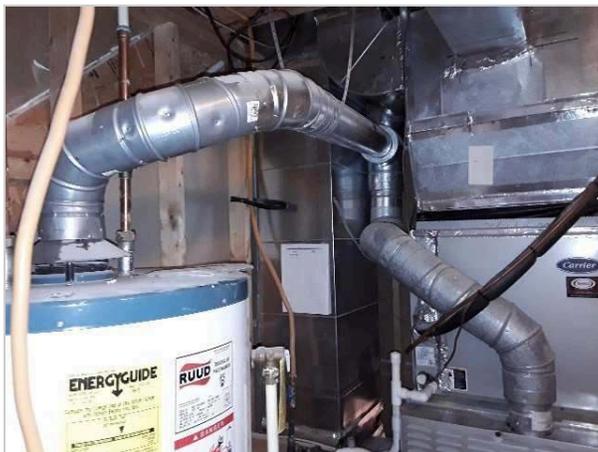
There was a 75 gallon capacity, natural gas water heater located in the basement. The water heater was manufactured by Ruud, model number PR75-70N and serial number RULN 1204104348. Information on the water heater indicated that it was manufactured 14 years ago.

Most tank-type water heaters last 10 to 20 years, with the average age of replacement between 12 and 14 years. The age of the water heater was approximately 14 years old and was most likely at or nearing the end of its useful life.

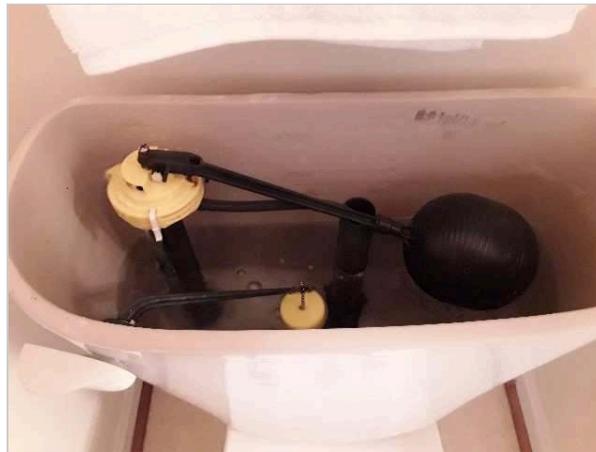
There was a leaky fill valve in the toilet located in the 2nd floor hallway bathroom. Consult with a qualified plumber or handyman for repairs.

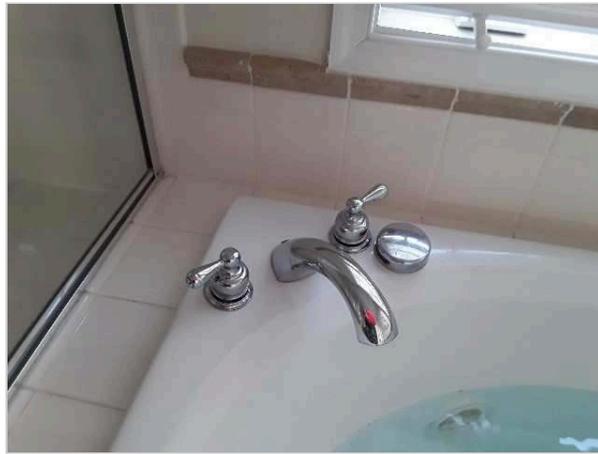
The hot and cold water handles on the jetted tub were loose and could be pulled off.

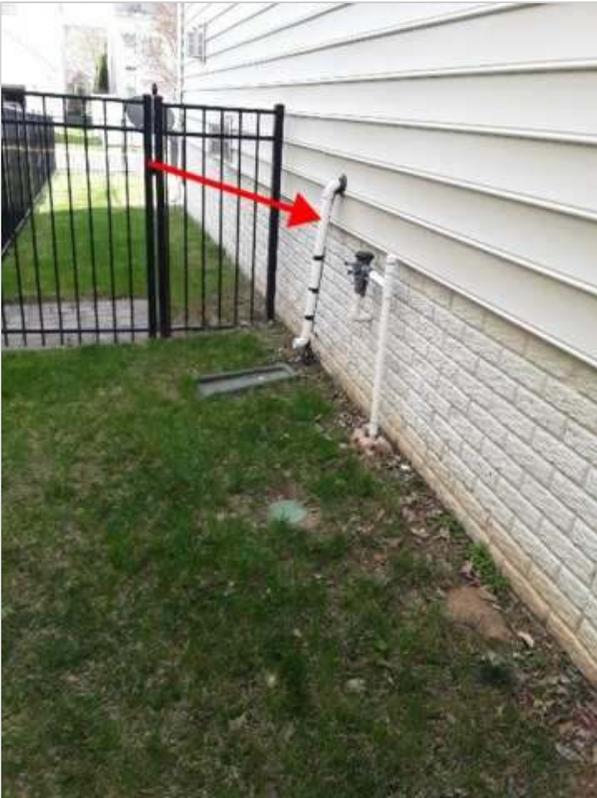
Sump pump discharge on the left side of the home

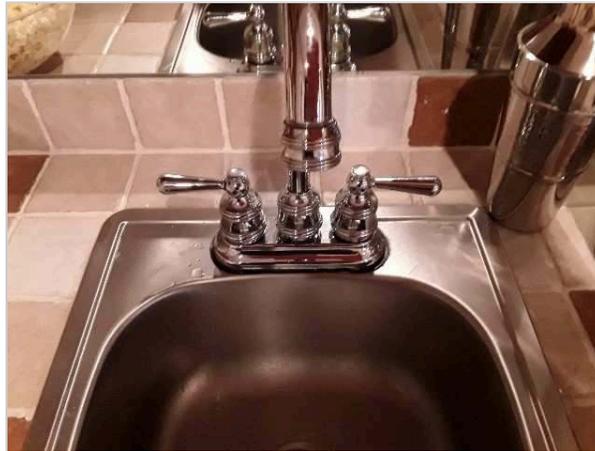
The faucet assembly located in the basement wet bar was loose.

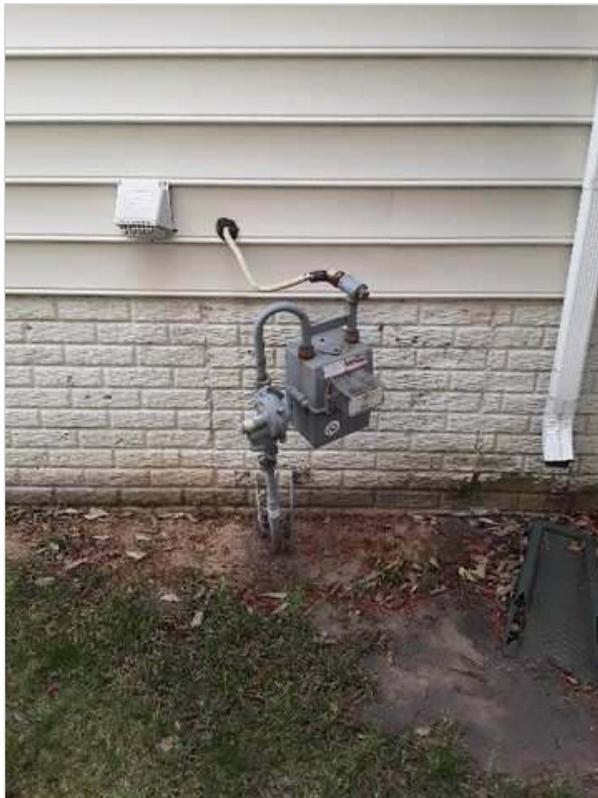
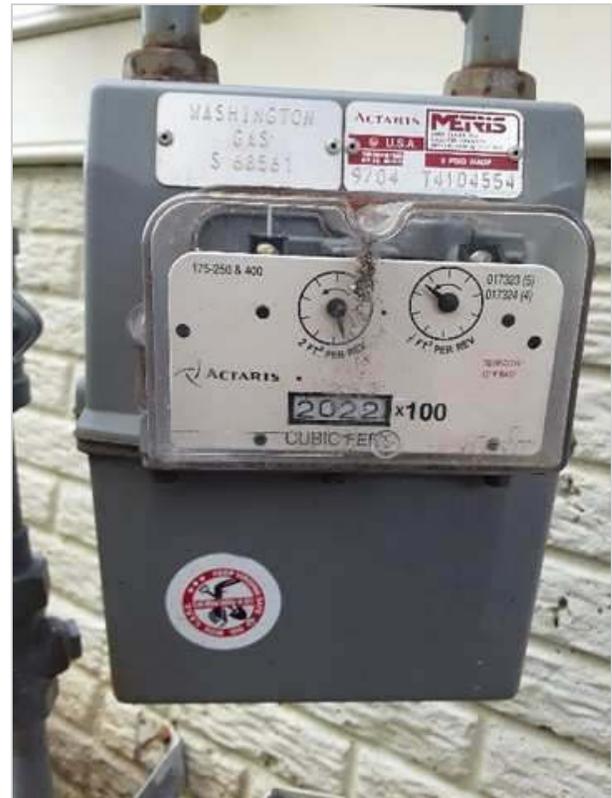
There was no bonding on the CSST gas plumbing found within the home. Manufacturers believe that this product is safer if properly bonded and grounded by the manufacturer's installation instructions. Proper bonding and grounding of the product should be determined by a contractor licensed to perform the work in the Commonwealth of Virginia.

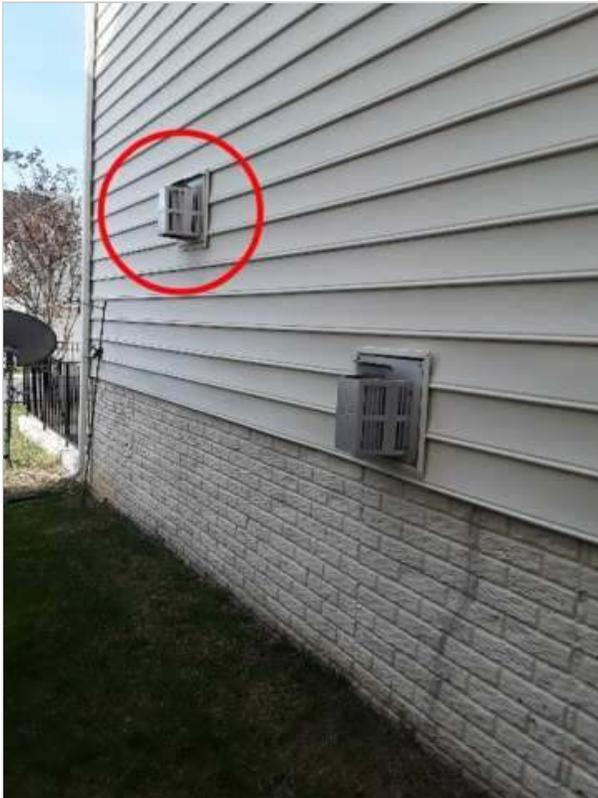
Direct vent for family room

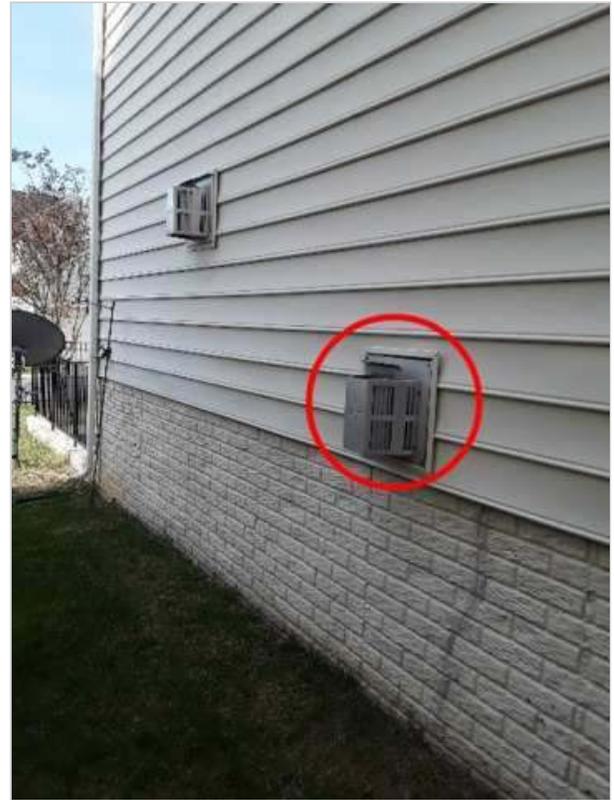
Direct vent for fireplace in basement

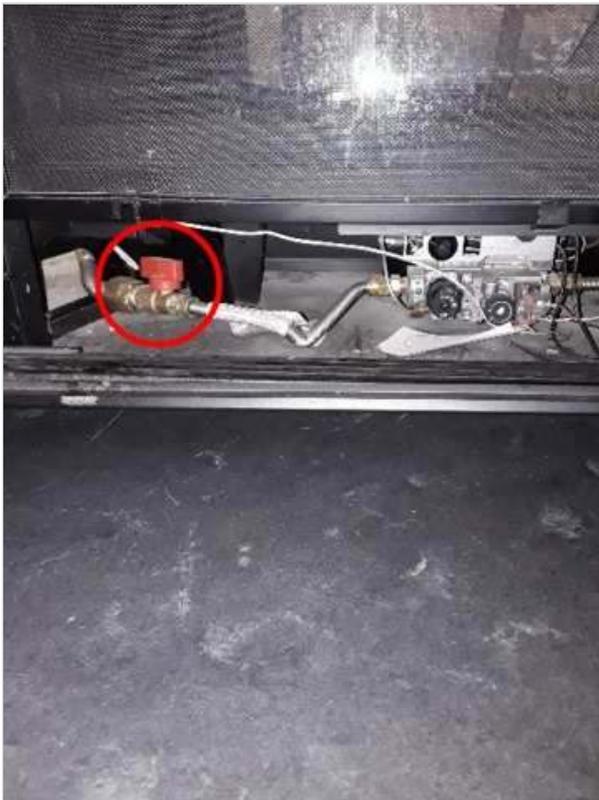
Main gas shutoff

The pilot light was tested on the basement fireplace. The fireplace would not light after the pilot was lit. Consult with a gas company for further evaluation.
