**HomeTeam**<sup>®</sup>  
INSPECTION SERVICE

### HOME INSPECTION REPORT

*This summary provides a simplified overview of the results of the Friday, April 13, 2018 inspection at 123 Sample Drive, Woodbridge, VA 22191. Be sure to read the full body of the inspection report; it contains much more detail about the property. Any additional evaluations we've recommended must be performed prior to the conclusion of the inspection contingency period.*

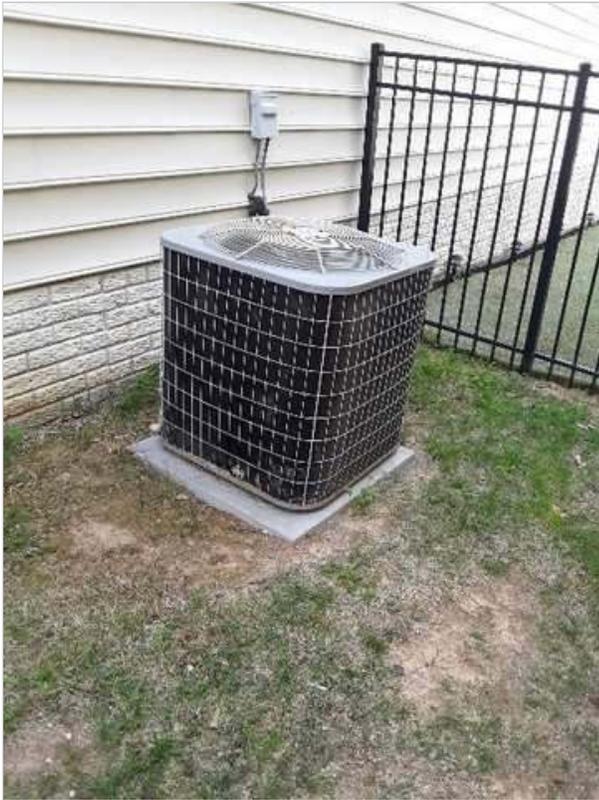
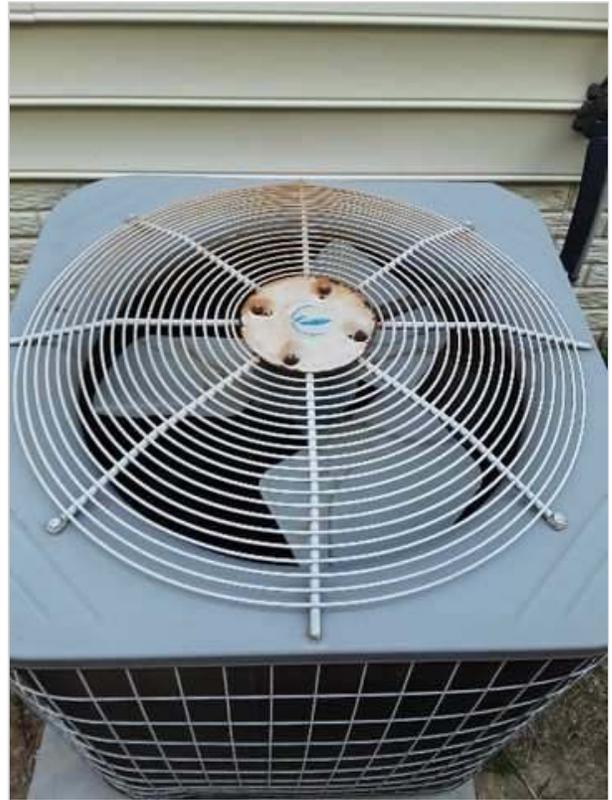
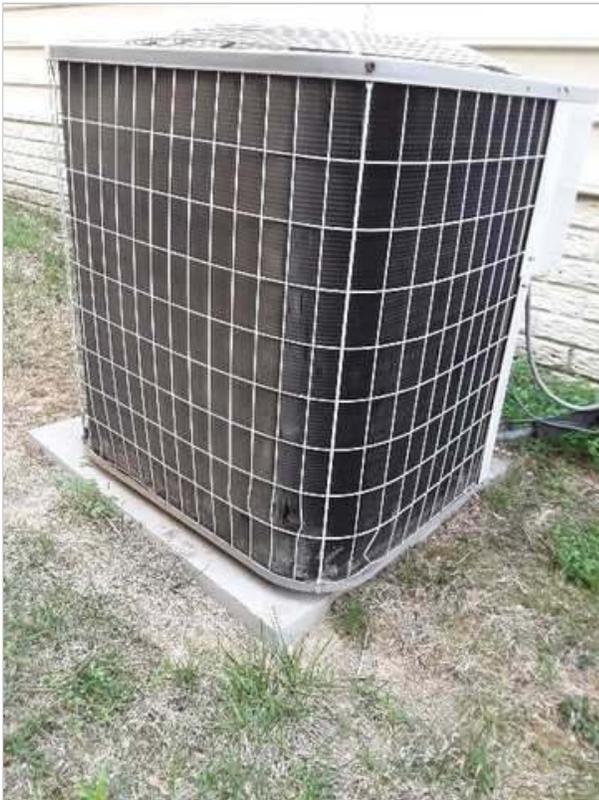
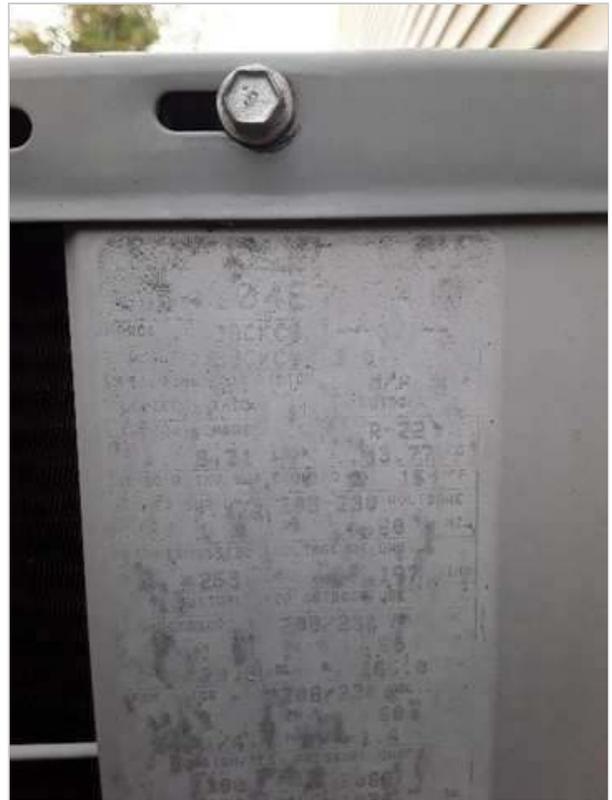
The lineset needs to be resealed where it passes through the exterior wall of the home to prevent water and/or insects from entering the home.
