Wednesday, August 26, 2020

On Wednesday, August 26, 2020 The HomeTeam Inspection Service made a visual inspection of 1234 Sample Dr. Any Town, USA 55555. Enclosed please find a written, narrative report of our findings in accordance with the terms of our Inspection Agreement.

HOME INSPECTION REPORT

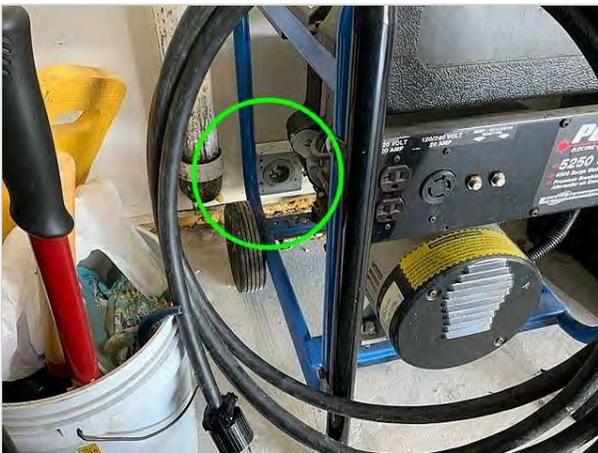
Photo 49

generator outlet in garage

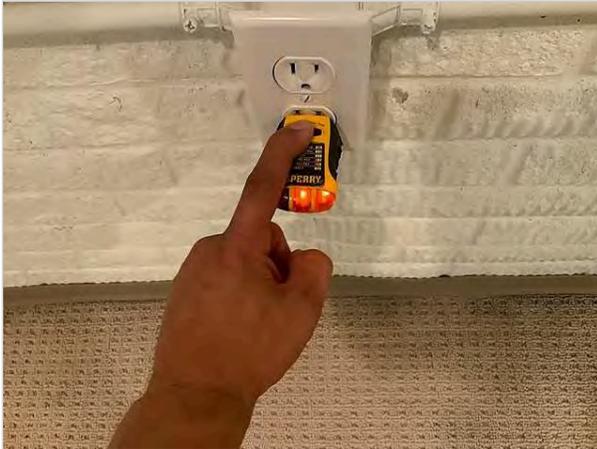
Photo 50

The laundry room and basement lack GFCI protection. Installation of GFCI's in kitchens, baths, garages, basements, outdoor receptacles, and any other high-risk areas, will increase the overall safety of the electrical system. A qualified electrician should be consulted when working on or updating the electrical system in your home.

Basement lacks GFCI protection

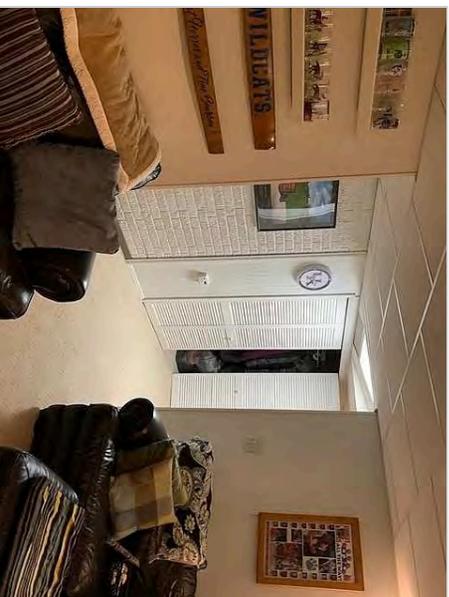
Photo 54

The basement was partially finished and cluttered with personal belongings; therefore, a complete visual examination of the foundation and floor structure was not possible in areas that were visually obstructed.

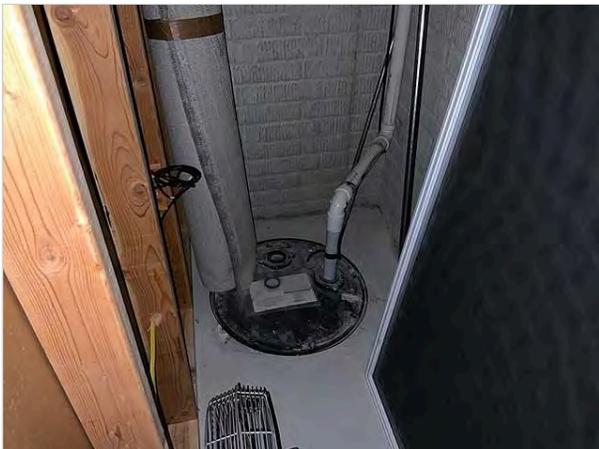
Photo 59

The sump pump appears to be missing a check valve. Check valves prevent the backflow of water back down into the sump crock which can overwork the sump pump and cause early failure. HomeTeam recommends consulting with a qualified plumber to instal a check valve in the discharge pipe.

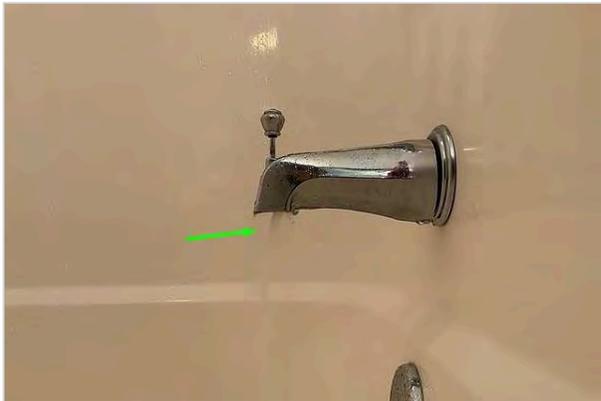
Photo 62

The shower head for the upstairs hallway bathroom is loose where it attaches to the wall. The pipe should be secured and the area sealed in order to prevent water intrusion.

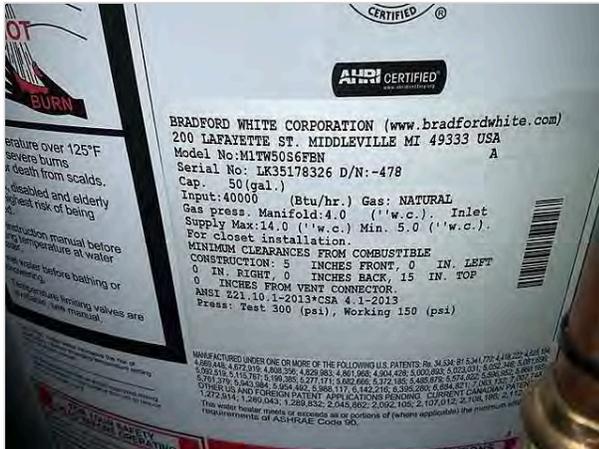
Photo 69

A 50 gallon capacity, natural gas water heater was located in the basement. The water heater was manufactured by Bradford White, model number M1TW50S6FBN and serial number LK35178326. Information on the water heater indicated that it was manufactured 6 years ago. Hot water temperature was approximately 138 degrees F.

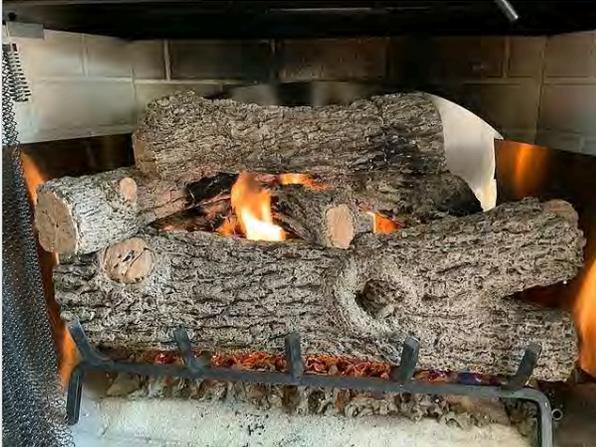
Photo 76

A refractory panel-lined fireplace was located in the living room. A natural gas supply line was present. The damper did appear to be functional. The chimney flue was metal. There was no visual evidence of creosote buildup in the firebox and/or chimney.

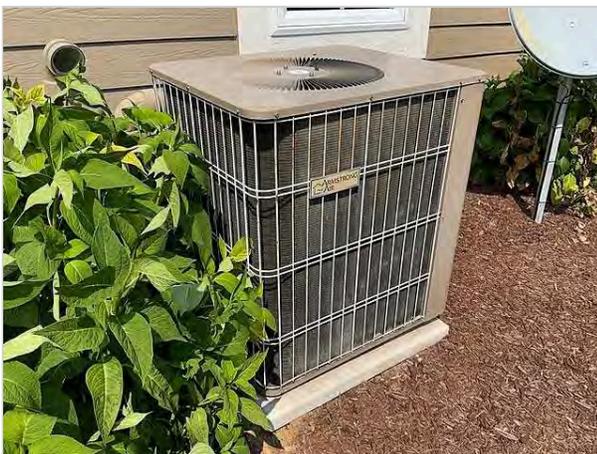
Photo 80

The electric outdoor air conditioner condensing unit was an Armstrong Air, Model Number SCU10B48A-7 and Serial Number 1604M10918. The unit is located on the right side of the structure. This unit is approximately 16 years old. Periodic preventive maintenance is recommended to keep this unit in good working condition, and HomeTeam strongly recommends partnering with a reputable HVAC company for routine maintenance for the heating and cooling systems in the fall and spring. The air conditioning system was tested and found to be functional. As a reminder, this is functionality test and visual inspection only; we do not check suction pressures, contactor amps, or refrigerant levels. If a more detailed inspection is required, please consult with an HVAC company.

The air conditioner may be past its design life. Unless noted otherwise, the system was functional at the time of the inspection. As with a light bulb that functions normally one day but the next may not turn on, a system's age is a helpful factor that assists in budgeting for eventual replacement, as are changes in regulations, most notably the Clean Air Act which required the phasing out of R22 freon by the year 2020.

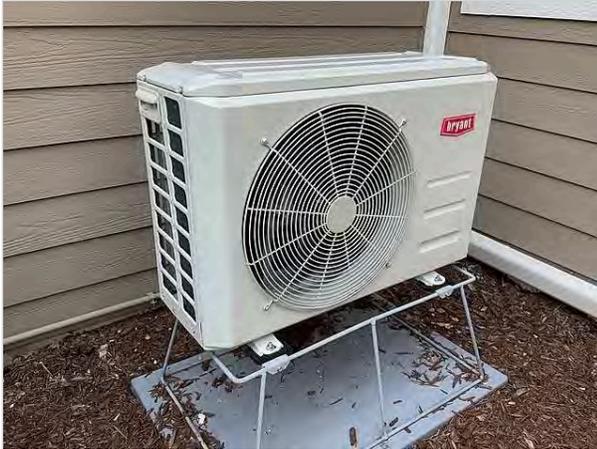
Photo 82

The second electric outdoor air conditioner / heat pump condensing unit was a Bryant, Model Number 38MAQB12R-3 and Serial Number 2317V14195. The unit is located in the back of the structure. This unit is approximately 3 years old.

Periodic preventive maintenance is recommended to keep this unit in good working condition. The air conditioning system was tested and found to be functional.
