On Thursday, June 15, 2023 The HomeTeam Inspection Service made a visual inspection of 123 Address Street, City, ST 12345. Enclosed please find a written, narrative report of our findings in accordance with the terms of our Inspection Agreement.

HOME INSPECTION REPORT

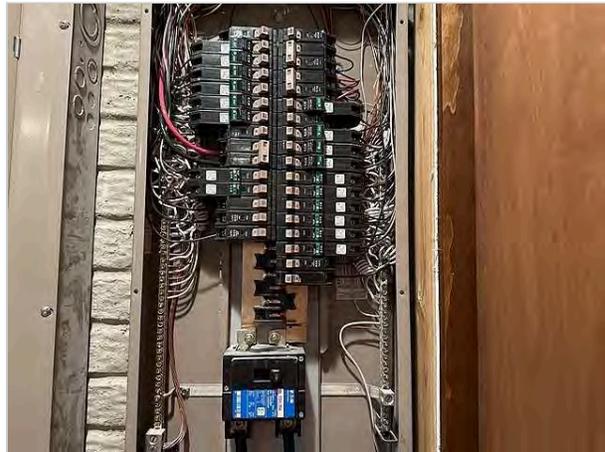
Photo 75

A breaker in the electrical panel in the basement has a tendency to trip. This condition is usually the result of too heavy a load on the circuit, or in some instances a cross connection on something running on the circuit. Although the condition happened on inspection, this appears to be an intermittent problem that was unable to be reproduced at the time of inspection. HomeTeam recommends consulting with a qualified electrical contractor to further assess and repair the circuit, load and fixtures as necessary.

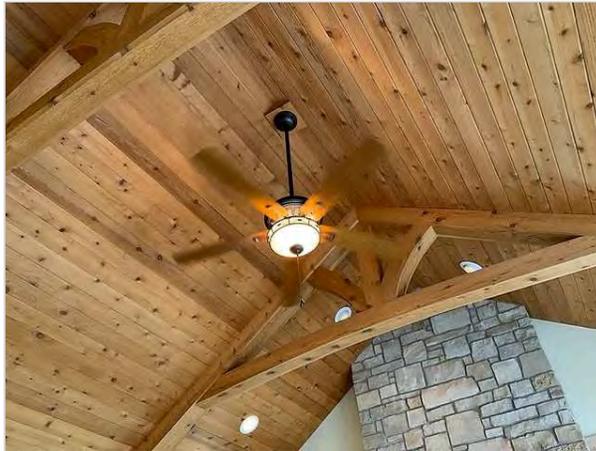
Photo 81

The sun room ceiling fan did not function properly. The fan makes a clicking noise during operation. To help prevent worsening conditions and for proper functionality, HomeTeam recommends consulting with a qualified contractor for service of the fan.

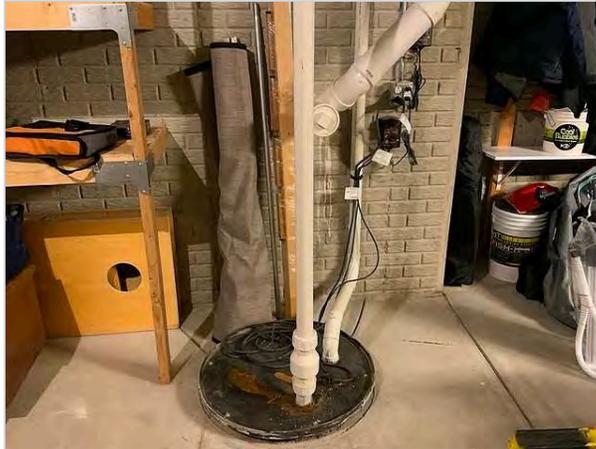
Photo 95

The pump cover for the ejector pump in the basement is rusted. This condition can allow for gasses from the wastewater in the crock to enter the living area of the home. For proper functionality, HomeTeam recommends the pump cover be resealed.

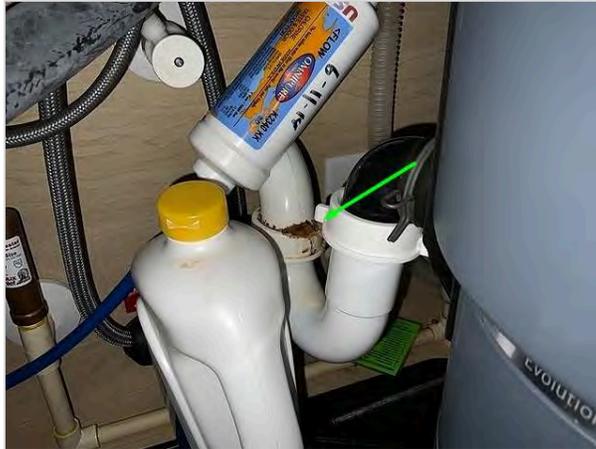
Photo 104

Signs of prior seepage or leaking were noted under the kitchen sink. This is an indication that the lines have leaked in the past. Although no leaks were detected at the time of inspection and the areas were dry, HomeTeam recommends monitoring the areas closely for any signs of new or continued activity a consult with a qualified plumbing contractor for further evaluation and repair as necessary.

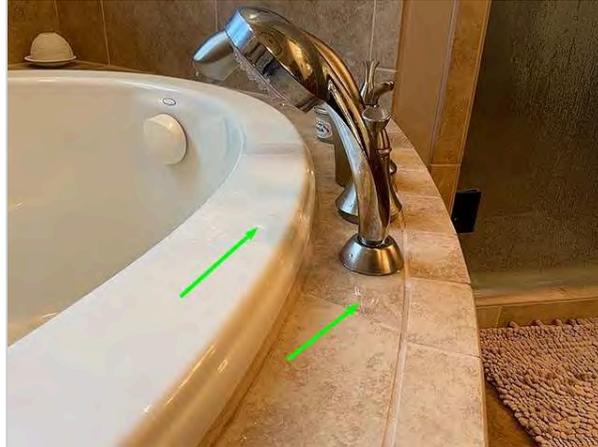
Photo 115

The master bathroom tub wand drips outside of the tub enclosure after water is stopped. To help prevent water intrusion, HomeTeam recommends consulting with a qualified contractor for options on different wands or an extender to allow the wand to drip inside the tub enclosure.

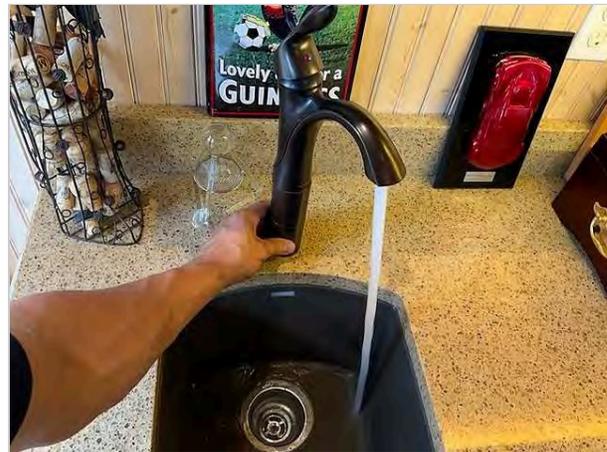
Photo 117

The kitchen and wet bar faucets were not properly secured. To help prevent worsening conditions, HomeTeam recommends tightening of the faucet mounting hardware.

Sun room wet bar faucet was not properly secured

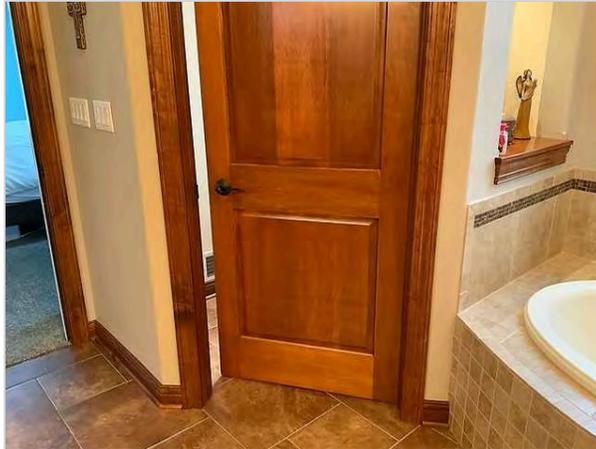
Photo 128

The door to the master bathroom toilet closes on its own. To allow for proper operation of the door, HomeTeam recommends adjusting the door, hinges, and/or latching mechanism.

Master bathroom toilet door closes on its own

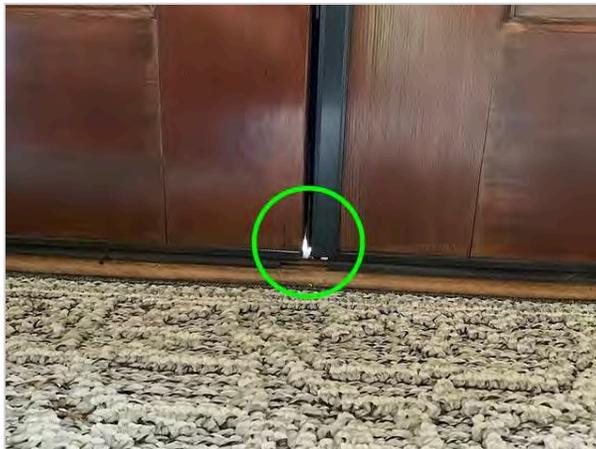
Photo 129

Damaged weather stripping was noted on or around the front exterior door. This is a common condition with age. For improved efficiency, HomeTeam recommends replacing the weather stripping.

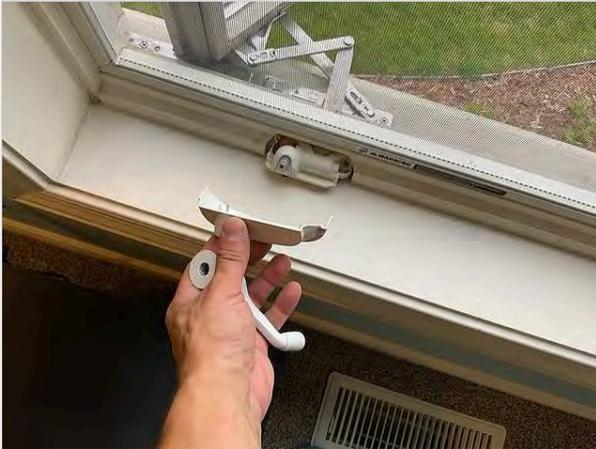
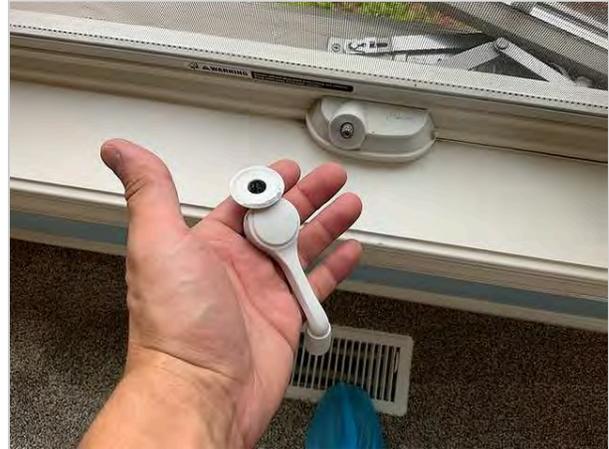
Several of the window cranks or operator arm covers were not secured. To help prevent damage, HomeTeam recommends tightening the hardware.

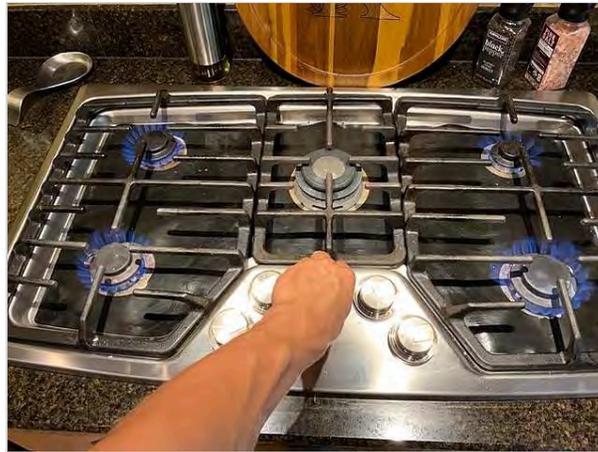
Photo 136

The center range burner worked intermittently with the automatic ignition system. The burner may need to be cleaned, or the ignition/pilot system repaired. For proper functionality, HomeTeam recommends consulting with a qualified contractor for further evaluation and repair.

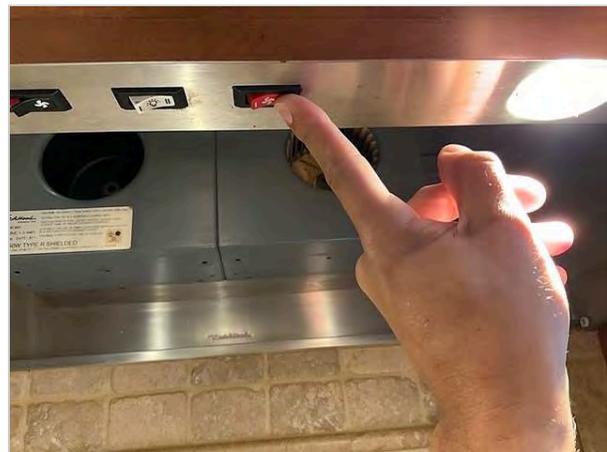
Photo 138

One of the fans for the range hood was nonfunctional at the time of inspection. For proper functionality, HomeTeam recommends consulting with a qualified contractor for further evaluation and repair.

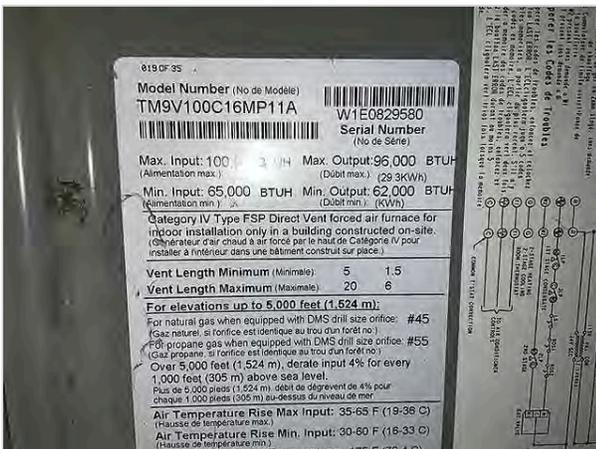
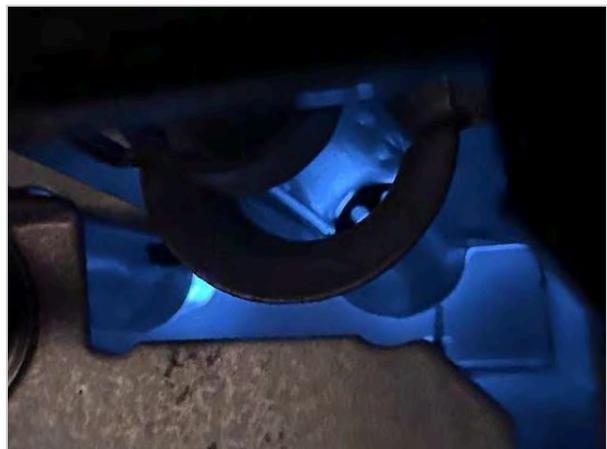
Evidence of prior water was present inside the furnace compartment. This condition may have been caused by a

prior leak in a condensate line or drain line which can damage the furnace cabinet or other operational components. HomeTeam recommends closely monitoring the area for any reoccurrence and consult with a qualified HVAC technician for repair as necessary.

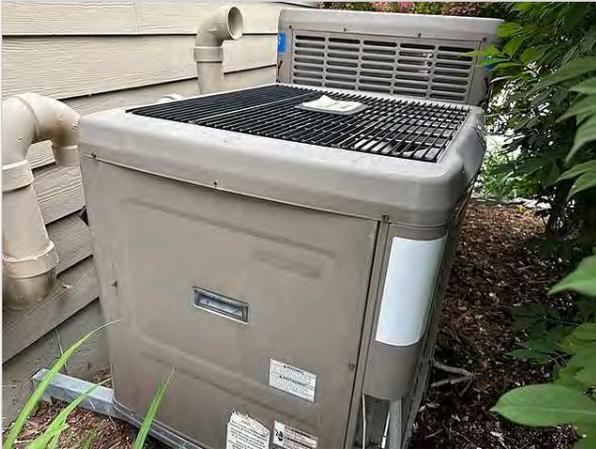
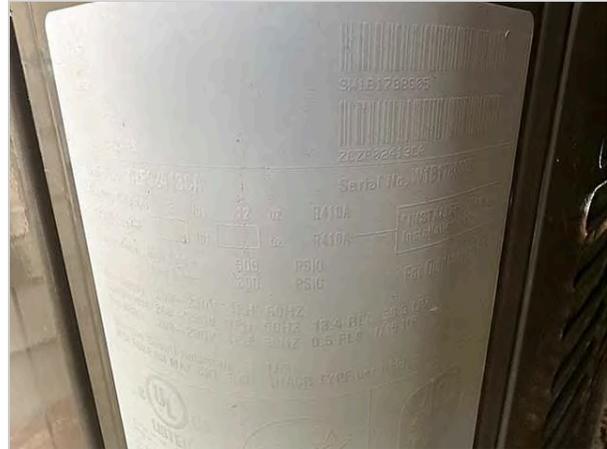
The structure was cooled with an electric outdoor air conditioner condensing unit manufactured by York, Model Number CZF02413CA and Serial Number W1B1788605. The unit is located on the left side of the structure. This unit is approximately 12 years old. Periodic preventive maintenance is recommended to keep this unit in good working condition, and HomeTeam strongly recommends partnering with a reputable HVAC company for routine maintenance for the heating and cooling systems in the fall and spring. The air conditioning system was tested and found to be functional but in need of service. As a reminder, this is functionality test and visual inspection only; we do not check suction pressures, contactor amps, or refrigerant levels. If a more detailed inspection is required, please consult with an HVAC company.

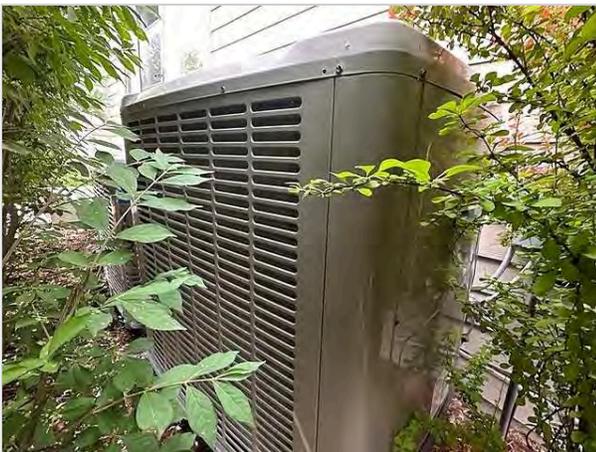
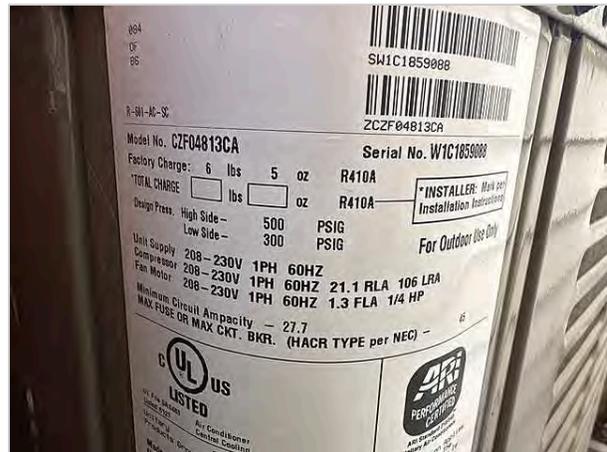
The second electric outdoor air conditioner condensing unit was a York, Model Number CZF04813CA and Serial Number W1C1859086. The unit is located on the left side of the structure. This unit is approximately 12 years old. Periodic preventive maintenance is recommended to keep this unit in good working condition. The air conditioning system was tested and found to be functional but in need of service.

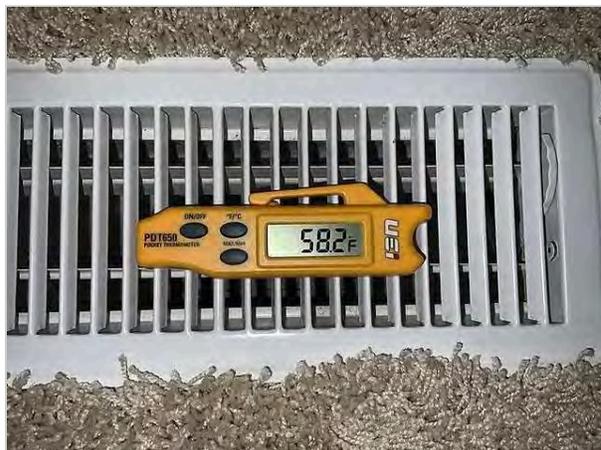
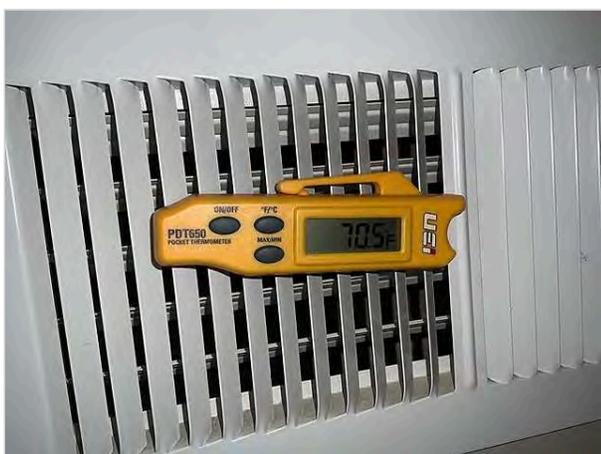
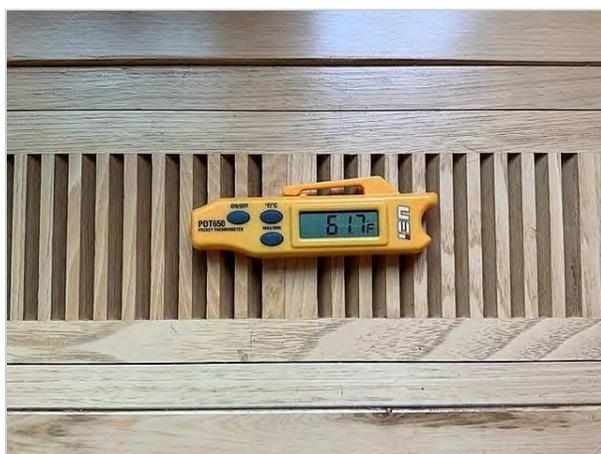
The temperature differential for the air conditioning units was approximately 9 to 14 degrees which is inadequate. Typically an air conditioning unit should have a temperature differential of approximately 16-22 degrees. To help improve the efficiency and performance, HomeTeam recommends consulting with a qualified HVAC technician for further evaluation and options on repair, recharge, or replacement.

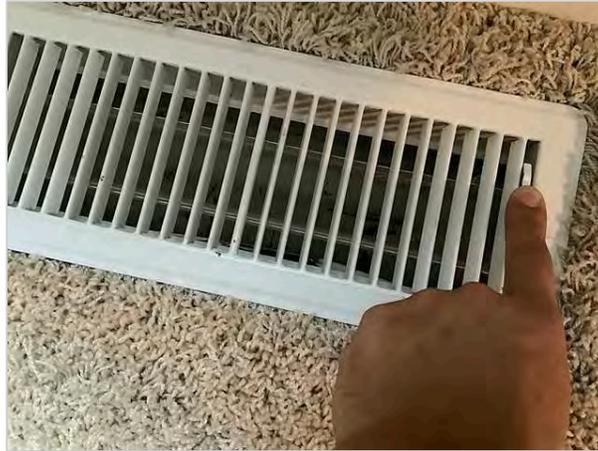
Photo 157

The damper control on the HVAC register in the front right bedroom was nonfunctional. As a result, the vent is always open. For proper functionality, HomeTeam recommends the register be repaired or replaced.
