HOME INSPECTION REPORT

File Number: **6549**

Address of Inspection: **123 Sample Drive**

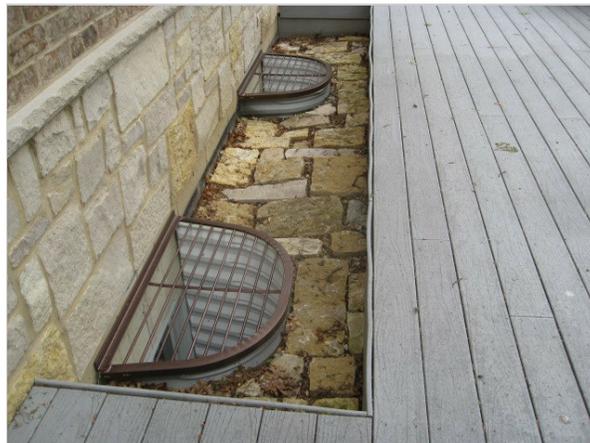
- ***We recommend monitoring the area in back by the house, between the sections of deck, to ensure water does not pool in this area.***

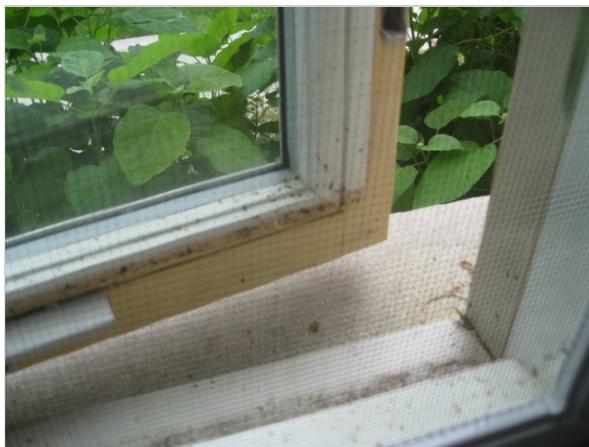
- *The attached garage front window edges were bare wood that should be treated to prevent eventual wood rot.*

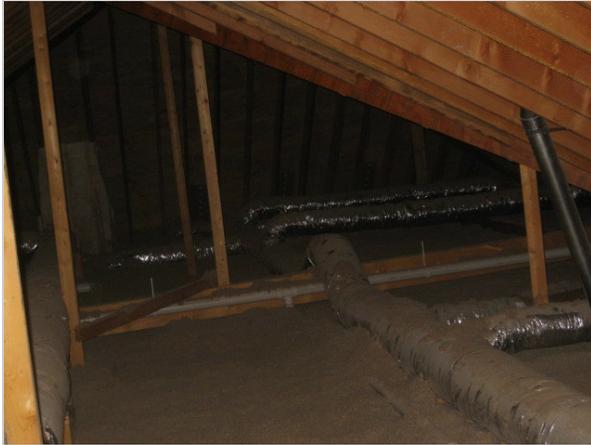
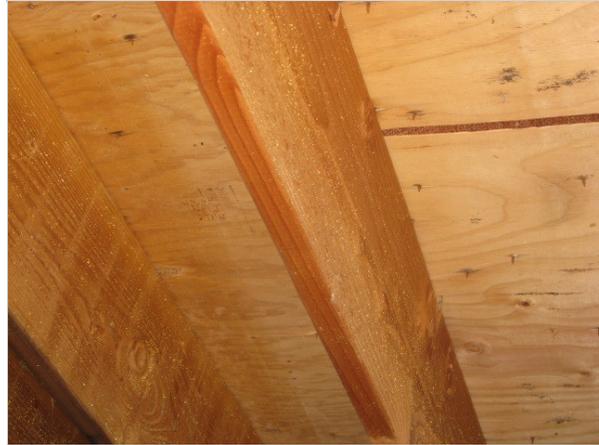
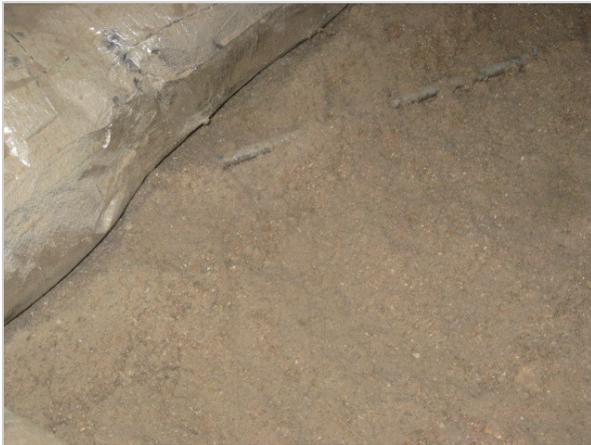
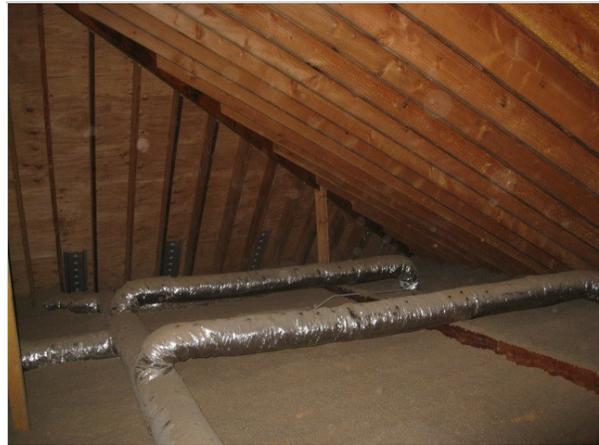
- ***There was darkened sheathing, with possible light mold growth, in the right front section of the attic that should be further evaluated and treated as necessary.***

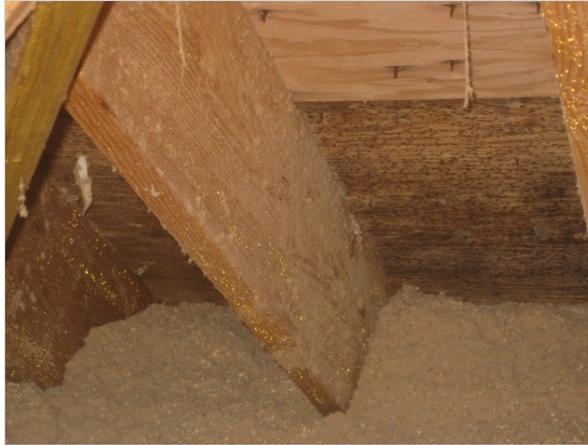
- ***One of the support columns on the far left side of the attic space was completely loose and needs to be secured.***
