### HOME INSPECTION REPORT

The HomeTeam Inspection Service made a visual inspection of 123 Main Street, Anytown, USA 55555. Enclosed please find a written, narrative report of our findings in accordance with the terms of our Inspection Agreement.

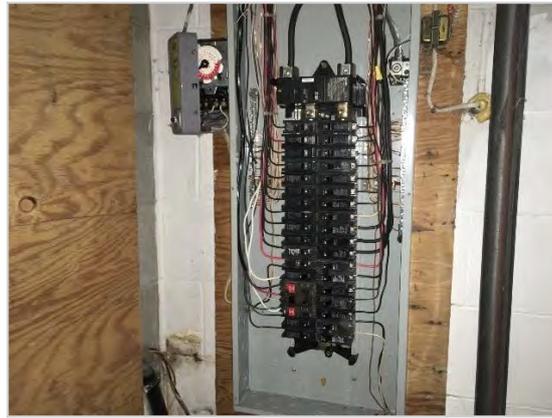
Photo 9

The electrical service appeared to be adequate. As a reminder, alarms, electronic keypads, remote control devices, landscape lighting, telephone and television wiring are beyond the scope of this inspection.

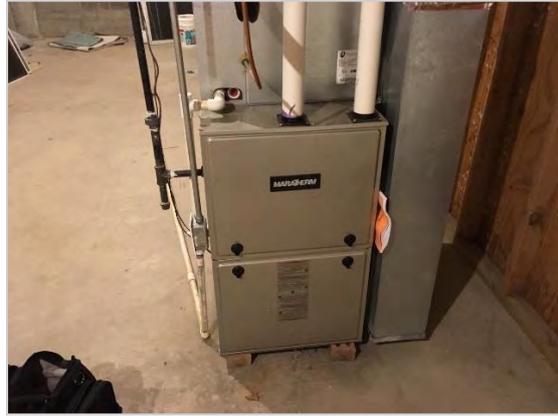
Photo 15

**A condensate leak was noted on the air handler drain line.** Repairs should be made by a qualified contractor.

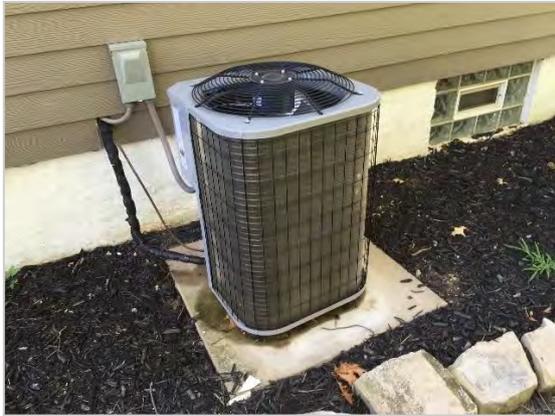
Photo 19

Serial Number X15330728. The unit is located on the left side of the structure. This unit is approximately 1 years old. Periodic preventive maintenance is recommended to keep this unit in good working condition, and HomeTeam strongly recommends partnering with a reputable HVAC company for routine maintenance for the heating and cooling systems in the fall and spring. The air conditioning system was tested and found to be functional. As a reminder, this is functionality test and visual inspection only; we do not check suction pressures, contactor amps, or refrigerant levels. If a more detailed inspection is required, please consult with an HVAC company.

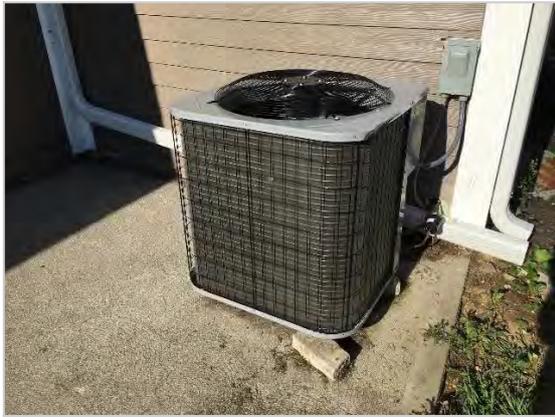
Photo 21

The second electric outdoor air conditioner condensing unit was a Comfortmaker, Model Number R4A348AKN100 and Serial Number X152462739. The unit is located in the back of the structure. This unit is approximately 1 years old. Periodic preventive maintenance is recommended to keep this unit in good working condition. The air conditioning system was tested and found to be functional.
