HOME INSPECTION REPORT

On January 1, 2020 The HomeTeam Inspection Service made a visual inspection of 1234 Sample Drive, Anytown, FL 55555. Enclosed please find a written, narrative report of our findings in accordance with the terms of our Inspection Agreement.

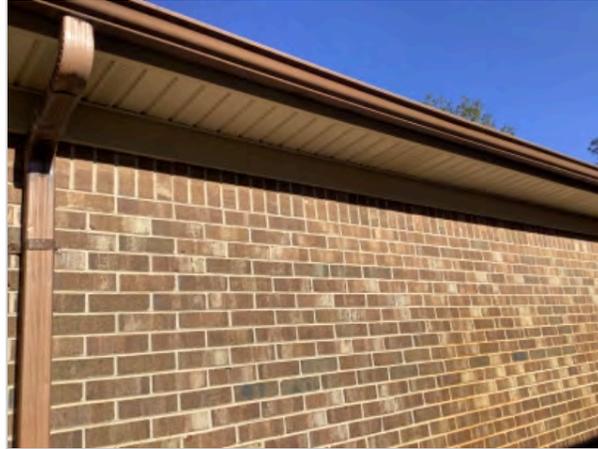
Photo 2

One or more of the steel lintels above the windows on the exterior of the structure is rusting and appears to have expanded. Lintels support masonry materials above doors and windows. Keeping the lintels sealed will help prevent rusting and expansion. Expanded lintels can lead to cracks in the masonry on the outside of the structure. The affected lintels should be properly sealed to prevent further expansion.

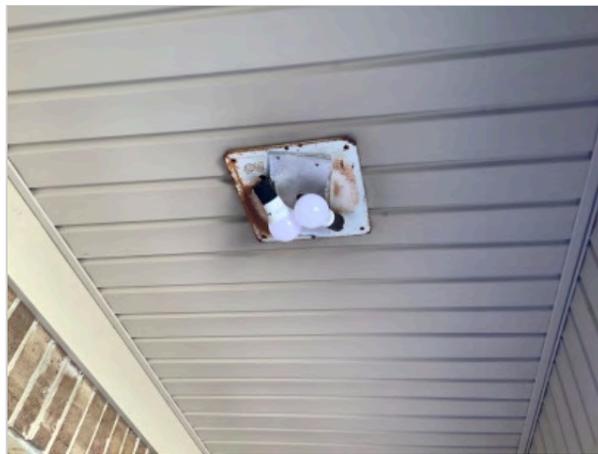
Photo 10

light fixture cover missing.

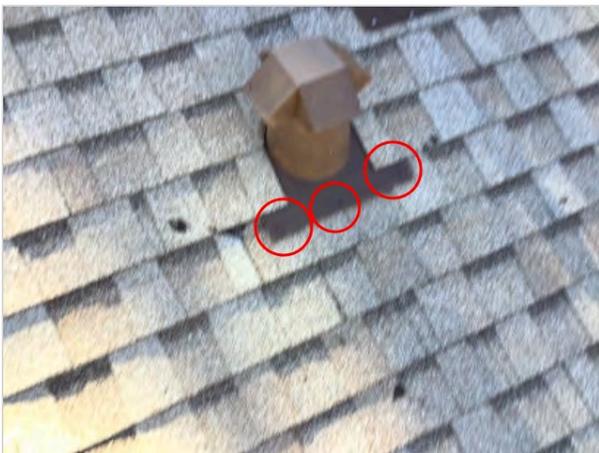
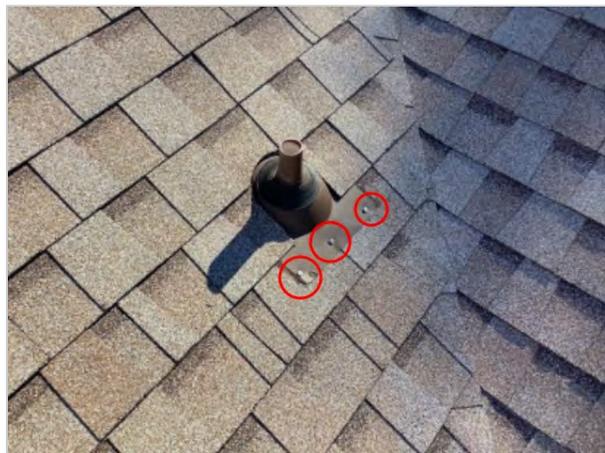
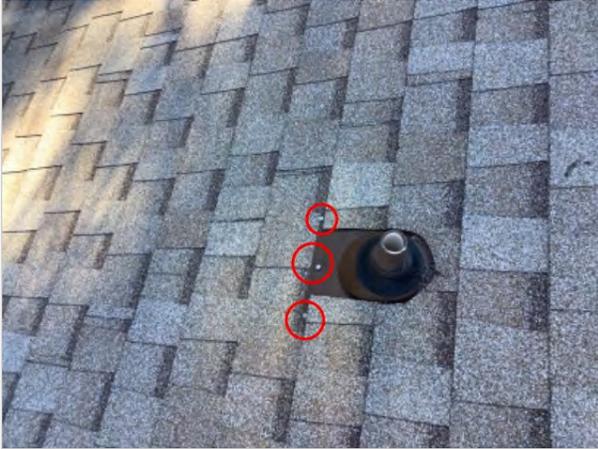
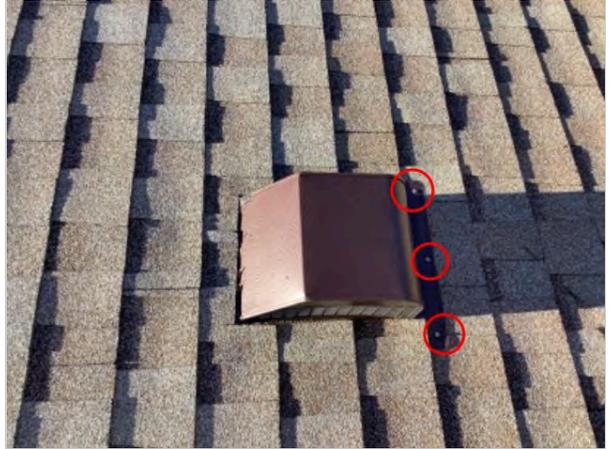
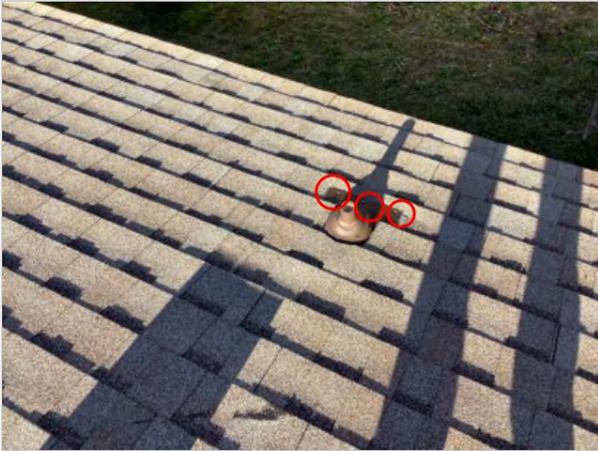
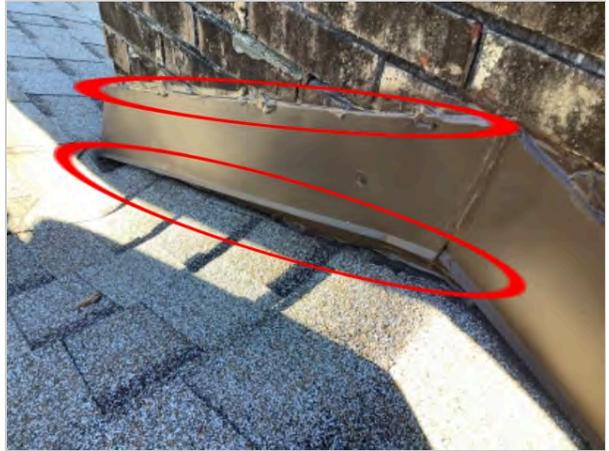
Numerous flashing techniques used on the newly installed roof are not the preferred methods of installing roof flashing. It appears that all of the areas in question have been caulked sufficiently however these areas should be monitored in the future to ensure they are not cracking allowing water to enter the attic structure.

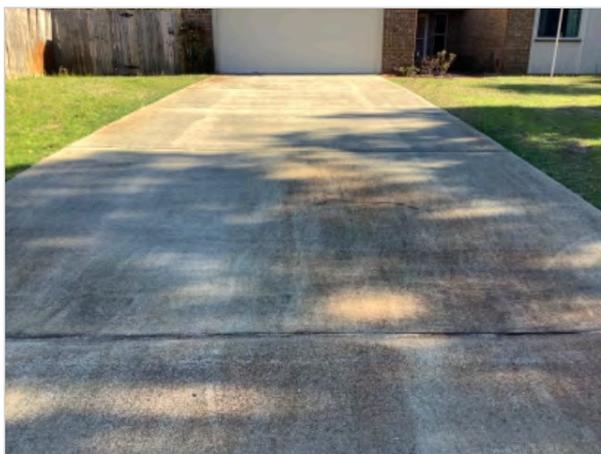
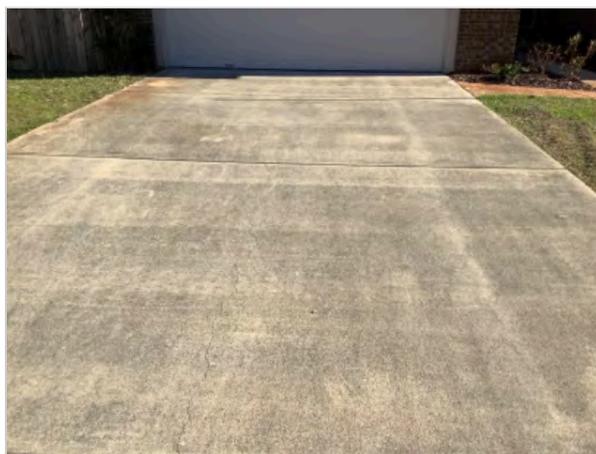
A concrete driveway is present in the front of the structure. Cracks and spalling were observed on the driveway. Surface defects in driveways develop and progress with age and are considered normal as long as they do not create a safety hazard. Sealing defects may help slow the rate of deterioration.

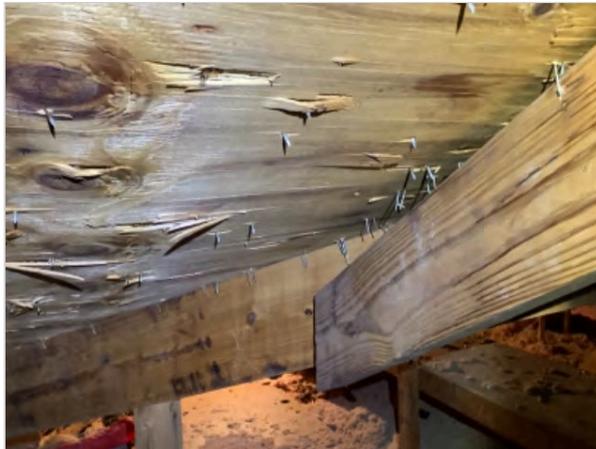
Photo 32

One of the rafters in the roof structure is loose. This condition could weaken the roof structure in the affected area. The area should be repaired and further assessed for additional repairs.

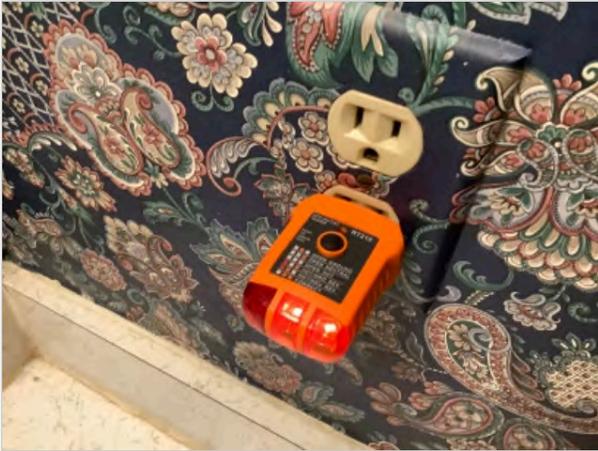
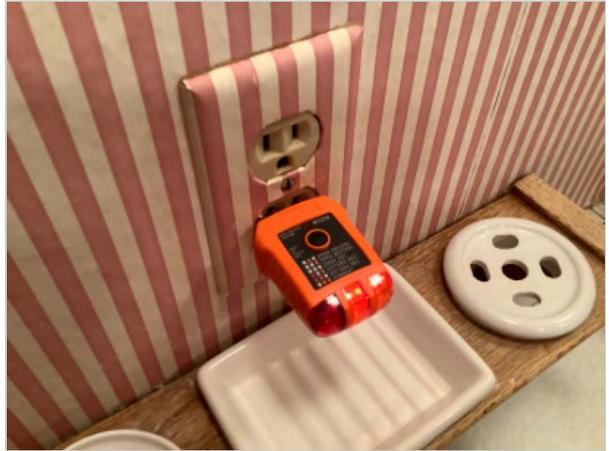
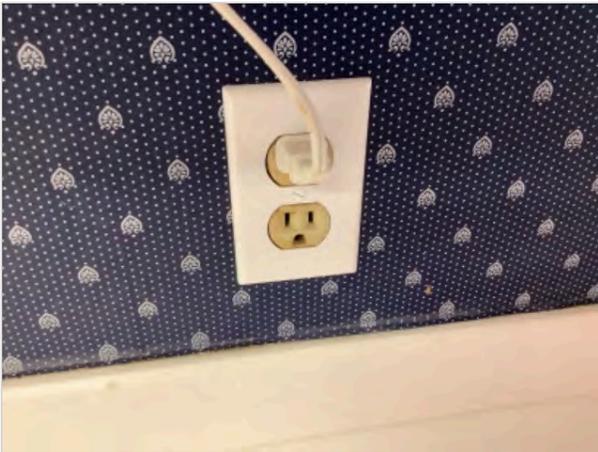
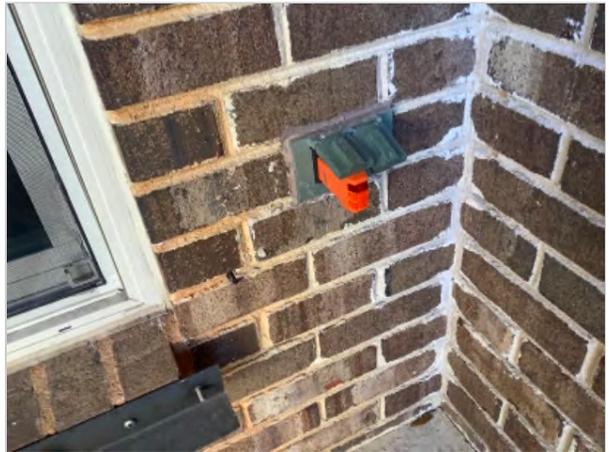
The home lacks GFCI protection.

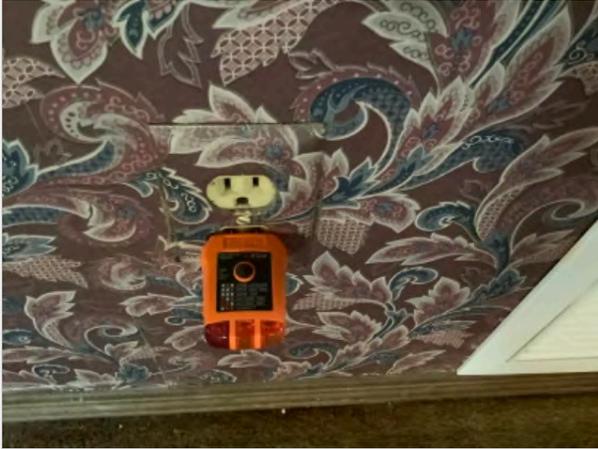
Photo 47

Multiple outlets were not functional. Consult with a qualified electrician for repair and further assessment of outlets.

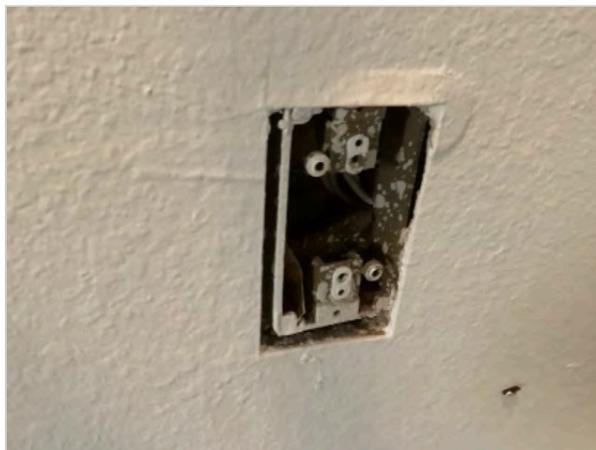
Photo 51

Cover plate appears to be burnt

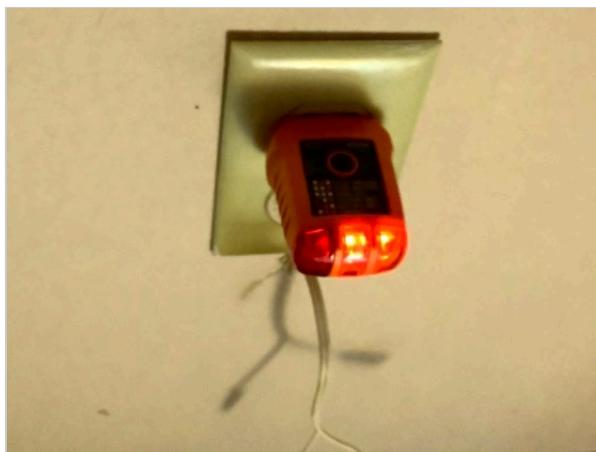
Photo 53

The receptacle is pulled loose from the wall.

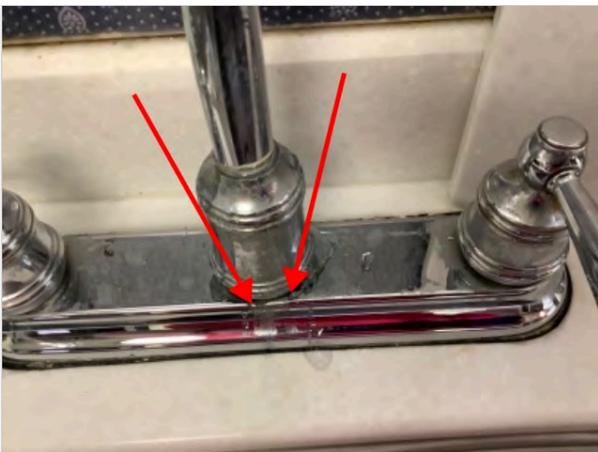
Photo 57

A leak was observed at the faucet to the kitchen sink. The faucet should be repaired or replaced to prevent water intrusion.

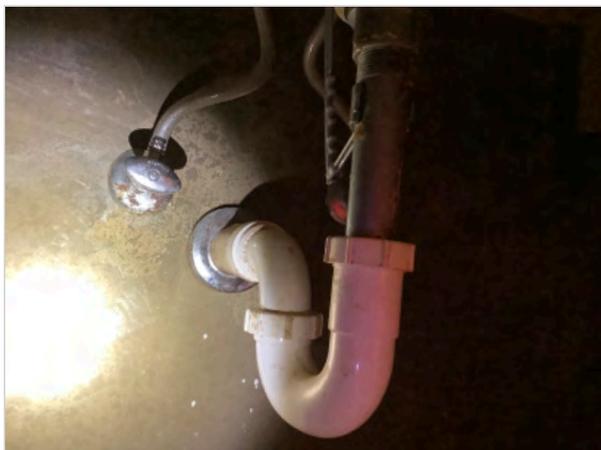
Photo 59

Master bathroom

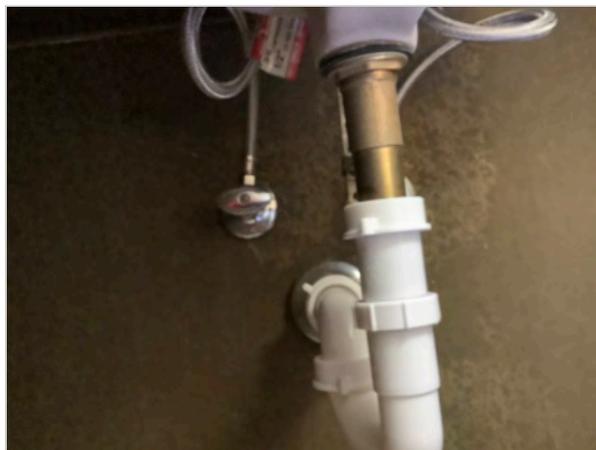
Photo 60

Hall bathroom

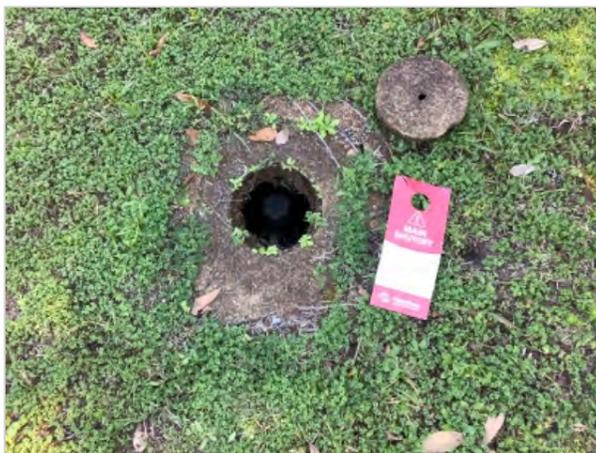
Photo 61

Front yard

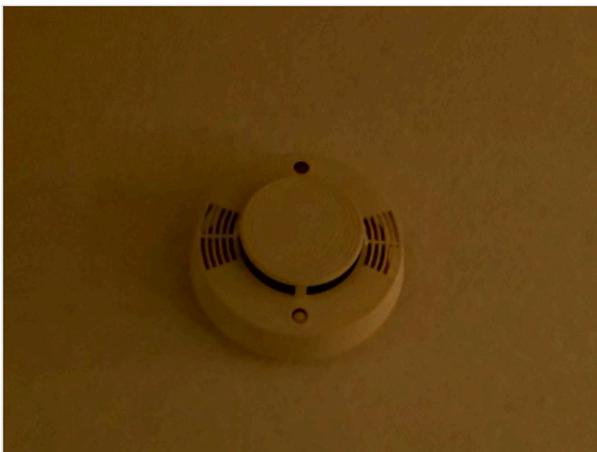
Photo 69

The home did not have a carbon monoxide detector

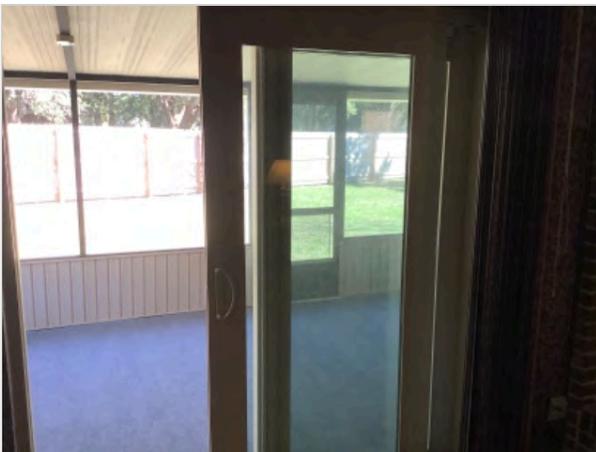
Photo 72

The latching mechanism to the Sliding glass door does not latch. The door, frame, and/or latching mechanism should be adjusted to allow for proper operation of the door.

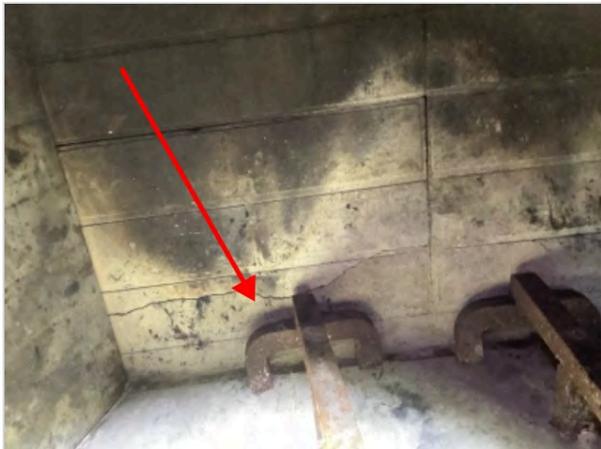
Photo 81

Cracks were present in the firebox of the fireplace located in the living room. Generally, firebox cracks are acceptable unless they are wide enough to fit a quarter into. The bricks and mortar inside the firebox are designed to act as a heat and spark shield and should be free of any voids. The firebox should be repaired and further assessed by a qualified chimney and fireplace service.

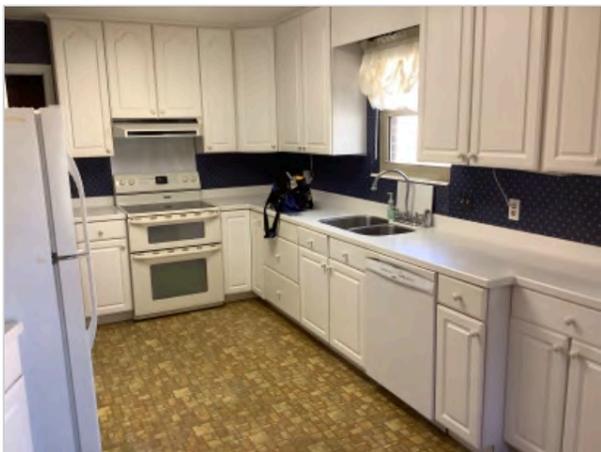
Photo 82

The electric oven and range combo was inspected and did appear to be functional. The accuracy of the clock, timers and settings on ovens are not within the scope of this inspection.

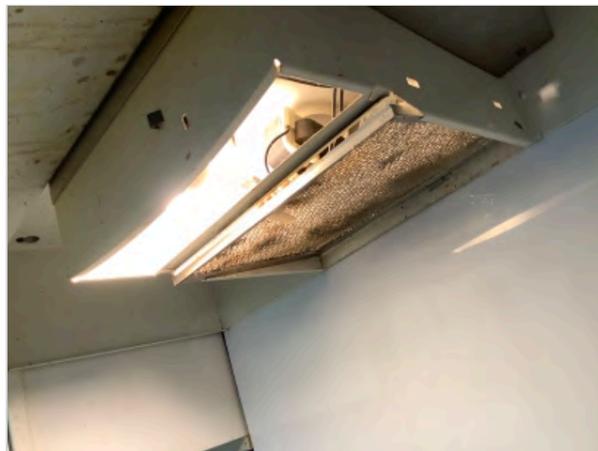
Photo 86

The range hood was inspected and did appear to be functional. The exhaust capacity is not within the scope of this inspection. Cleaning the fan and filter may increase the exhaust capability.

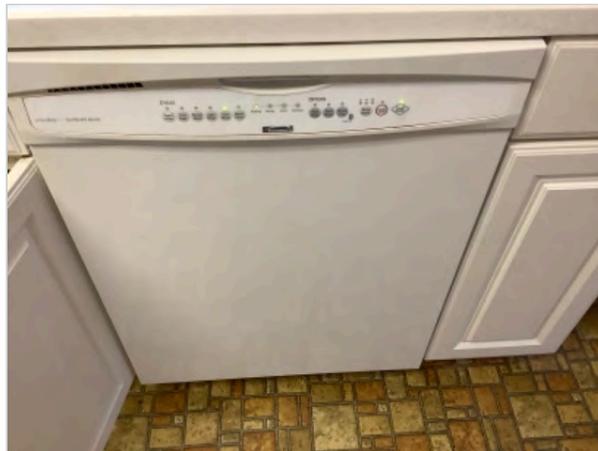
Photo 89

The dishwasher was tested and did appear to be functional.

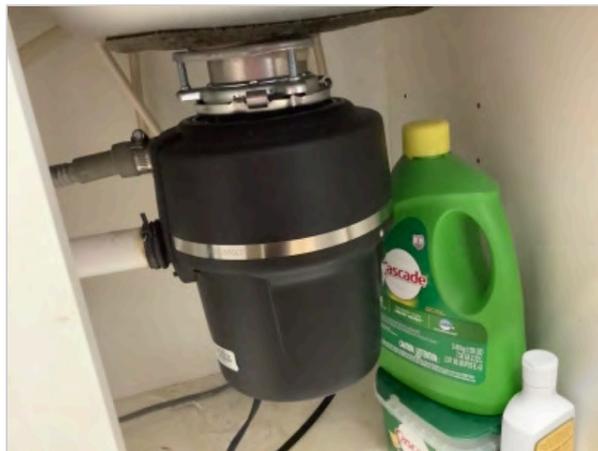
Photo 90

The disposal was inspected and did appear to be functional. The efficiency rating and chopping / grinding ability of the unit is not within the scope of the inspection.

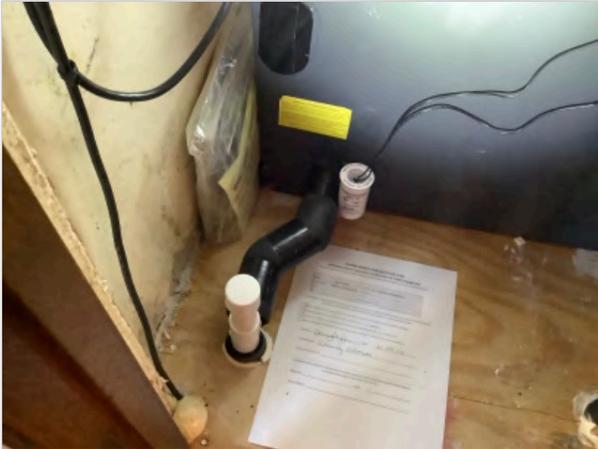
Photo 99

The HVAC condensate line terminated in floor drain raised above the floor drain or drain inlet. The condensate line did not appear to be trapped. The HVAC condensate line must be trapped and not in contact with wet drain inlets to prevent the possible migration of bacteria and mold into the air-handling system. The heating system was found to be functional.

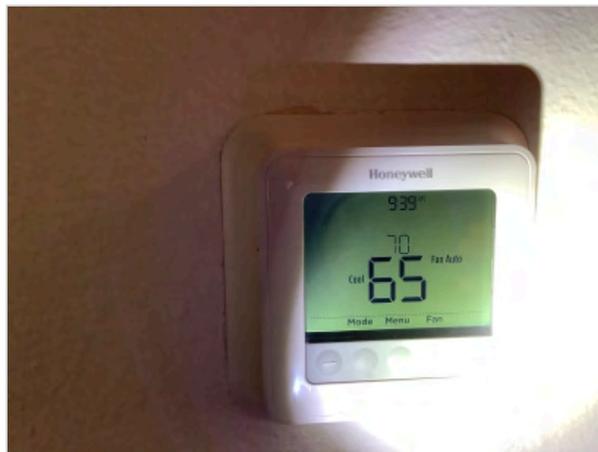
Photo 105

The control for the heating and air conditioning system was a 24 volt digital thermostat located on the hallway wall of the home. The thermostat was manufactured by Honeywell and was found to be in working order.

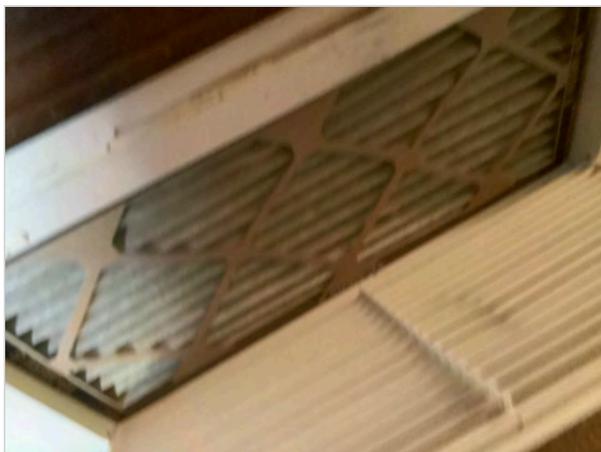
Photo 106

The disposable/washable filter should be replaced/cleaned on a regular basis to maintain the efficiency of the system. The efficiency rating is not within the scope of this inspection. Two 12x24x1 filter(s) were installed at the air handler.
