HOME INSPECTION REPORT

On Thursday, August 6, 2020 The HomeTeam Inspection Service made a visual inspection of 123 Sample Dr. Any Town, USA 55555. Enclosed please find a written, narrative report of our findings in accordance with the terms of our Inspection Agreement.

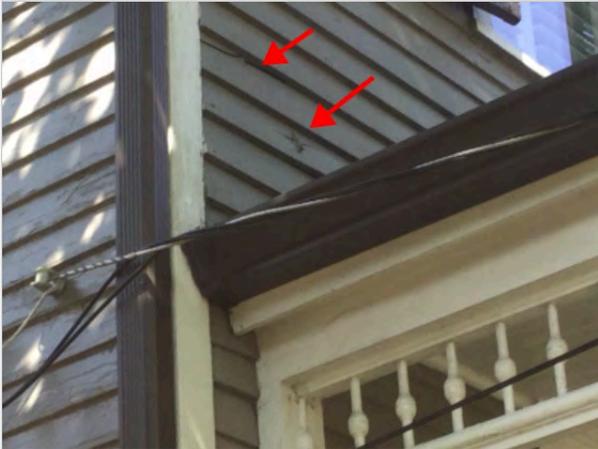
Photo 5

Front left

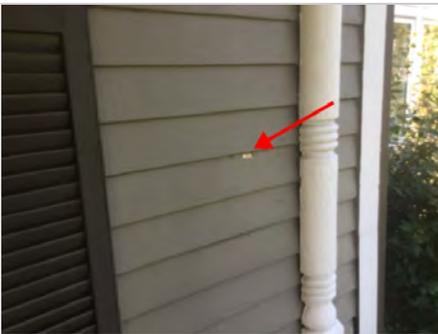
Photo 7

Front right

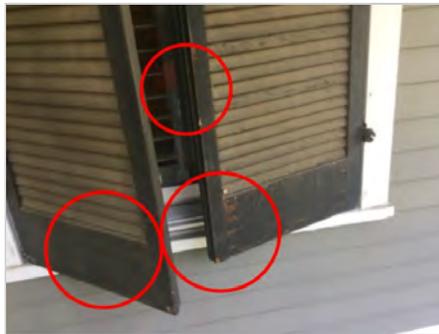
Photo 8

Backs of shutters

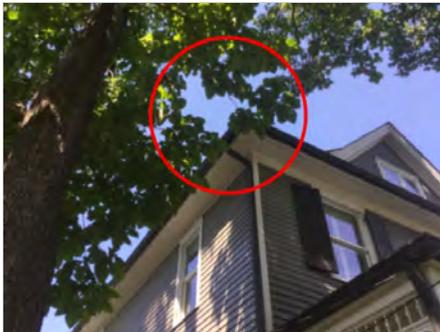
Photo 23

Vegetation around the house does create a risk of contact. Vegetation in contact with the house can cause physical damage and also retain moisture. Plants and trees should not be allowed to maintain or come into contact with the home to improve the longevity of the roof, gutters, chimneys and siding.

Left front

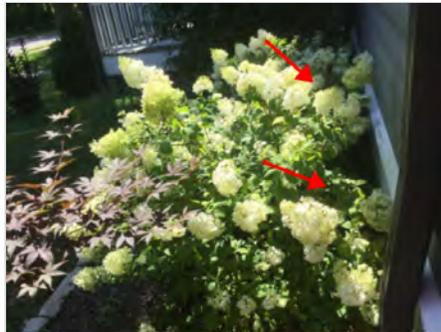
Photo 24

Front right

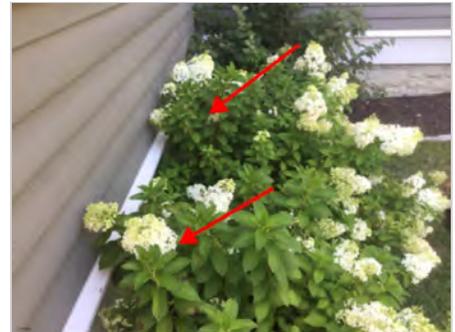
Photo 25

Right front

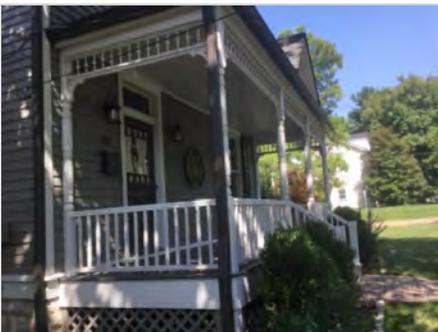
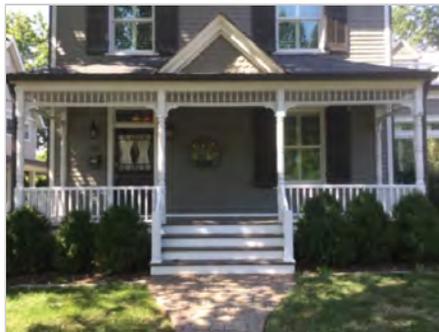
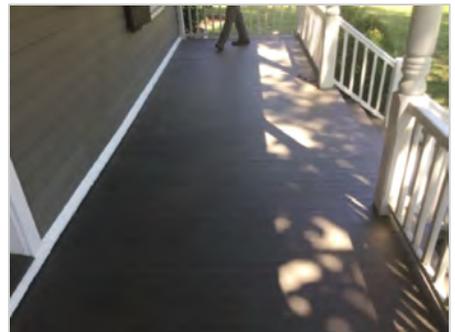
There is an insufficient amount and/or type of bolts attaching the ledger board to the structure. There should be two, 1/2" diameter lag screws or through bolts, with one-inch washers, at both ends, within five inches from the ends. Additionally, there should be an alternating pattern of same sized fasteners and washers, every 12-16 inches. (If utilizing bolts, they should have nuts and one-inch washers additionally on interior side.) Specific modifications to the

existing condition that are similar to the recommended standard cannot be specified by HomeTeam Inspection Service.

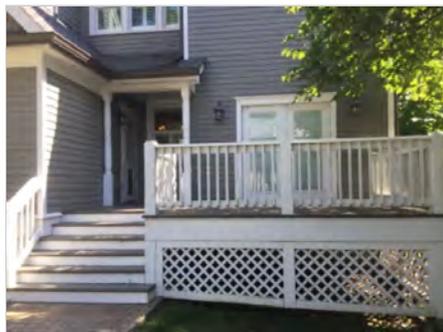
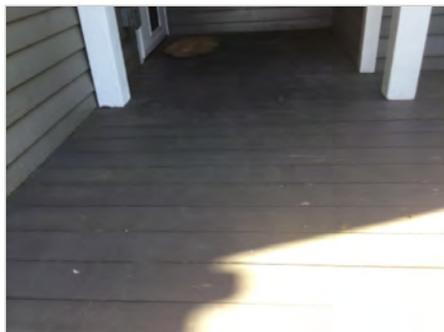
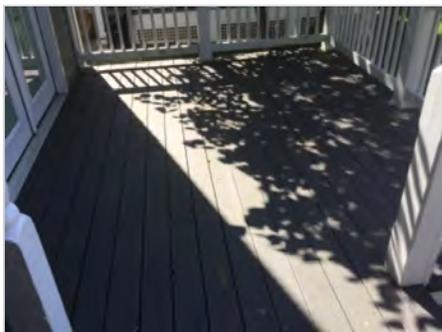
A graspable handrail is not present on the deck.

wood deck should be cleaned and sealed regularly to prevent deterioration.

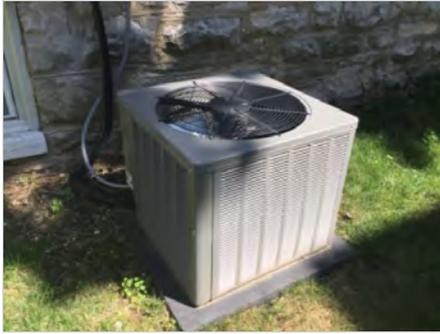
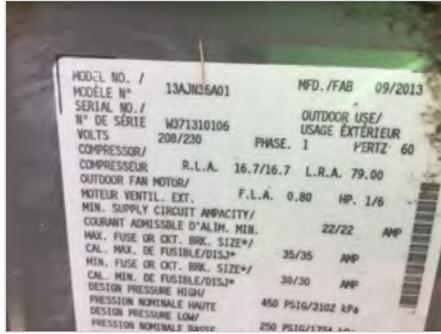
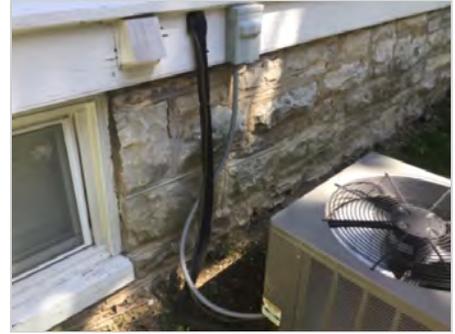
The electric outdoor air conditioner condensing unit was a Ruud, Model Number 13AJN36A01 and Serial Number W371310106. The unit is located on the left side of the structure. This unit is approximately 7 years old. Periodic preventive maintenance is recommended to keep this unit in good working condition, and HomeTeam strongly recommends partnering with a reputable HVAC company for routine maintenance for the heating and cooling systems in the fall and spring. The air conditioning system was tested and found to be functional. As a reminder, this is

Caulk is missing from areas where cabling or tubing enters the house. Caulk helps prevent moisture from entering the home and helps keep out pests. It is recommended that the gapped areas around the areas noted below be sealed.

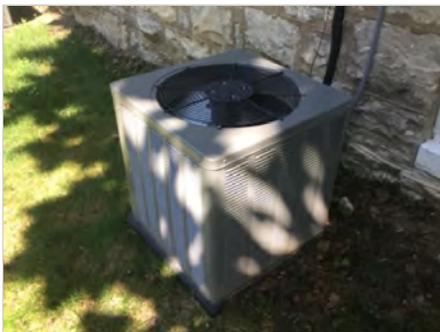
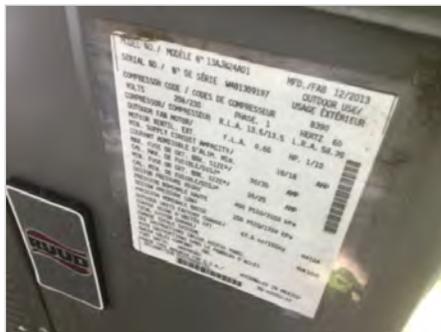
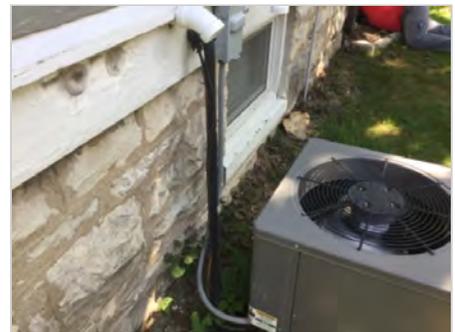
The second electric outdoor air conditioner condensing unit was a Ruud, Model Number 13AJN24A01 and Serial Number W481309197. The unit is located on the left side of the structure. This unit is approximately 7 years old. Periodic preventive maintenance is recommended to keep this unit in good working condition. The air conditioning system was tested and found to be functional.

Caulk is missing from areas where cabling or tubing enters the house. Caulk helps prevent moisture from entering the

home and helps keep out pests. It is recommended that the gapped areas around the areas noted below be sealed.

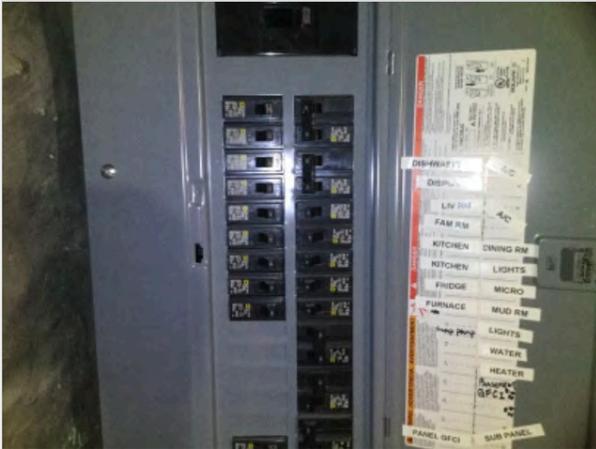
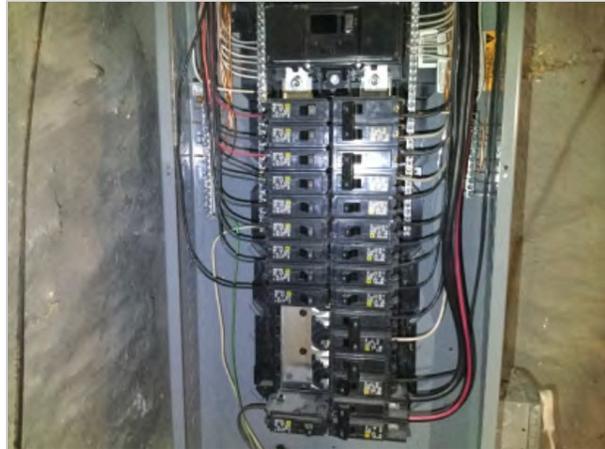
The service wire appeared to be 120/240 volt and 200 amp and entered a Square D service panel, located on the left basement wall. The main service disconnect was 200-amp rated and was located in the main panel. The branch circuits within the panel were copper. These branch circuits and the circuit breaker to which they were attached appeared to be appropriately matched. The internal components of the service panel, i.e. main lugs, bus bars, etc were in good condition. Proper electrical service grounding was found to be present.

A circuit breaker in the electric panel had two attached circuits (wires). Each circuit should have its own dedicated breaker to prevent nuisance tripping and ensure good terminal contact, which may help prevent overheating. This situation is commonly referred to as a "double-tap". An electrician should repair this condition and further assess the panel for any additional required repairs.

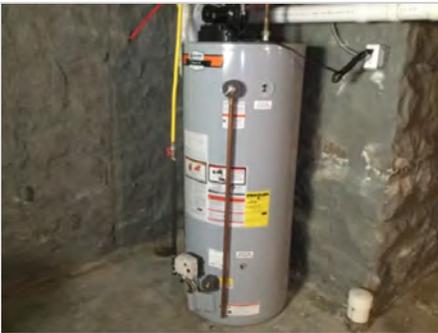
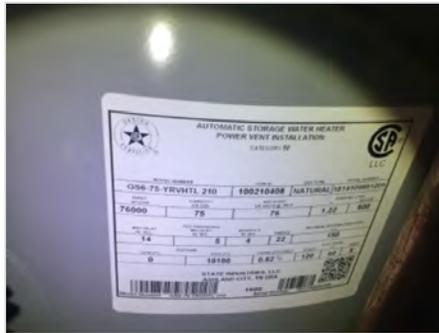
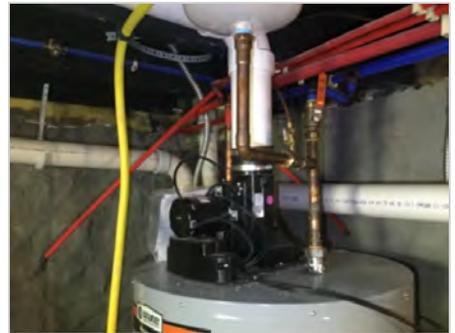
A 75 gallon capacity, electric and heat pump water heater was located in the basement. The water heater was manufactured by State, model number GS6-75-YRVHTL 210 and serial number 1814109891209. Information on the water heater indicated that it was manufactured 2 years ago. Hot water temperature was approximately 131 degrees F.

The expansion tank lacks a support strap, placing torque on the plumbing connection, which could lead to a leak. It is recommended that a support strap be added to add support from the joist above.

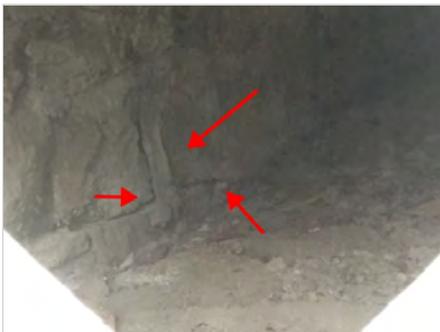
Photo 84

Tuckpointing is needed on the stone foundation to prevent water intrusion and structural integrity. The areas needed are noted in the pictures.

Front left under porch

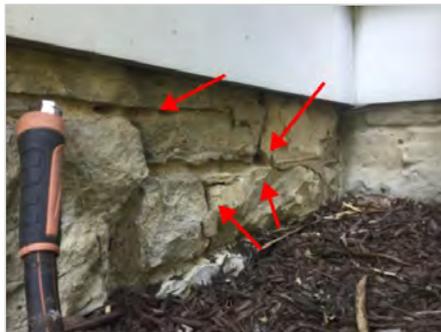
Photo 85

Right front

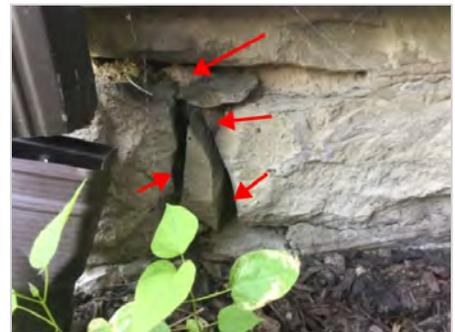
Photo 86

Right front

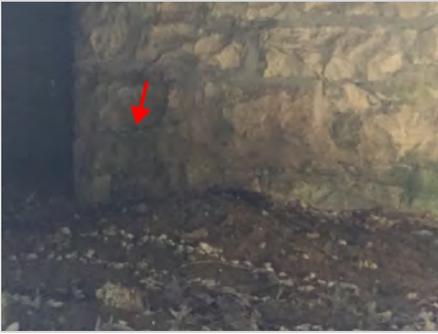
Photo 87

Rear center under deck

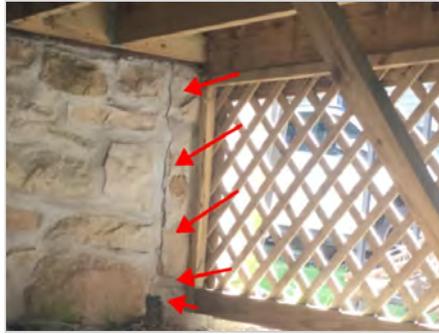
Photo 88

Rear left

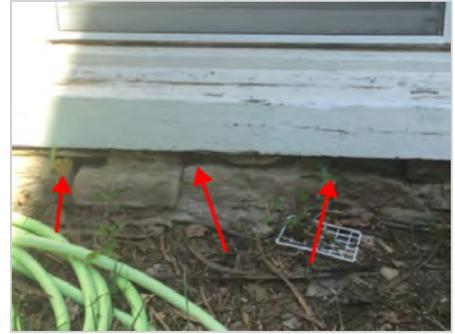
Photo 89

Left rear

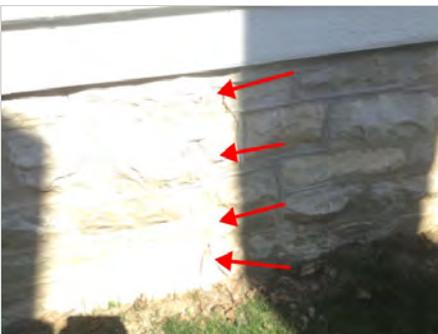
Photo 90

Left center

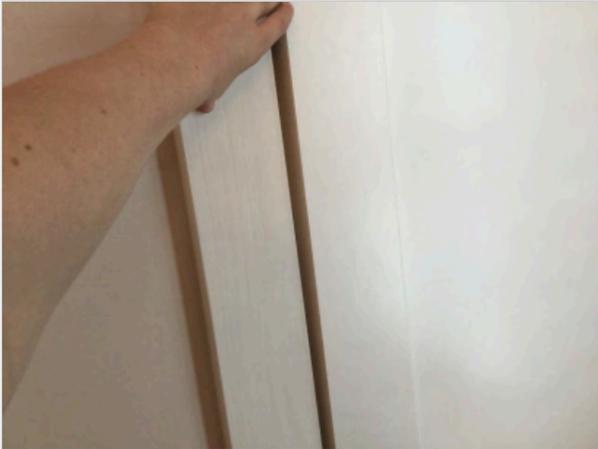
Photo 95

The door to the basement and front door does not latch. The door, frame, and/or latching mechanism should be adjusted to allow for proper operation of the door.

Basement stairs

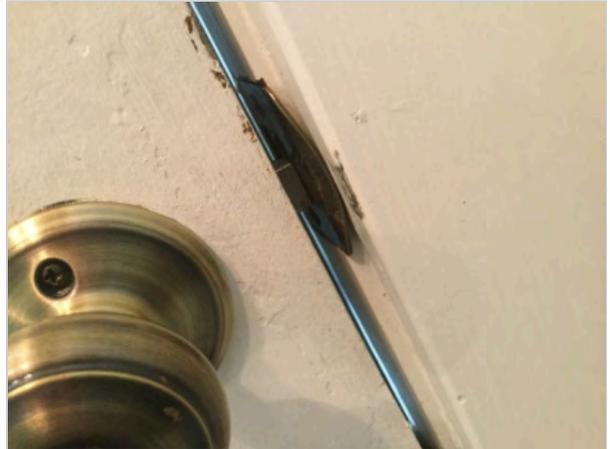
Photo 96

Front door

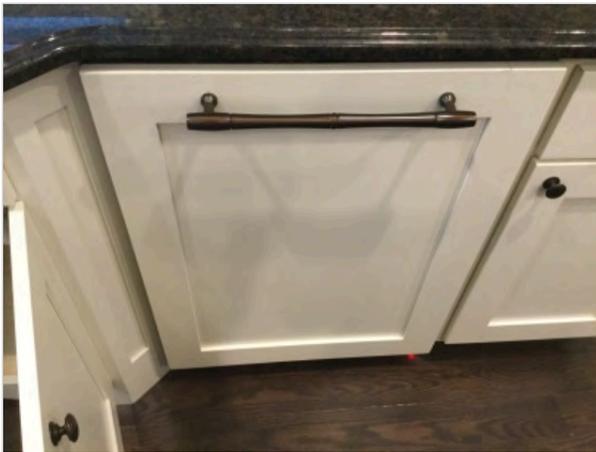
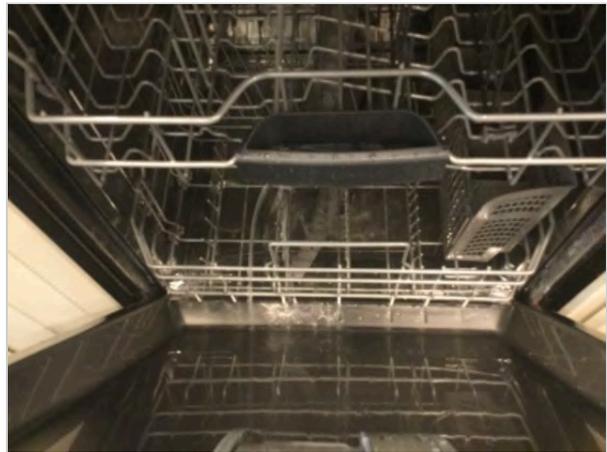
The dishwasher was tested and did appear to be functional. An anti-siphon or high drain loop was present.

The dishwasher's drain hose is not equipped with an anti-siphon valve (air gap) and may not be configured in a way to prevent a back-flow of grey water into the dishwasher. Consult with the manufacturer to determine if this particular model requires an air gap or external high loop (some are integrated and are not visible). If so, HomeTeam recommends having an anti-siphon valve (air gap) installed or the drain hose looped higher than the attachment point of the drain hose (high loop) to the disposal/plumbing drain to prevent grey water returning back into the dishwasher.

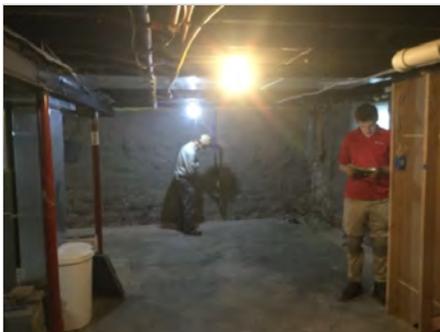
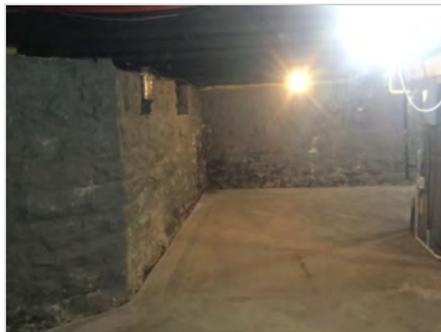
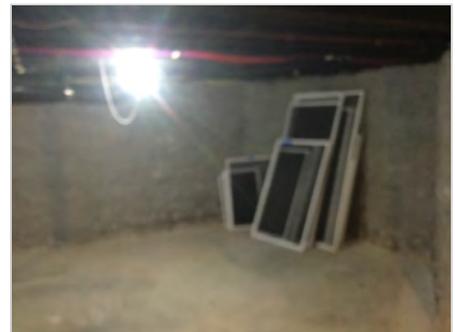
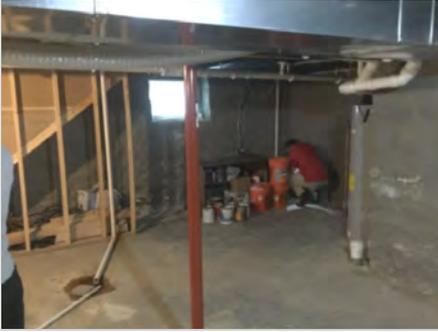
The concrete basement floor was in fair condition. Minor cracks within any concrete slab are common and are most often due to shrinkage and settlement. Concrete floors are poured after the structure is built and serve no purpose with regard to structural support.

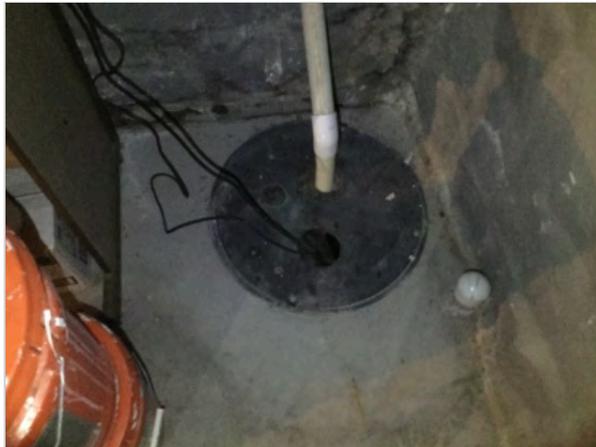
Photo 120

There was a sump pump located in the basement. The sump pump was not tested because the access panel was not removable. HomeTeam recommends all sump pumps be tested regularly. Backup pumps (battery and hydro) provide an added measure of protection and should be considered as an upgrade.

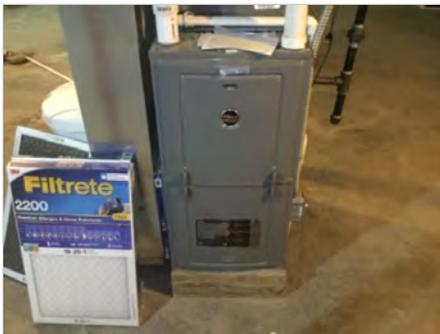
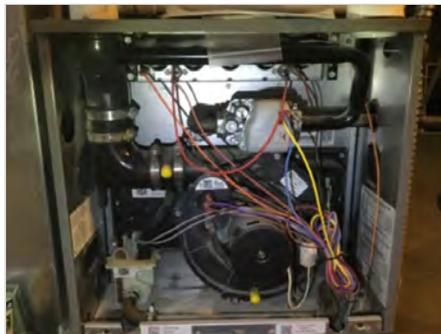
An additional heating system was also present and was a RUUD natural gas forced air furnace, model number R92PA0701317MSA, serial number W451310141 which is 7 years old. The temperature split was measured at several locations and was approximately 49 degrees F.

The unit was located in the basement of the structure. The flue vent appeared to be configured in such a way as to properly vent the flue gases.

A central humidifier was installed. The humidifier was a Aprilaire. The humidistat was turned to maximum to see if the unit responded to a call for humidification. The humidifier did not appear to be functional. The water supply valve to the unit appeared to be on. The humidistat was located on the return air plenum at the furnace. Use care when raising the humidity setting for the home. Too much humidity in the air is can create undesirable conditions.

The humidifier attached to the heating system was not operational when tested. It is recommended that a qualified HVAC technician called to service the issue and make it operational.
