HOME INSPECTION REPORT

On Wednesday, April 6, 2022 The HomeTeam Inspection Service made a visual inspection of 123 Anywhere Drive Town, USA 55555. Enclosed please find a written, narrative report of our findings in accordance with the terms of our Inspection Agreement.

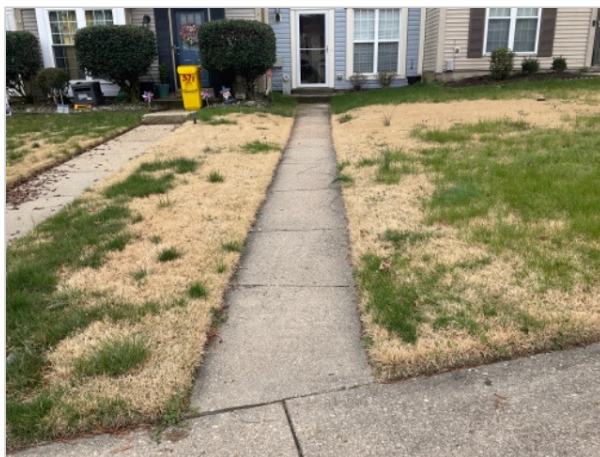
Photo 1

There was a concrete walkway leading to a concrete stoop in the front of the home. Surface defects in walkways develop and progress with age and are considered normal as long as they do not create a safety hazard.

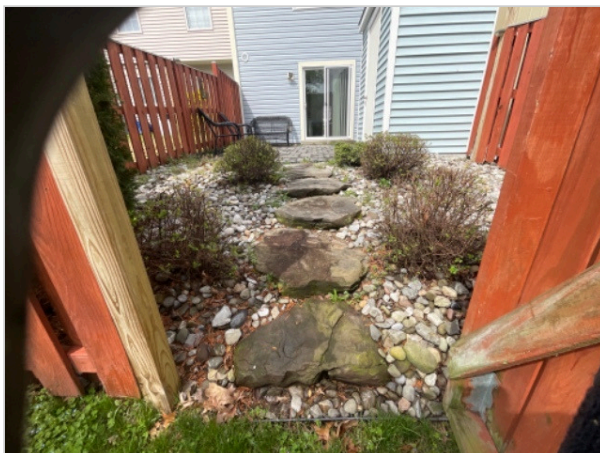
Photo 2

There was a stone walkway leading to a concrete and cement pavers patio in the back of the home. Surface defects in walkways develop and progress with age and are considered normal as long as they do not create a safety hazard.

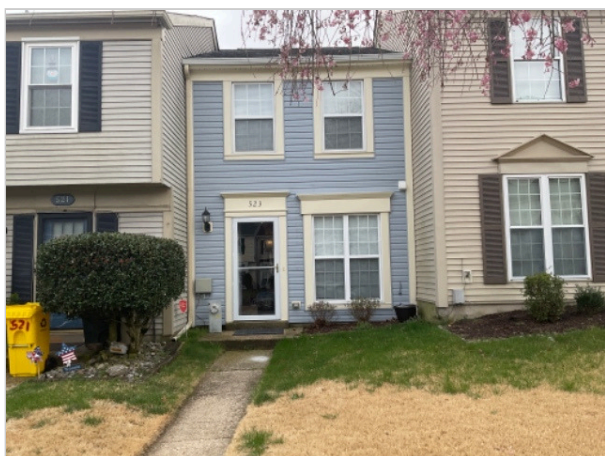
Photo 3

Front

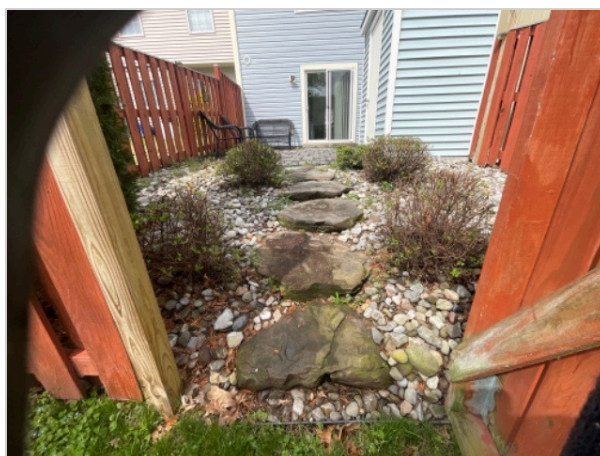
Photo 4

Rear

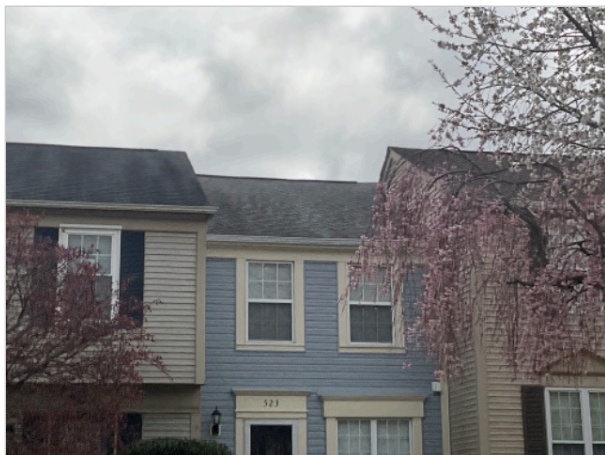
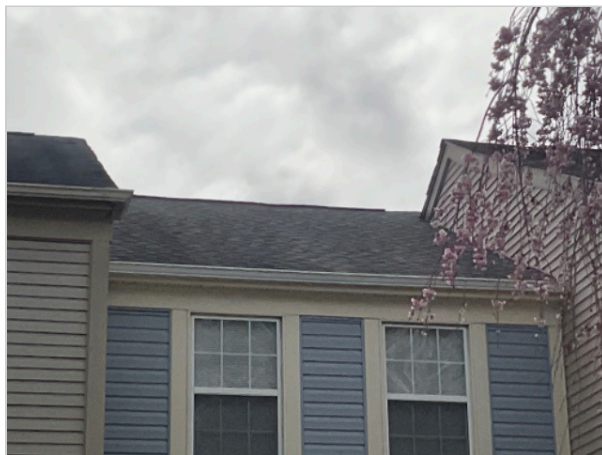
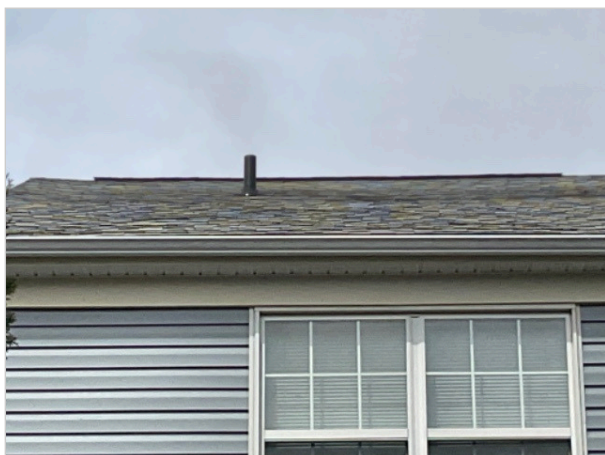
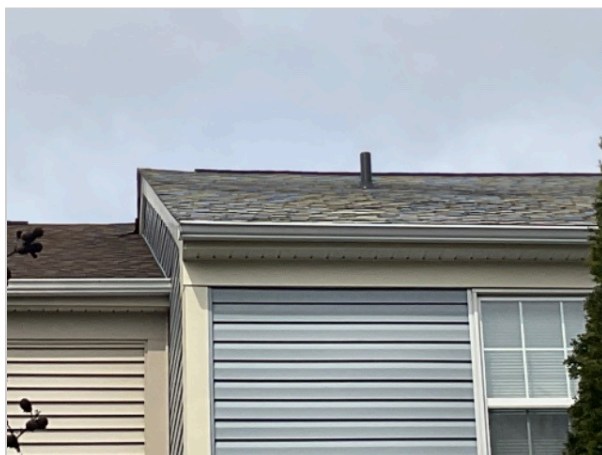
The roof shingles exhibited light curling and light surface wear. Nail pops were observed. Evidence of a hail event was not observed.

These conditions indicate the roof shingles were in the first half of their useful life.

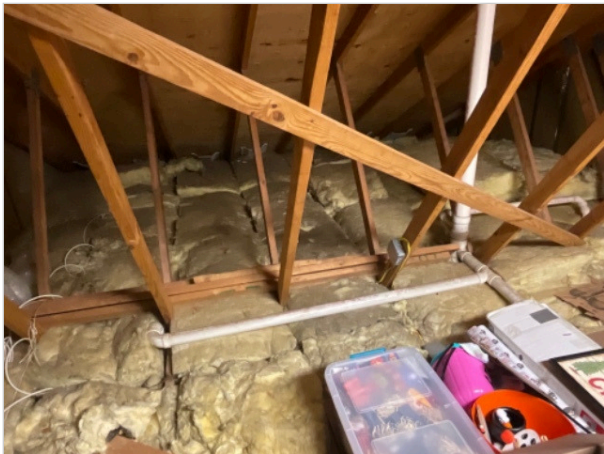
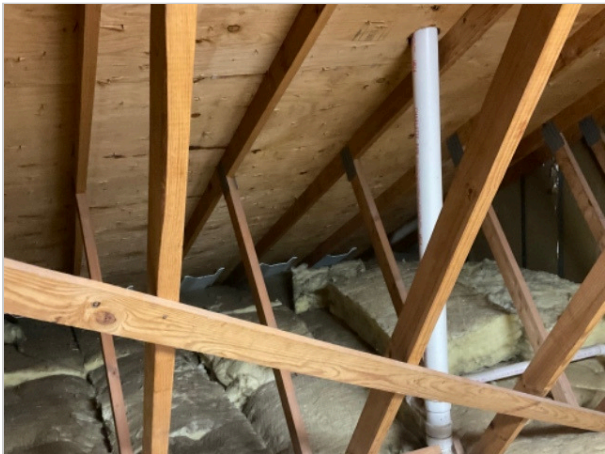
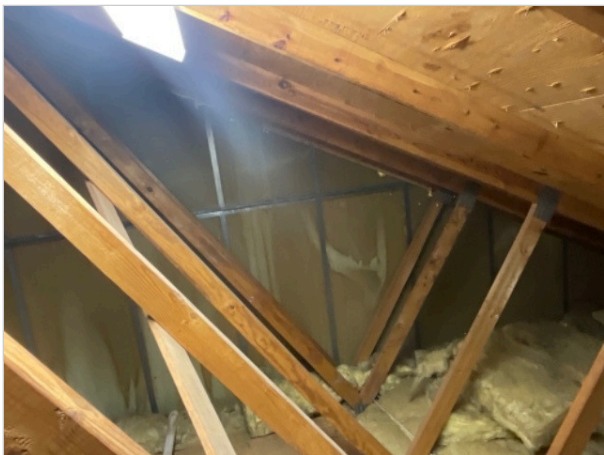
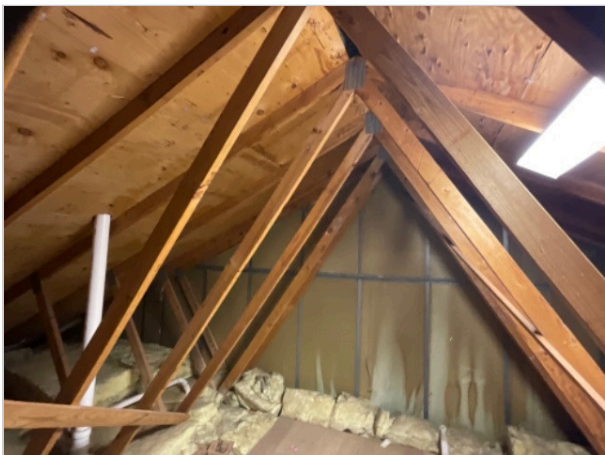
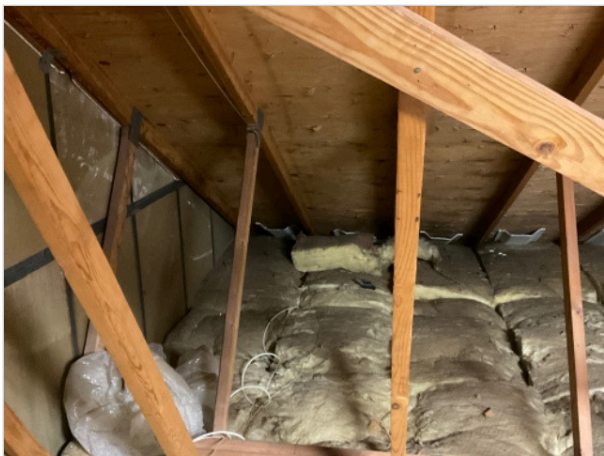
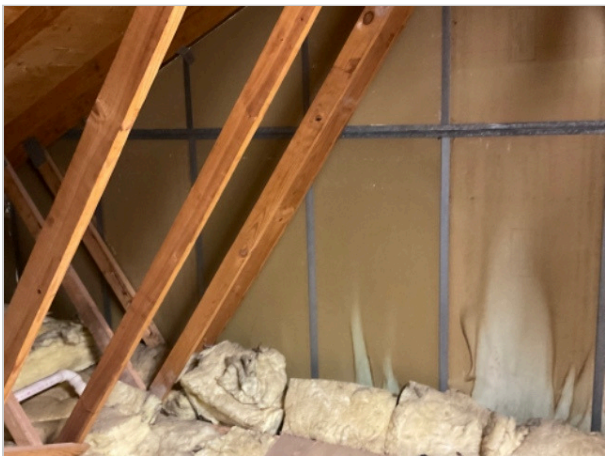
There was no moisture visible in the attic space.

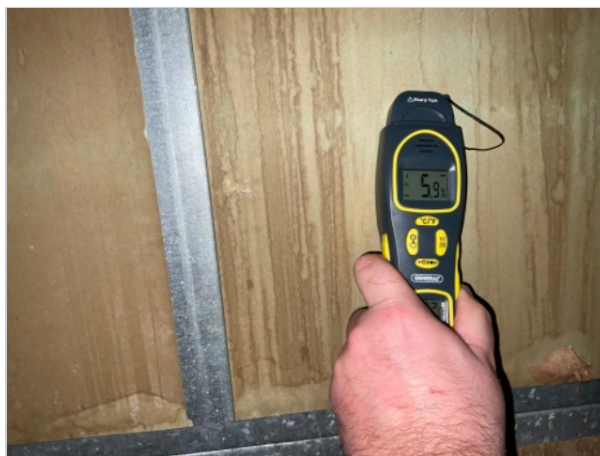
Photo 21

Parts of the attic show signs of previous water intrusion. These areas also show signs of a possible previous repair with spray foam. The areas were dry at the time of the inspection. The buyer should maintain vigilance in monitoring the areas for any recurrence of the previous issue and should rectify any issues immediately upon observing them.

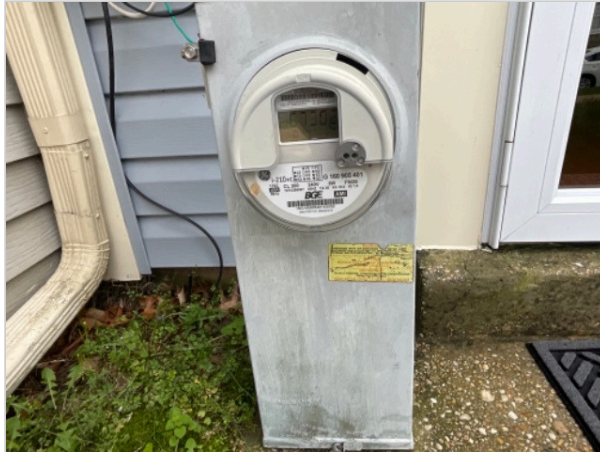
Photo 23

The underground electric service wire entered the structure on the front wall. The electric meter was located on the exterior wall.

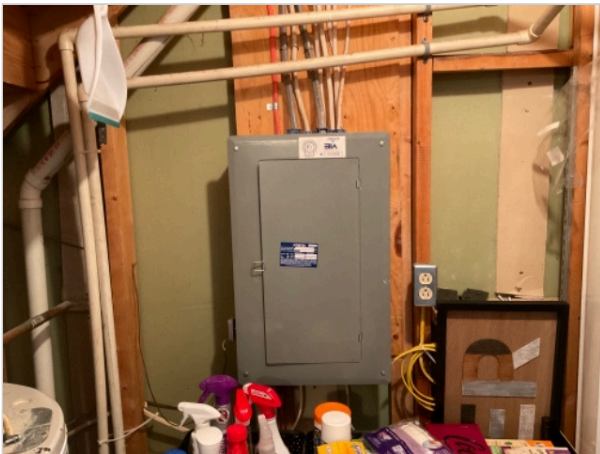
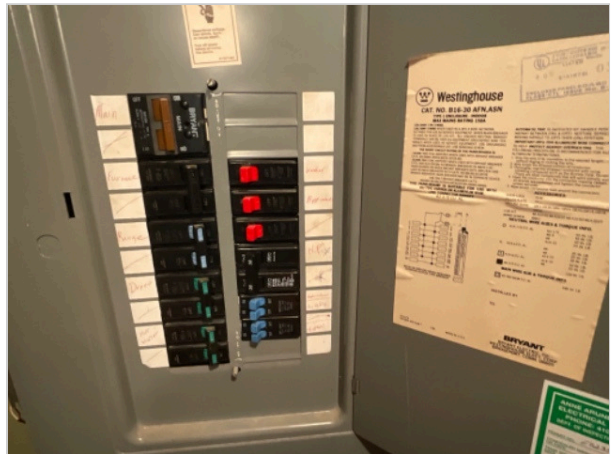
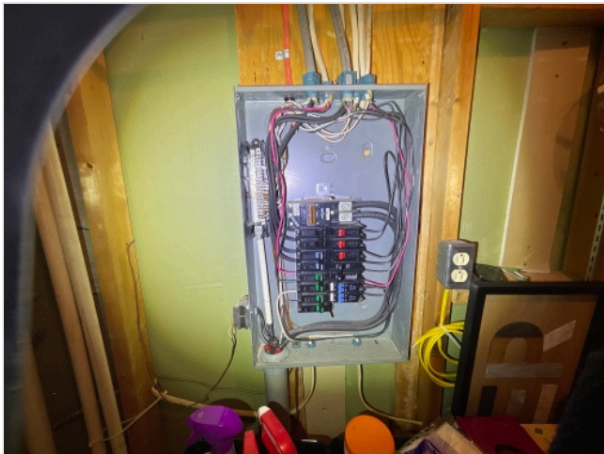
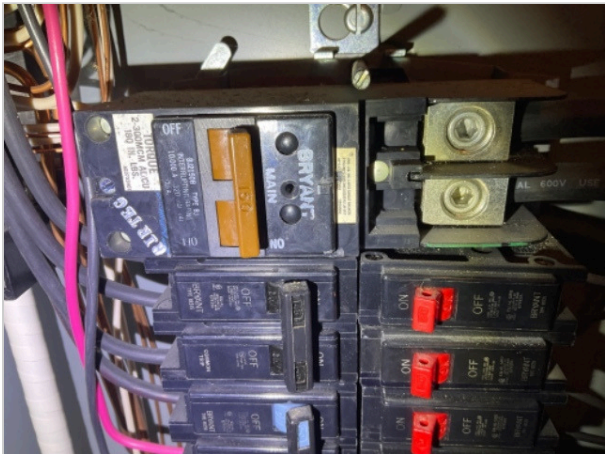
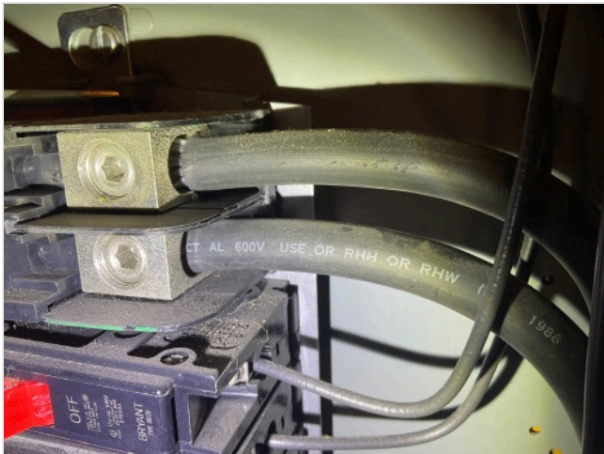
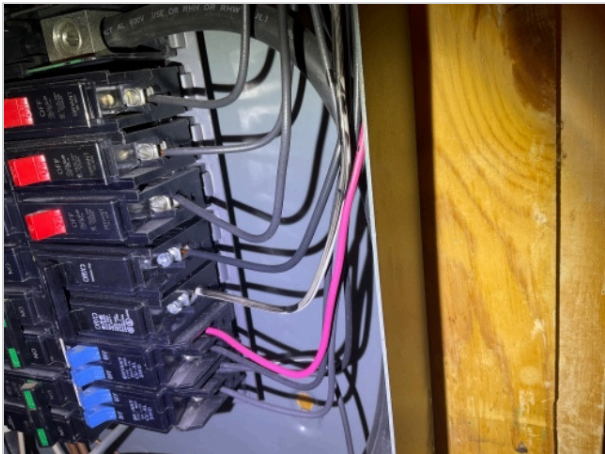
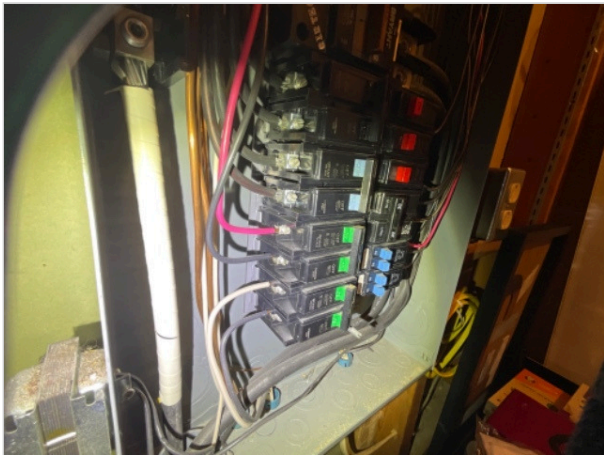
The service wire appeared to be 120/240 volt and 150 amp and entered a Westinghouse service panel, located on the rear utility room wall. The main service disconnect was 150-amp rated and was located in the main panel. The branch circuits within the panel were copper. These branch circuits and the circuit breaker to which they were attached appeared to be appropriately matched. The internal components of the service panel, i.e. main lugs, bus bars, etc were in good condition.

The electrical service appeared to be adequate. As a reminder, alarms, electronic keypads, remote control devices, landscape lighting, telephone and television wiring are beyond the scope of this inspection.

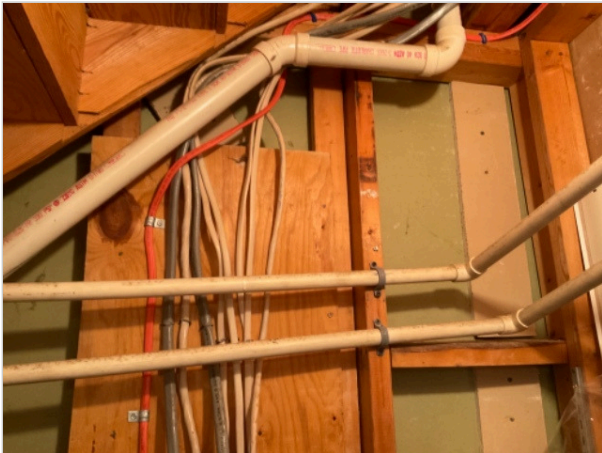
Photo 32

The visible house wiring consisted primarily of the non-metallic sheathed cable type and appeared to be in good condition. An electric service grounding system was installed. Service grounding requirements have changed many times over the years. The grounding system for a 30-year-old electric service is different from that of a 10-year-old service. The inspection does not attempt to verify that the grounding system or any other part of the electric service complies with current codes.

Utility Closet

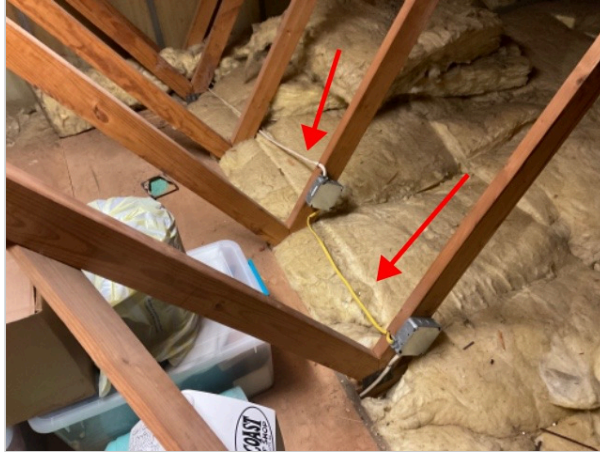
Photo 34

Sections of unsupported electrical wiring were present in the attic. All electrical wiring should be properly supported at regular intervals.

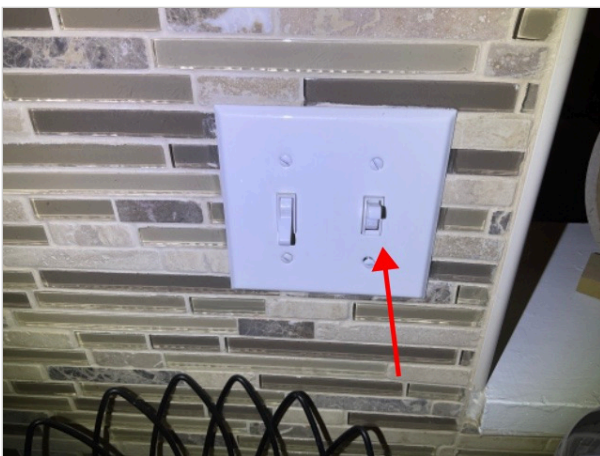
Photo 35

Kitchen

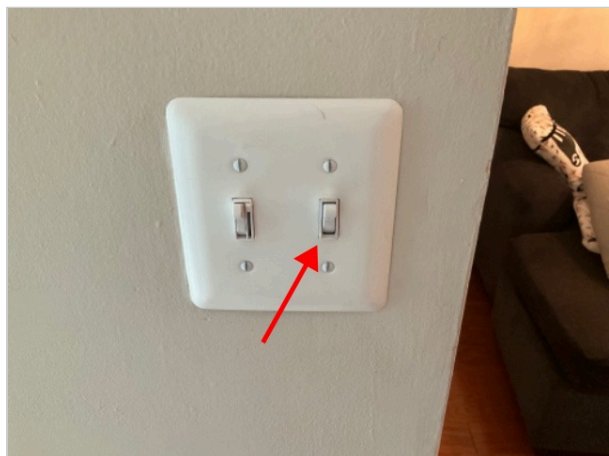
Photo 36

Kitchen

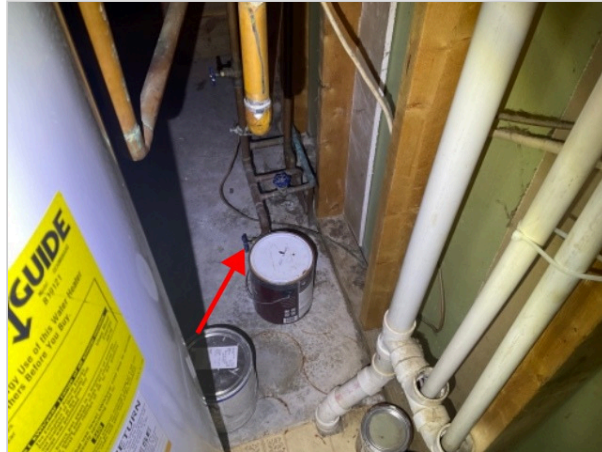
Photo 45

The water meter was located in the front yard. The main water shutoff valve for the structure was located adjacent to the water service entry point in the utility room. Water shutoff valves are visually inspected only. No attempt is made to operate the main or any other water supply shutoff valves during the inspection. These valves are infrequently used and could leak after being operated. The only exception to this policy is made when the main water supply valve is off upon arrival at the inspection. Since it is the buyers right to have all utilities operable for the home inspection, we will attempt to turn the main water valve on for the inspection. The HomeTeam is not responsible for leaks caused by operating the valve.

Utility Room

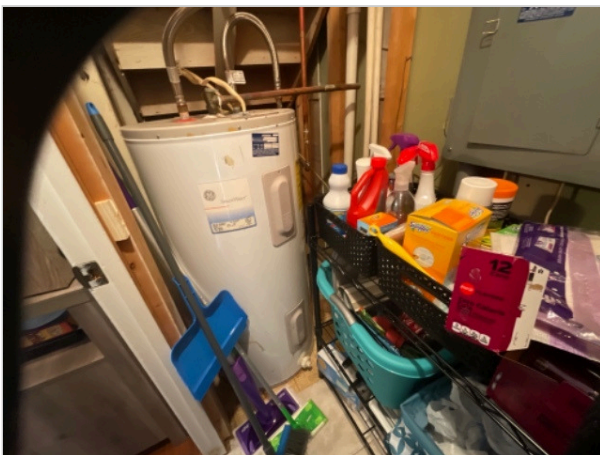
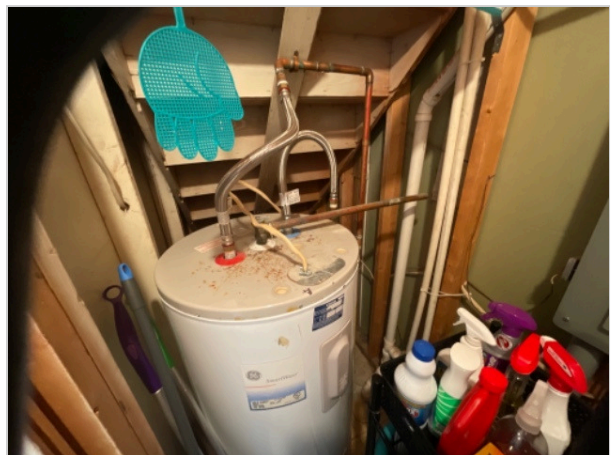
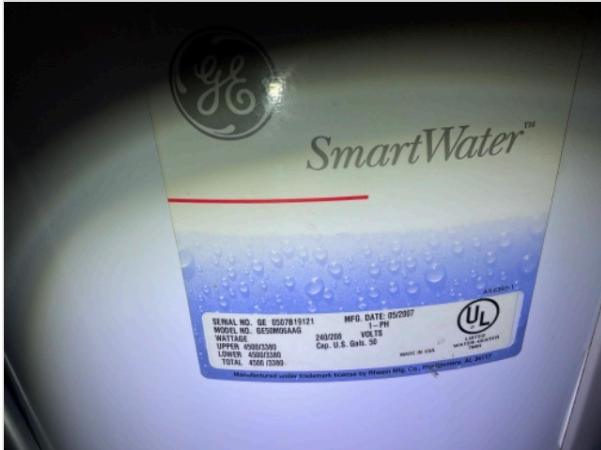
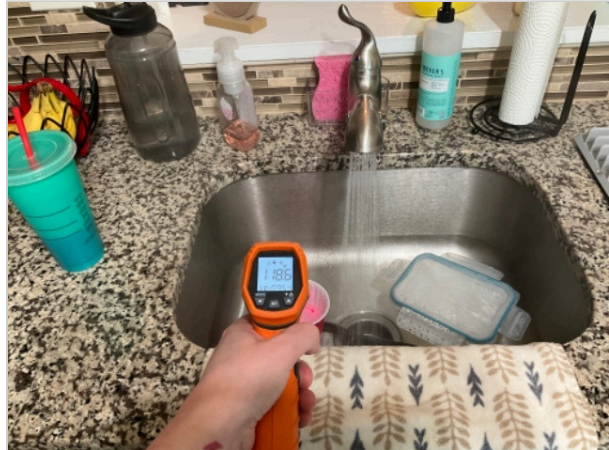
The water heater may be past its design life. This is an informational note only to help give an idea of future budgeting considerations. The unit was functional unless noted otherwise. Please note that since codes change, it is possible the configuration for a water heater's flue and/or discharge may need to be altered at the time of a future replacement.

The water heater overflow leg does not terminate properly. The overflow leg should be repaired/replaced with one that terminates properly.

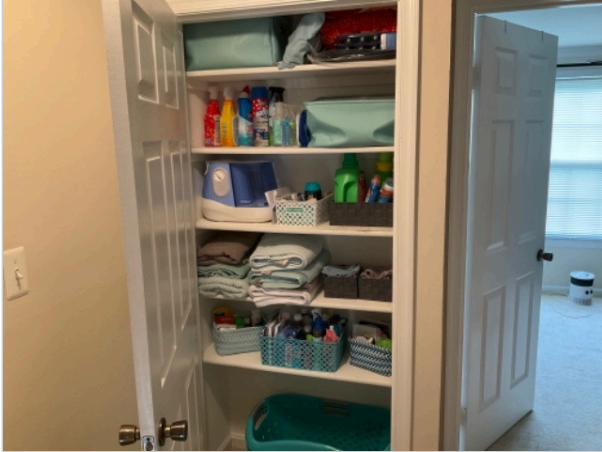
Photo 51

The closets were cluttered with many stored items and/or shelves at the time of inspection. The obstructed areas were not able to be visually inspected.

Second Floor Hallway

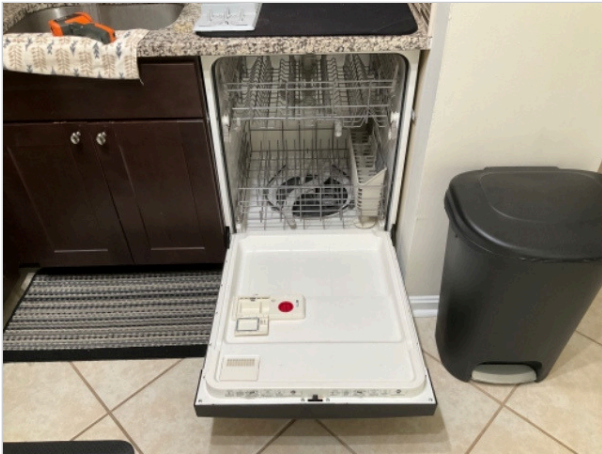
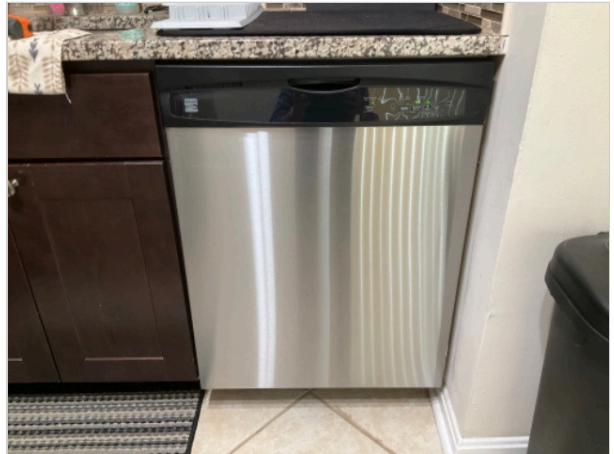
The dishwasher was tested and did appear to be functional.

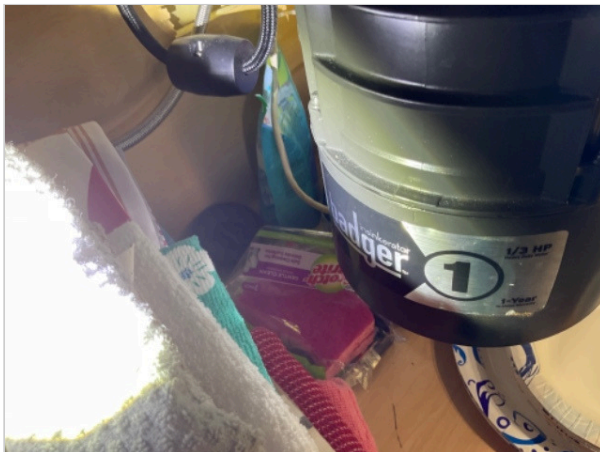
The disposal was inspected and did appear to be functional. The efficiency rating and chopping / grinding ability of the unit is not within the scope of the inspection.

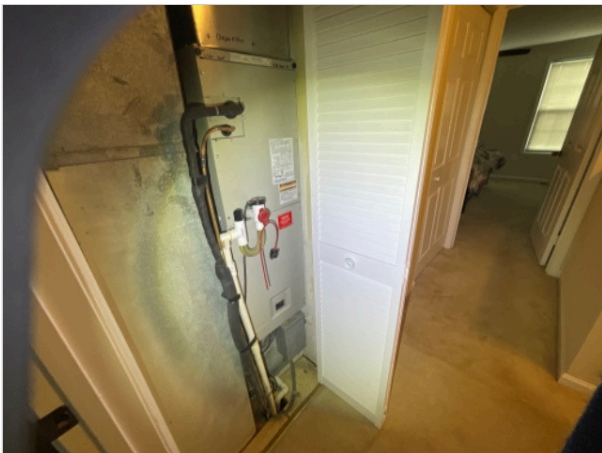
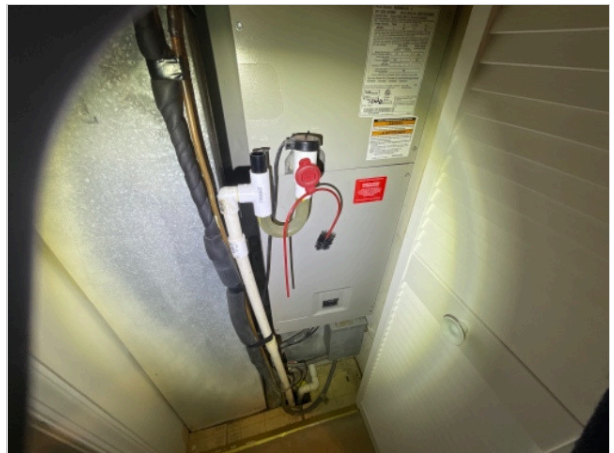
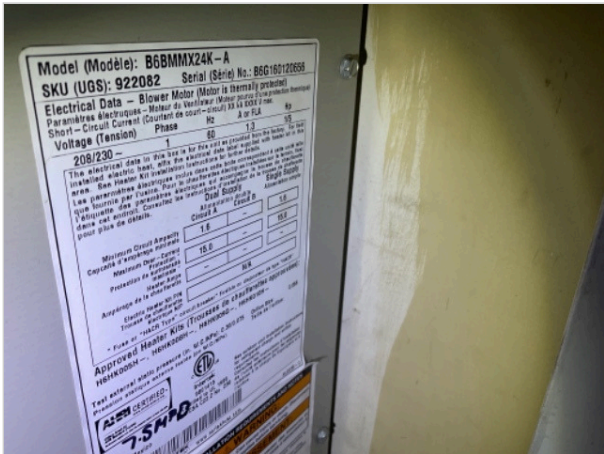
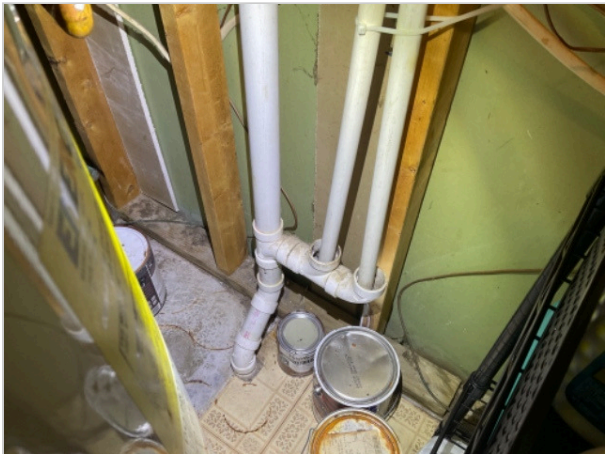
First Floor Utility Closet

The HVAC condensate line was tied into a drain line above the floor drain . The condensate line was trapped. The HVAC condensate line must be trapped and not in contact with wet drain inlets to prevent the possible migration of bacteria and mold into the air-handling system. The heating system was found to be functional.

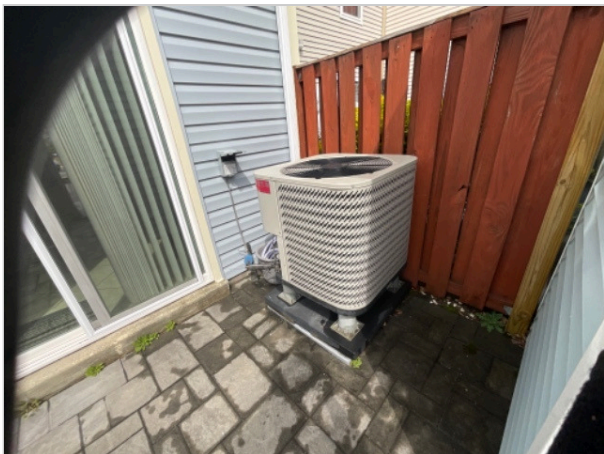
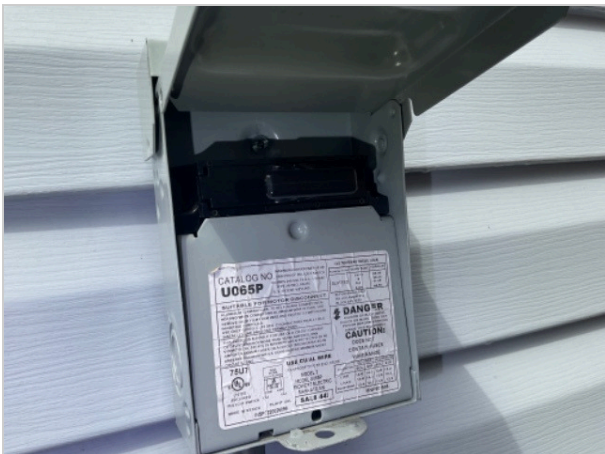
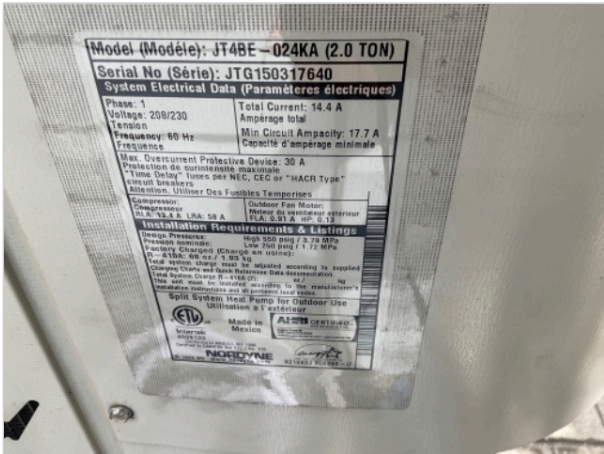
The electric outdoor heat pump condensing unit was a Nordyne, Model Number JT4BE-024KA and Serial Number JTG150317640. The unit is located in the back of the structure. This unit is approximately 7 years old. Periodic preventive maintenance is recommended to keep this unit in good working condition. The heat pump system was functional.

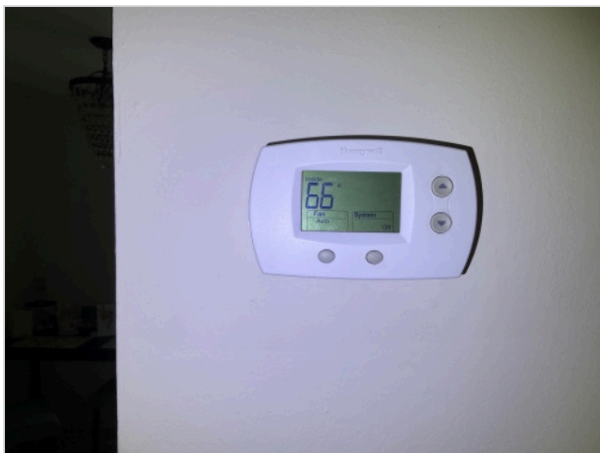
The control for the heating and air conditioning system was a 24 volt digital thermostat located on the living room wall of the home. The thermostat was manufactured by Honeywell and was found to be in working order.

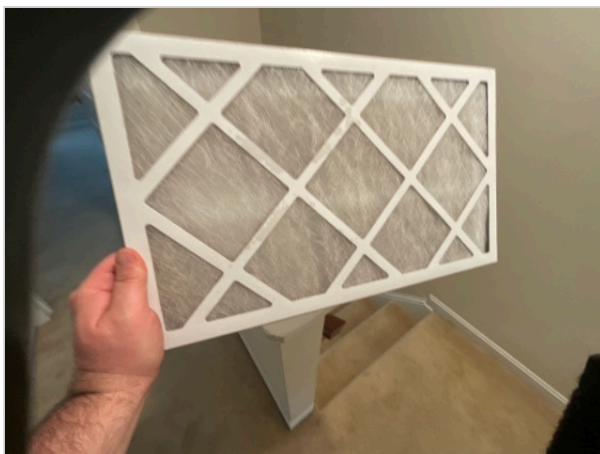
The disposable/washable filter should be replaced/cleaned on a regular basis to maintain the efficiency of the system. The efficiency rating is not within the scope of this inspection. A 12x20x1 filter(s) was installed above the air handler.
