HomeTeam[®]

HOME INSPECTION REPORT

On Saturday, August 4, 2018 The HomeTeam Inspection Service made a visual inspection of 123 Sample Dr, Anytown, AZ 55555. Enclosed please find a written, narrative report of our findings in accordance with the terms of our Inspection Agreement.

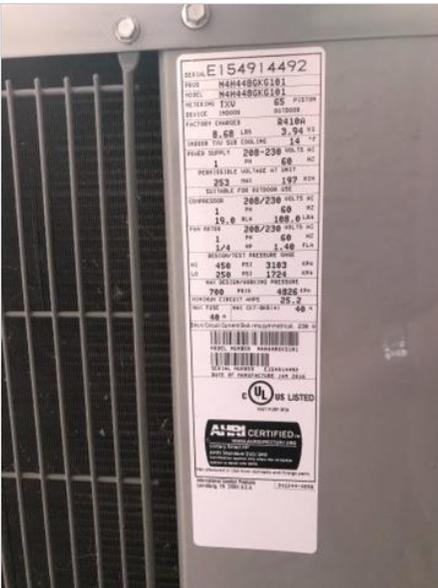
Photo 23

> HVAC unit does not have the correct fusing or breakers based on the information on the HVAC label. Suggest repair by a qualified HVAC technician or qualified electrician.

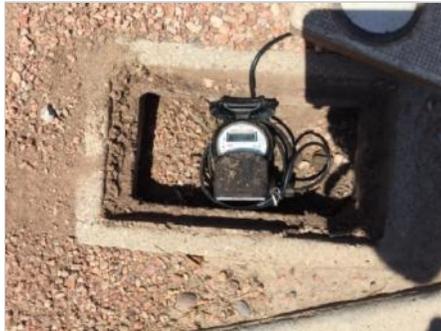
Photo 36

Water Meter

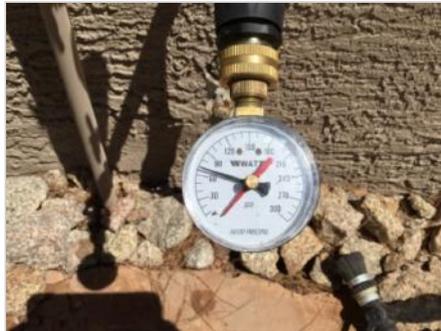
Photo 37

Water Pressure- 72 PSI

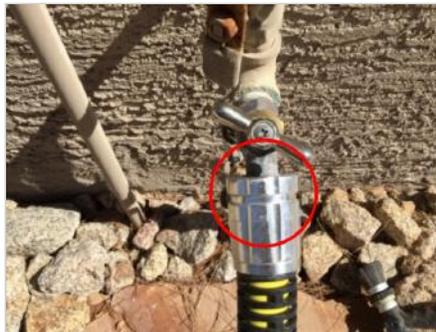
Photo 47

No Vacuum Breaker

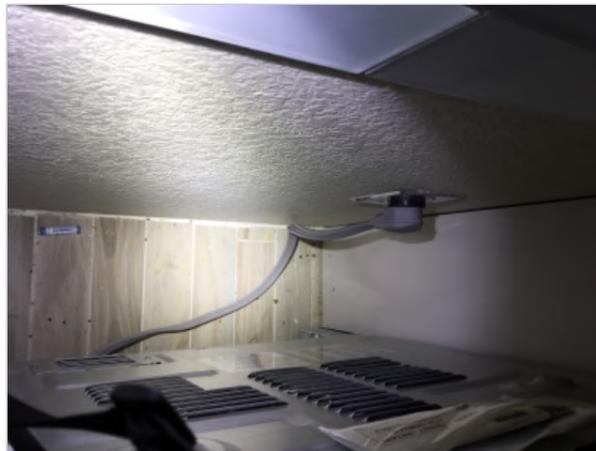
Photo 49

> **Oven and range combination does not have an anti-tilt bracket installed** to keep the unit from tipping forward. An anti-tilt bracket should be installed by a qualified party.

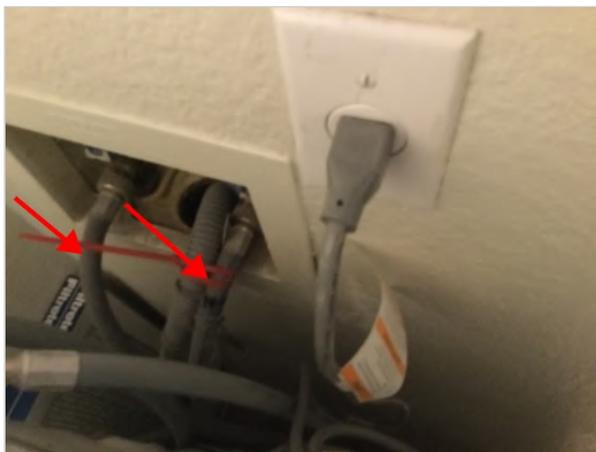
Photo 50

> **Rubber hose(s) under constant water pressure found in home.** HomeTeam recommends replacement of any rubber hose that under constant pressure (water heater, washing machine, toilet, sinks) with a stainless steel braided reinforced hose. The stainless steel braided hose will last much longer in the dry Arizona air than a typical rubber hose although the stainless steel hose will need to be replaced per the manufacturer's suggested interval.

Washer Supply Hoses

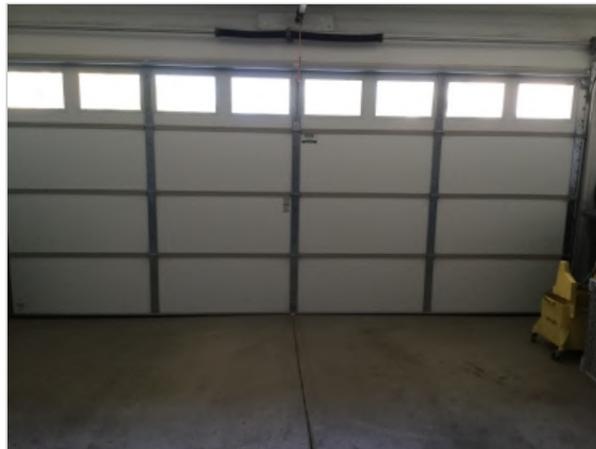
Photo 52

> **The garage door safety pressure reverse system is not operable.** This means that the door does not stop and reverse when resistance is placed at the base of the door. The opener should be adjusted or repaired.

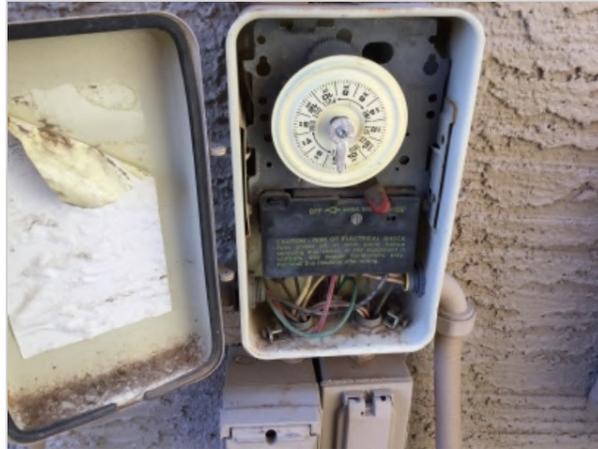
Photo 66

> **Terminal shield in timer box is damaged or missing.** Suggest replacement to ensure that electrical connections are not accidentally contacted while actuating timer.
