# HomeTeam<sup>®</sup>

### HOME INSPECTION REPORT

On Sunday, October 18, 2020 The HomeTeam Inspection Service made a visual inspection of 1234 Smith Road on Main Street in Libertyville. Enclosed please find a written, narrative report of our findings in accordance with the terms of our Inspection Agreement.

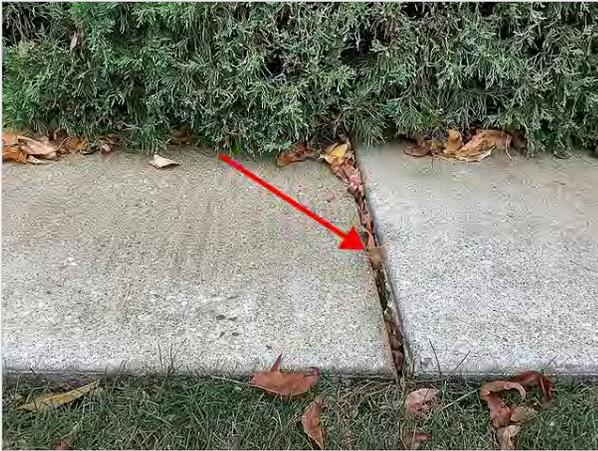
Photo 5

Garage left

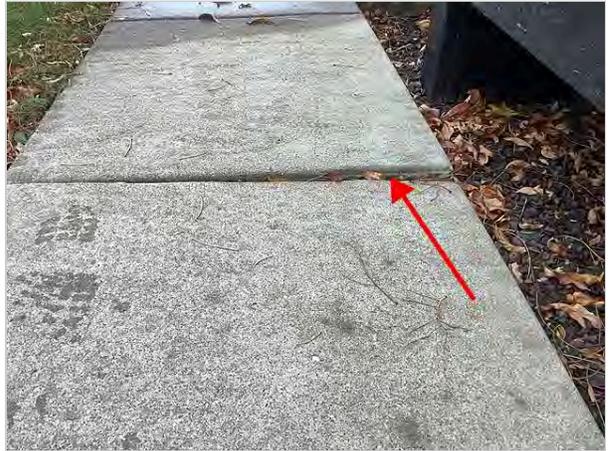
Photo 6

Garage front

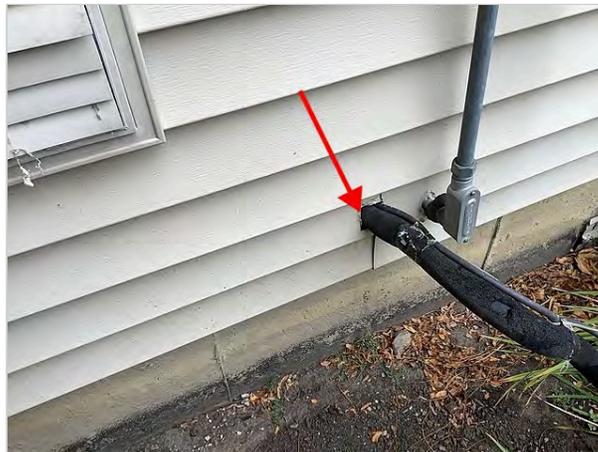
**Photo 8**

**Exterior caulking penetrations is cracked or missing.** The caulking should be repaired or replaced to help prevent water intrusion.

AC lineset

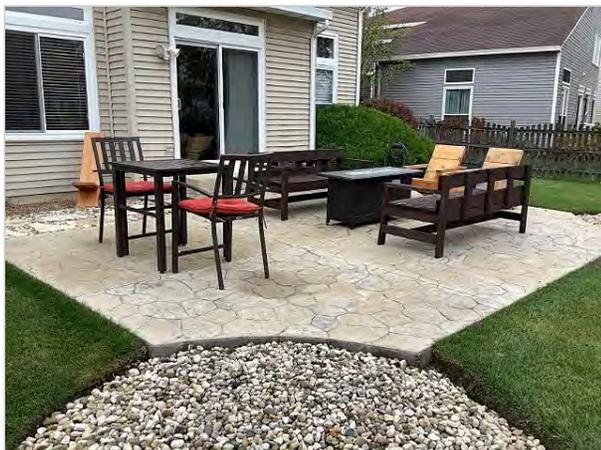
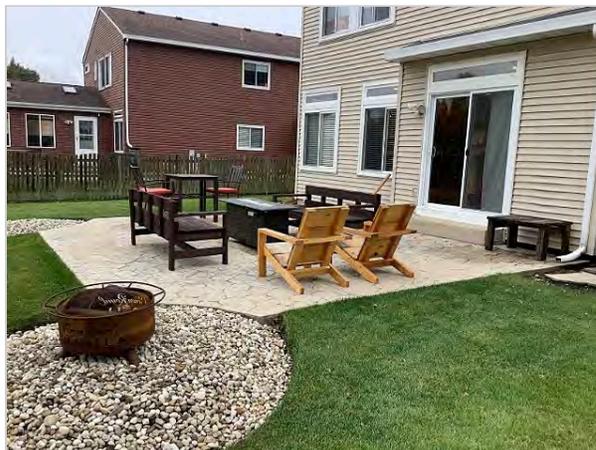
A gap was observed at the patio around the rear stoop. These areas can allow water to penetrate and cause further unseen damage. Penetrating water could create unseen problems with the structure. It is recommended that these areas be repaired as needed to help prevent water penetration.

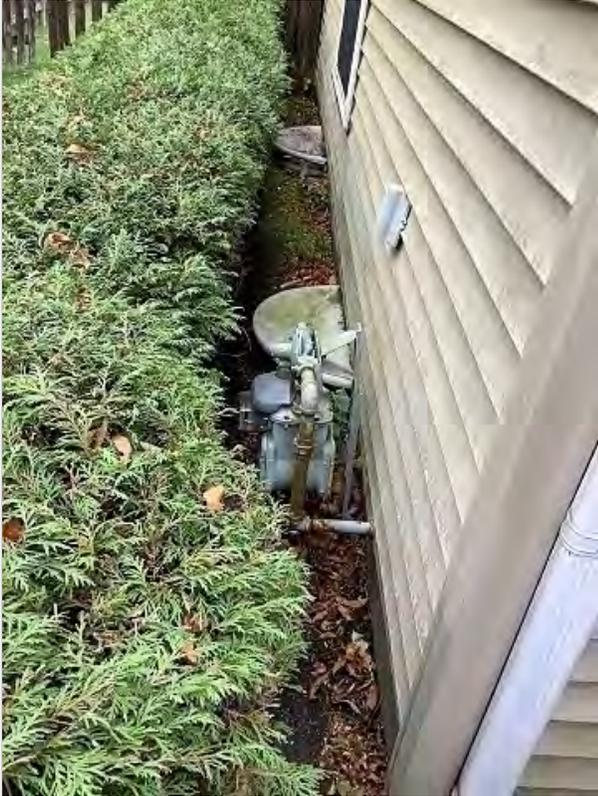
Photo 12

Left side behind bushes

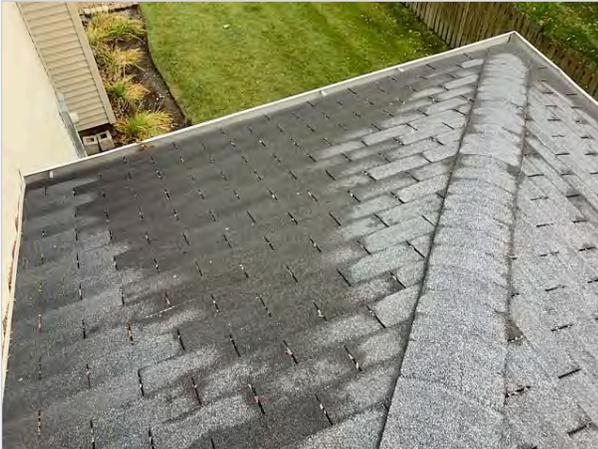
Photo 18

Previous repairs were evident on the roof. These signs may indicate exterior damage, problems with installation, age, previous water intrusion, or other factors, all of which should be considered when evaluating the health of the roof.

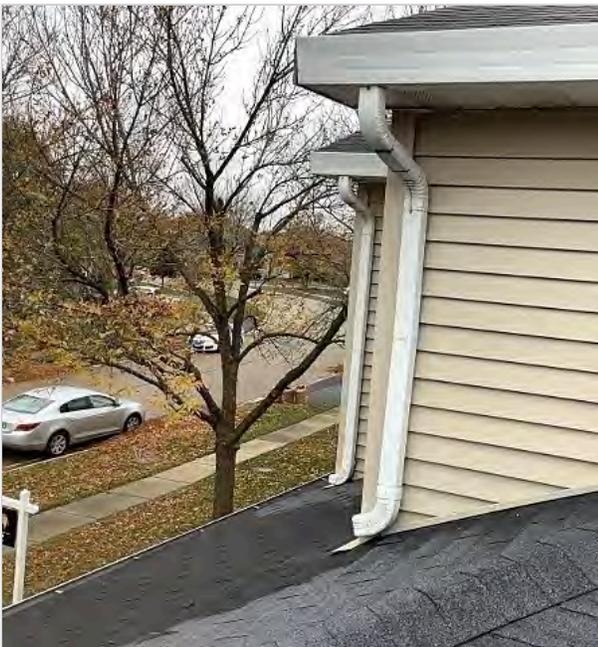
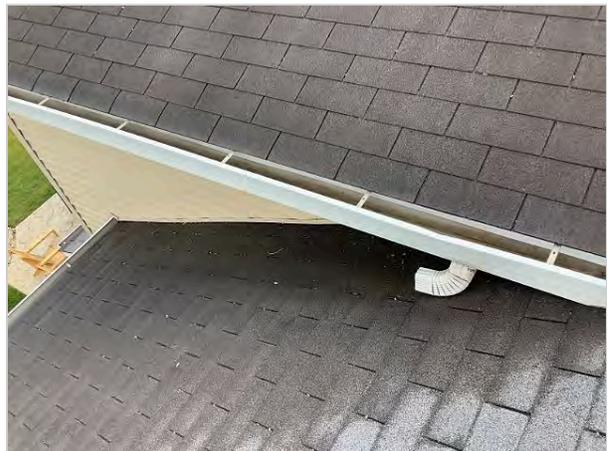
1. Some of the downspouts are missing and draining improperly onto the roof.

**Some of the downspouts are missing and draining improperly onto the roof.** HomeTeam recommends ensuring termination points for all downspouts are extended directly into the roof gutter system to prevent premature wearing of roofing materials and configured in such a manner to ensure all water flows away from the foundation during periods of rain.

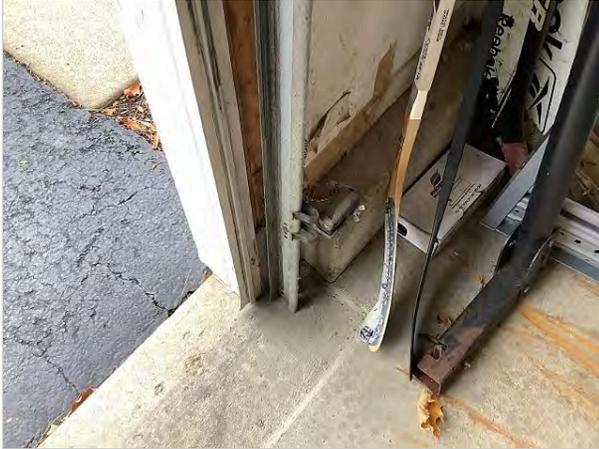
**Photo 46**

Electron eye safety reverse operational

**The garage door safety pressure reverse system was operable; however, it was highly tensioned and difficult to reverse when under reasonable force.** This means the door did not readily stop and reverse when a reasonable amount of resistance was placed at the base of the door. The opener should be adjusted to reduce the amount of tension required to trigger the reverse action.

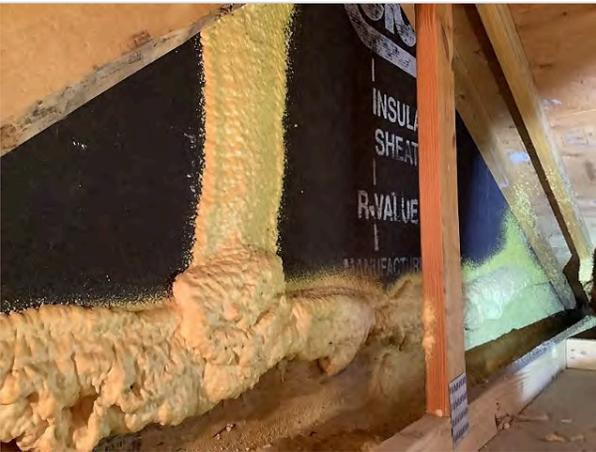
**Photo 49**

Spray foam insulation at seams between garage and main home

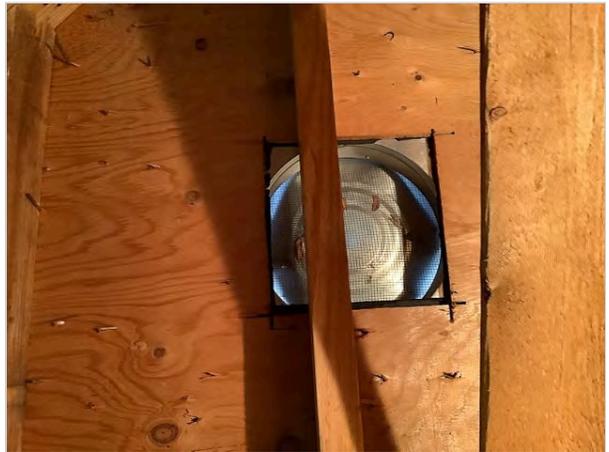
**Photo 50**

Roof vent in garage attic partially crushed above

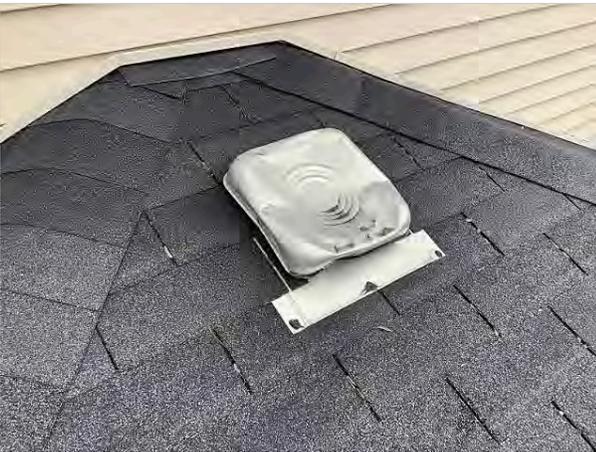
**Photo 51**

Roof vent above garage partially crushed

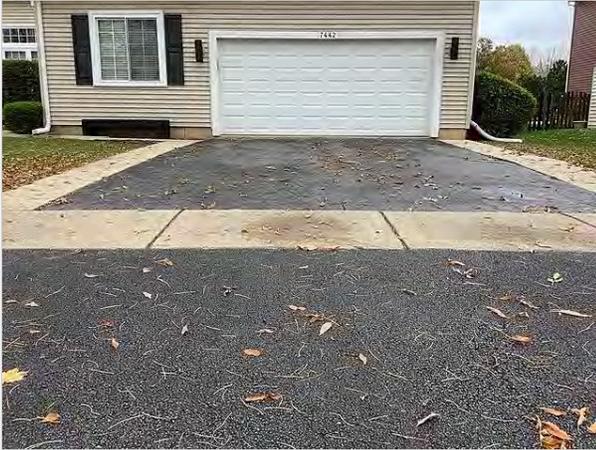
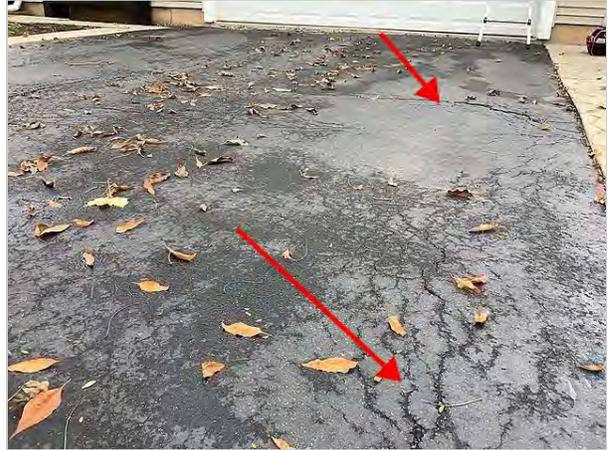
An asphalt driveway is present in the front of the structure. Cracks and spalling were observed on the driveway. Surface defects in driveways develop and progress with age and are considered normal as long as they do not create a safety hazard. Sealing defects may help slow the rate of deterioration.

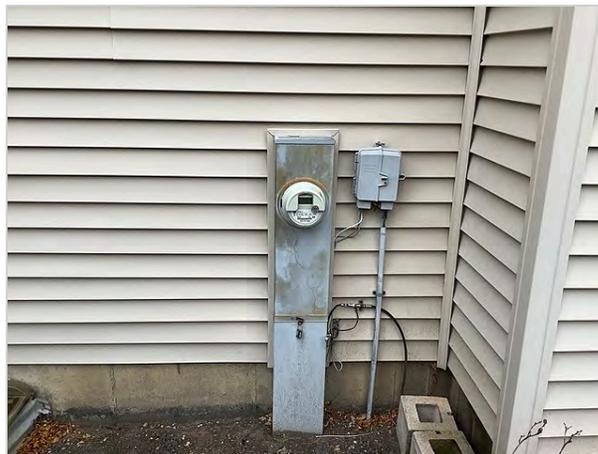
Photo 54

The underground electric service wire entered the structure on the right wall. The electric meter was located on the exterior wall.

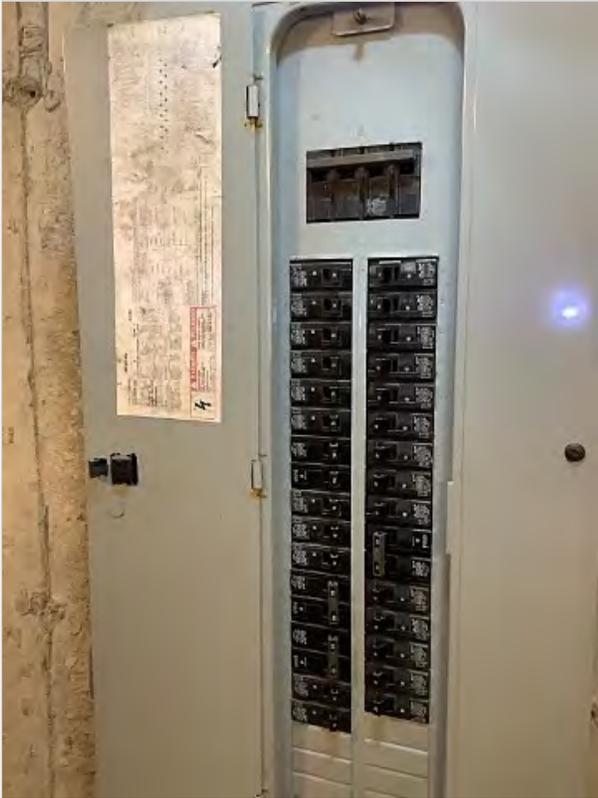
Photo 55

The service wire appeared to be 120/240 volt and 200 amp and entered a Siemens service panel, located on the right basement wall. The main service disconnect was 200-amp rated and was located in the main panel. The branch circuits within the panel were copper. These branch circuits and the circuit breaker to which they were attached appeared to be appropriately matched. The internal components of the service panel, i.e. main lugs, bus bars, etc were in good condition except where noted below.

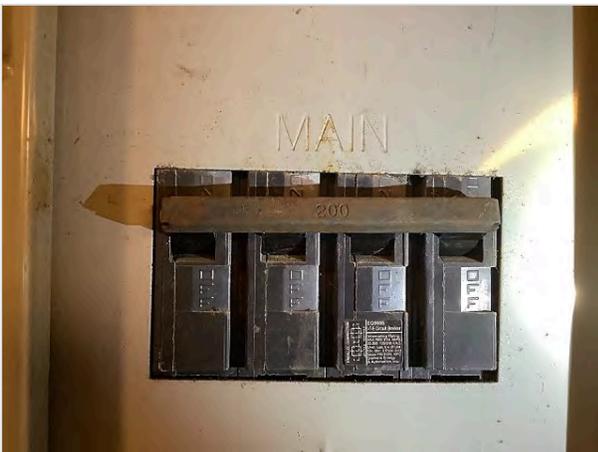
Photo 57

**Corrosion was observed on the metal electric panel due to direct contact with the concrete foundation wall.** The electrical connections inside the box have not been affected by corrosion; however, oxidation potential exists in its current state. HomeTeam recommends that a licensed electrician further evaluate the condition of the electrical panel for possible insulating/isolating solutions that separate it from direct contact with the wall.

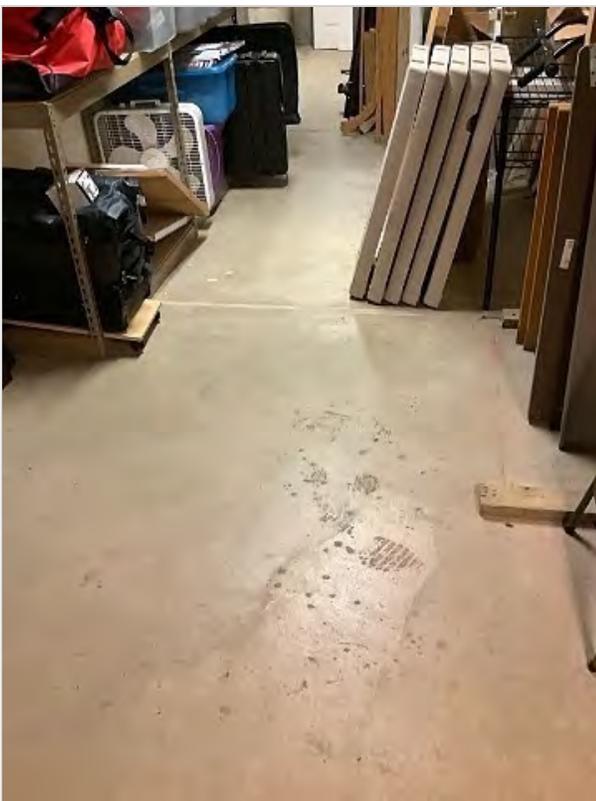
**Photo 67**

The concrete basement floor was in satisfactory condition. Minor cracks within any concrete slab are common and are most often due to shrinkage and settlement. Concrete floors are poured after the structure is built and serve no purpose with regard to structural support.

**Basement floor**

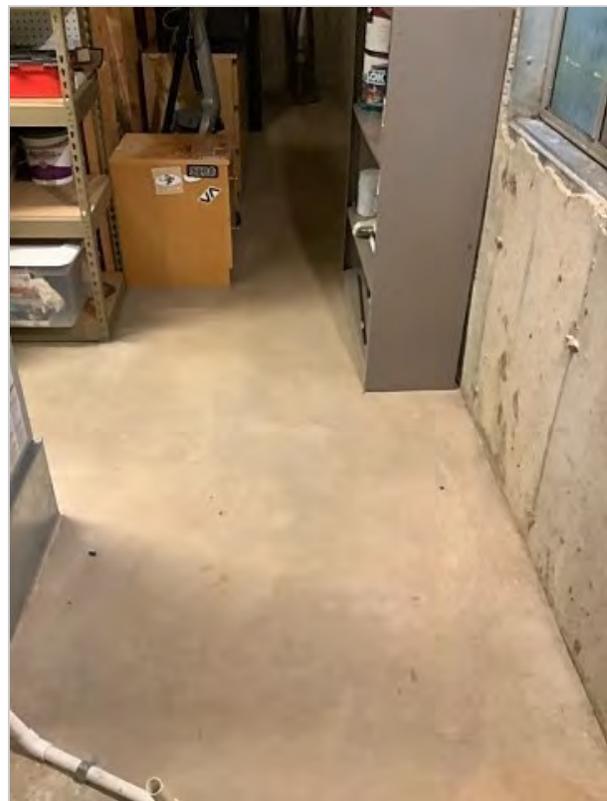
**Photo 68**

**Basement floor**

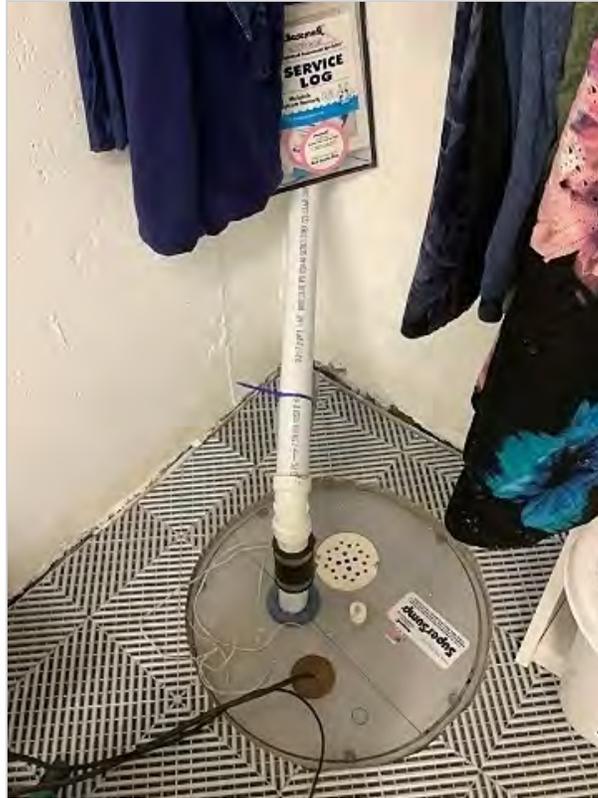
Photo 69

There was a sump pump located in the basement. The sump pump was functional. HomeTeam recommends all sump pumps be tested regularly. Backup pumps (battery and hydro) provide an added measure of protection and should be considered as an upgrade.

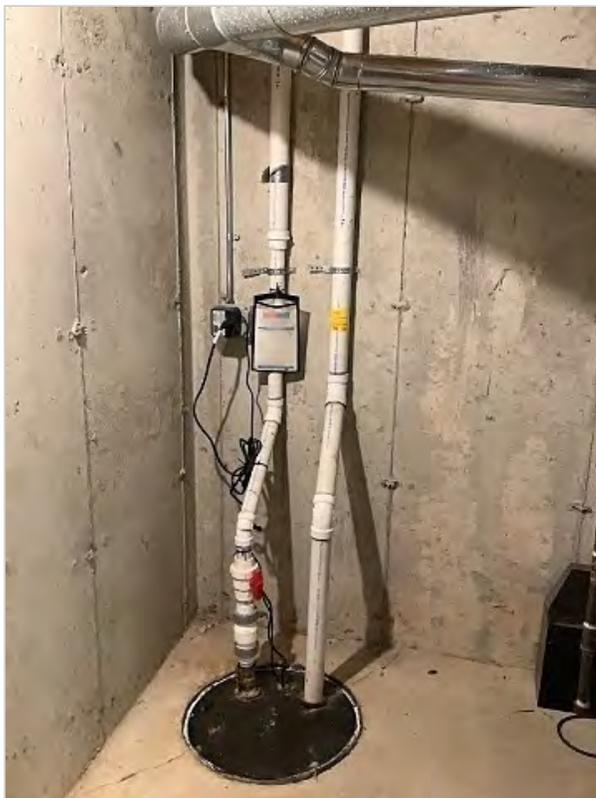
**Photo 70**

An ejector pump was present in the structure. The ejector pump was not tested due to it being a sealed pit with an internal control mechanism that was inaccessible.

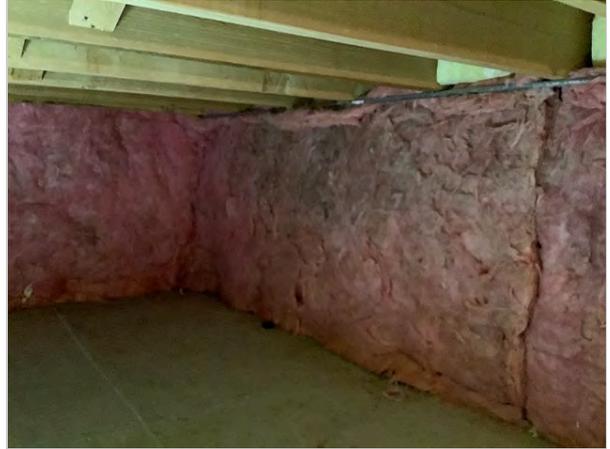
**Photo 72**

Crawlspace walls insulated with batted fiberglass

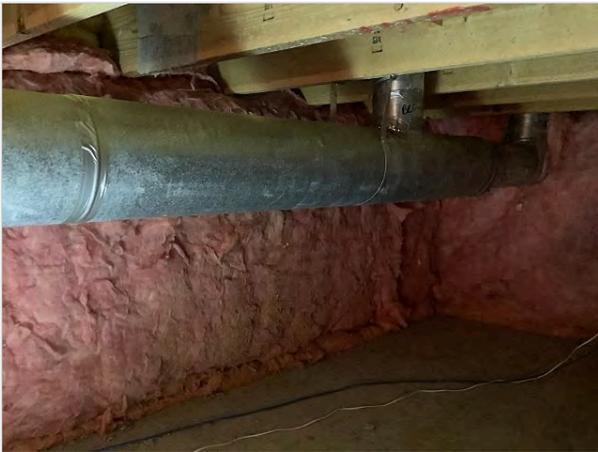
**Photo 73**

Crawlspace walls insulated with batted fiberglass

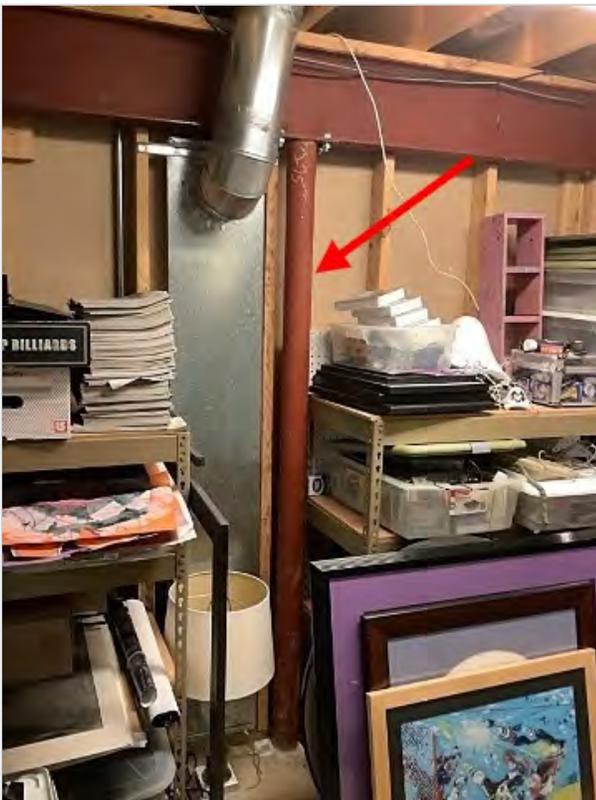
Photo 76

Steel post

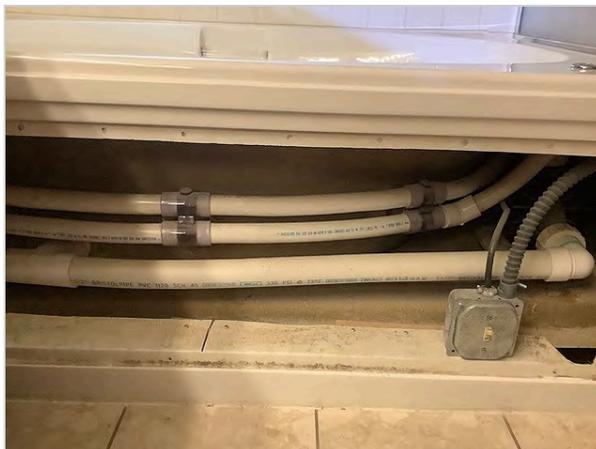
Photo 86

The GFCI for the jetted tub was not located and the motor was not properly bonded.

**The GFCI for the jetted tub was not located.** The buyer should consult with the seller to determine if such a circuit exists. If none is present, a dedicated GFCI should be added to the jetted tub prior to use. This is a potential safety

issue.

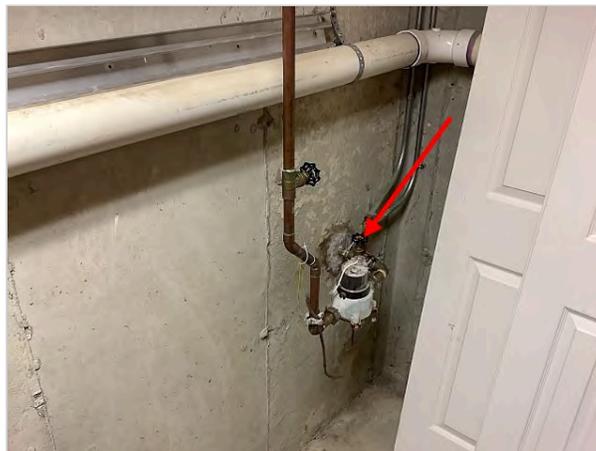
Photo 89

Water meter and main house water shutoff valve

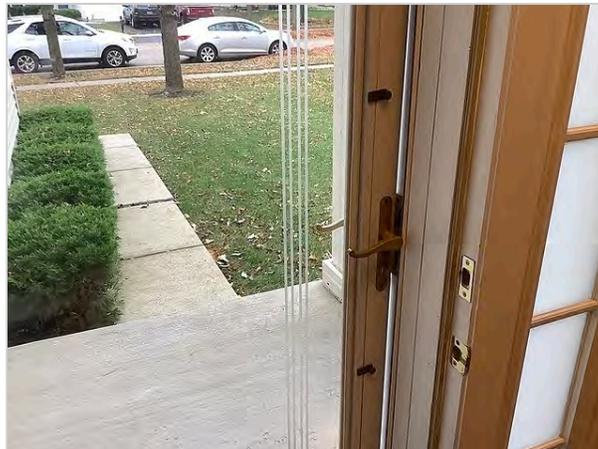
**Photo 101**

The screen door to the main entrance does not latch. The door, frame, and/or latching mechanism should be adjusted to allow for proper operation of the door.

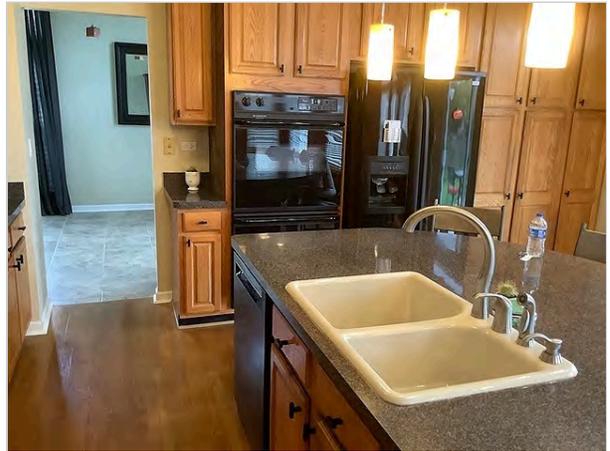
**Photo 105**

Kitchen cabinet door hinges are in need of adjustment. These adjustments are usually relatively simple and only require the tightening of screws or alignment of a variable adjustment hinge.

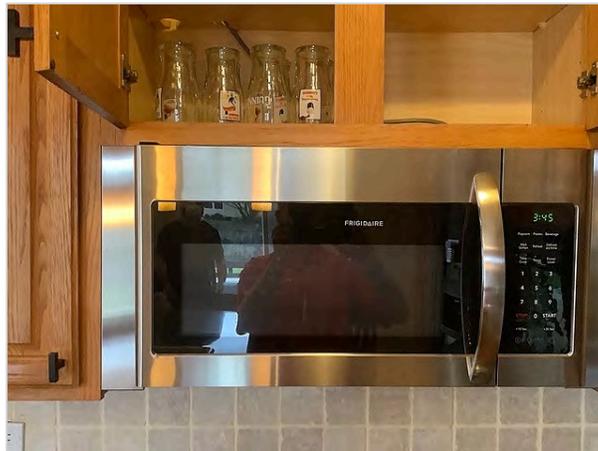
**Photo 111**

The range hood does not vent to the exterior of the structure. As an upgrade to improve indoor air quality, HomeTeam recommends having the gas range vented to the exterior.

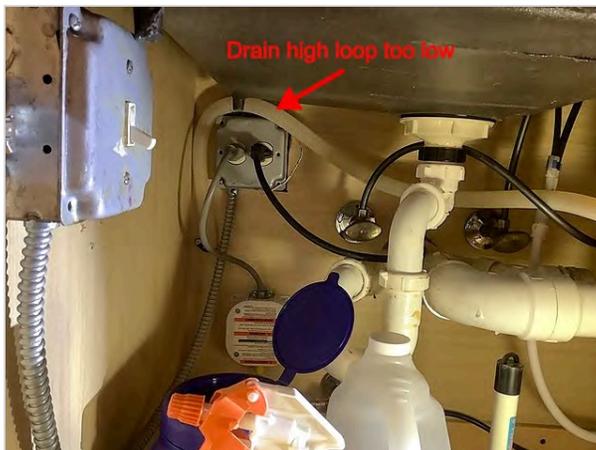
Photo 112

**The dishwasher did not appear to have an effective anti-siphon device installed in the drain line. An anti-siphon device prevents cross contamination between potable water and wastewater.** Some dishwashers have built-in integrated anti-siphon devices not readily visible. Consult with the manufacturer to determine if this particular model requires an additional air gap or high loop above the sink basin. If an anti-siphon device is needed to prevent cross-contamination of sink/dispenser drain water back into the dishwasher, then HomeTeam recommends having an anti-siphon valve (air gap) installed above the countertop or drain hose looped as high as possible to the underside of the countertop above the sink basin (high loop) by a qualified contractor.

Kitchen sink

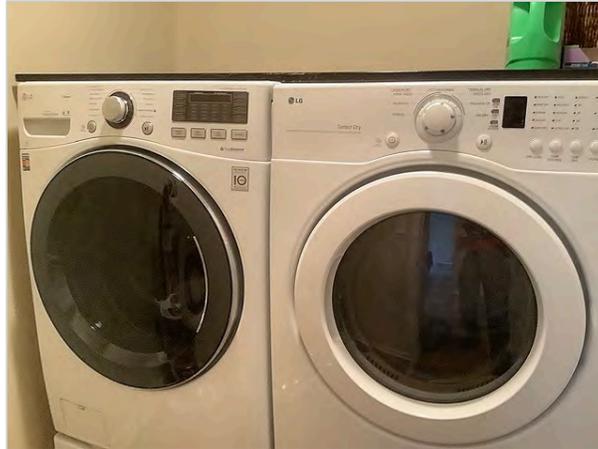
**Photo 114**

**The dryer vent has been reduced in size from the required 4-inch pipe.** To prevent clogs and lint buildup, the dryer vent pipe should consist of 4-inch pipe its entire length as it vents to the exterior of the structure. Consult with a qualified contractor for repair/replacement to ensure full size exhaust venting.

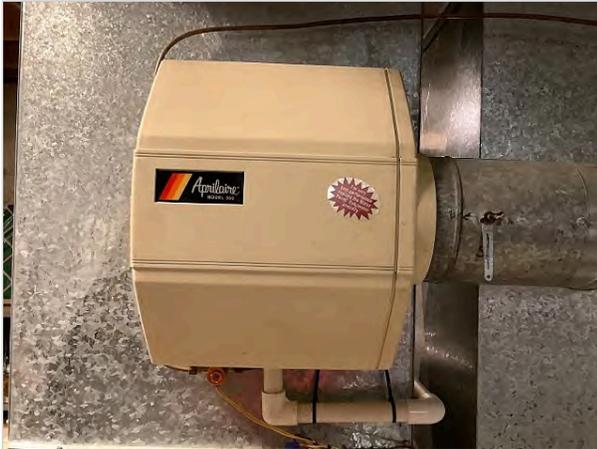
Photo 125

A central humidifier was installed. The humidifier was a Aprilaire Model 560. The humidistat was turned to maximum to see if the unit responded to a call for humidification. The humidifier did not appear to be functional. The water supply valve to the unit appeared to be off. The humidistat was located built into the thermostat. Use care when raising the humidity setting for the home. Too much humidity in the air is can create undesirable conditions. Humidifiers generally contain some type of replaceable media that should be monitored. The frequency of replacement depends upon how much use the humidifier gets. At a minimum, the unit should be checked by the HVAC contractor during annual maintenance of the heating system.
