# HomeTeam<sup>®</sup>

### HOME INSPECTION REPORT

On Thursday, July 30, 2020 The HomeTeam Inspection Service made a visual inspection of 123 Sample Dr. Anytown, USA 55555. Enclosed please find a written, narrative report of our findings in accordance with the terms of our Inspection Agreement.

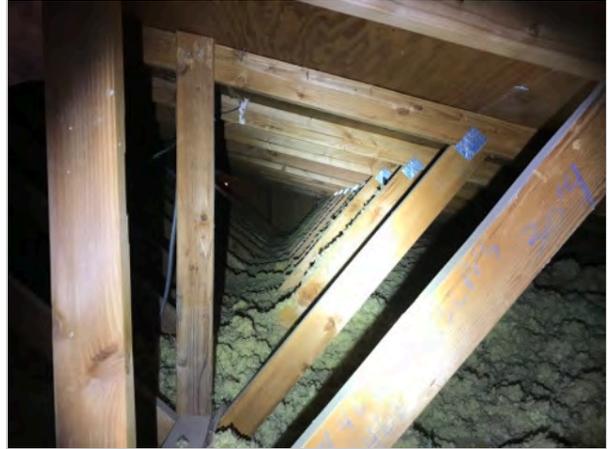
Photo 2

> **Insulation in attic has area(s) where insulation has been displaced.** This typically occurs when work is being done in attic and insulation is disturbed in the process. Insulation should be of consistent depth to provide a consistent thermal barrier. Suggest that this be addressed by a qualifying party.

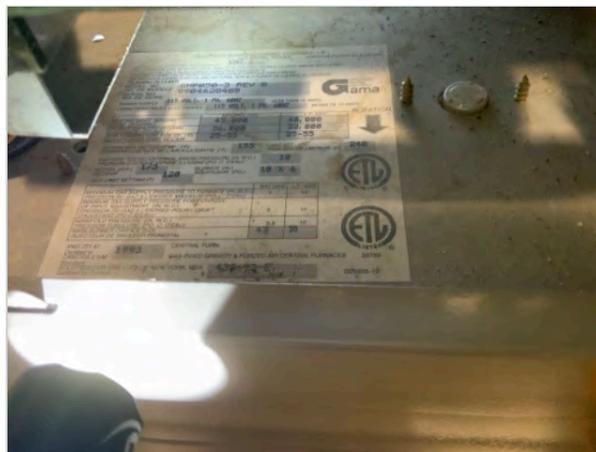
**Photo 9**

The unit does not appear to have been recently serviced. It is recommended that the indoor and outdoor units be cleaned and serviced by a qualified contractor upon taking ownership of the property (see below).

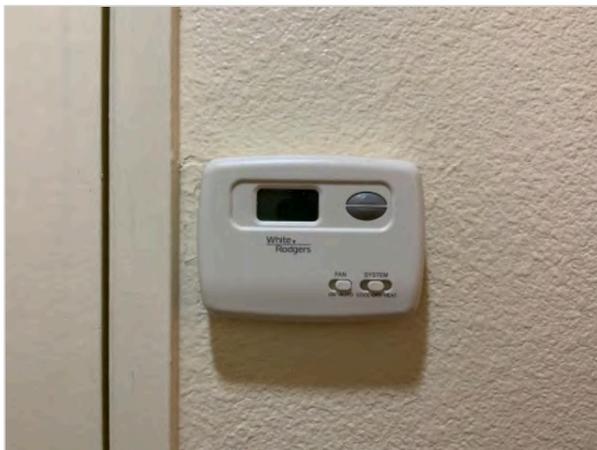
Photo 10

- Thermostat #1 is a digital manufactured by White-Rodgers. This thermostat is located on the hallway wall of the home and was found to be in working order.

Hallway

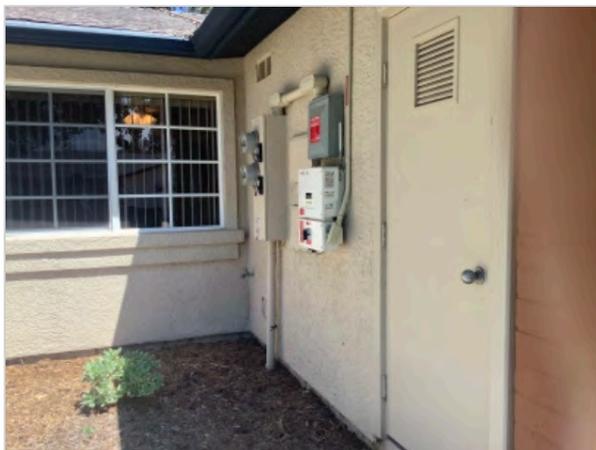
**Photo 11**

The underground electric service supplied an electric meter on the left exterior wall . There were not any adverse conditions observed with the service drop or service lateral to the main panel. The service conductors were not visible (Square D All in One) and their condition was not visible.

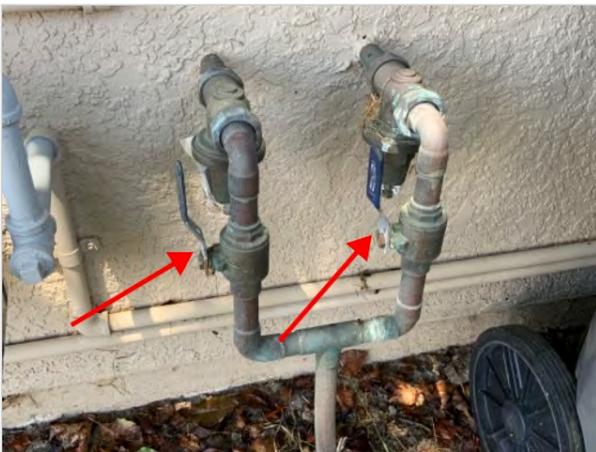
**Photo 16**

Main shut offs

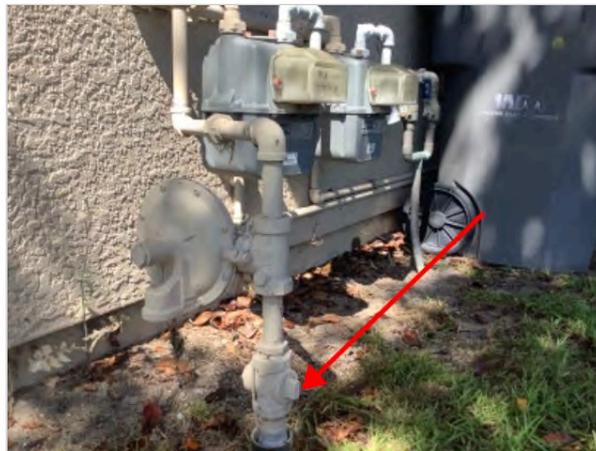
**Photo 21**

Gas main shutoff
