### HOME INSPECTION REPORT

On Thursday, July 29, 2021 The HomeTeam Inspection Service made a visual inspection of 123 Anytown Rd SC, USA 55555. Enclosed please find a written, narrative report of our findings in accordance with the terms of our Inspection Agreement.

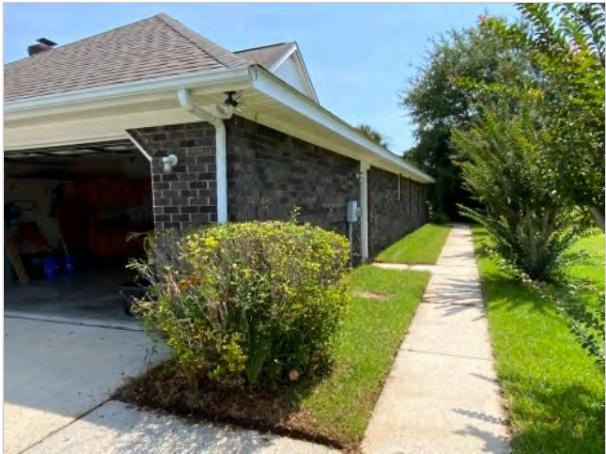
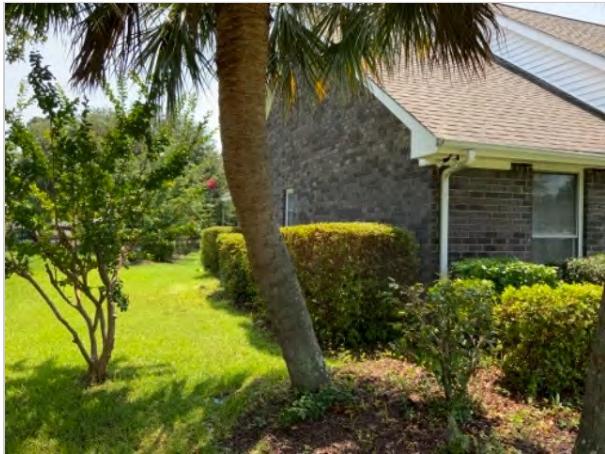
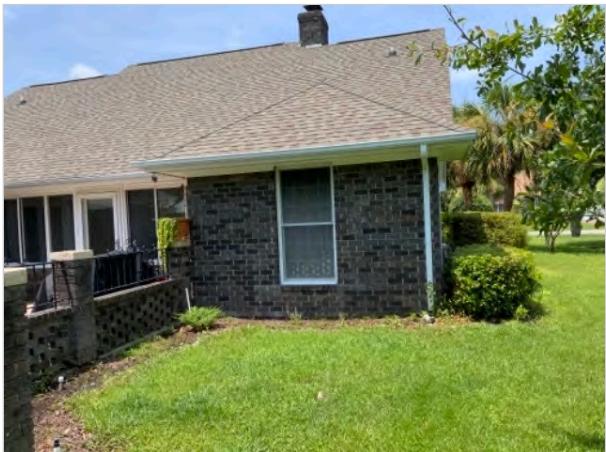
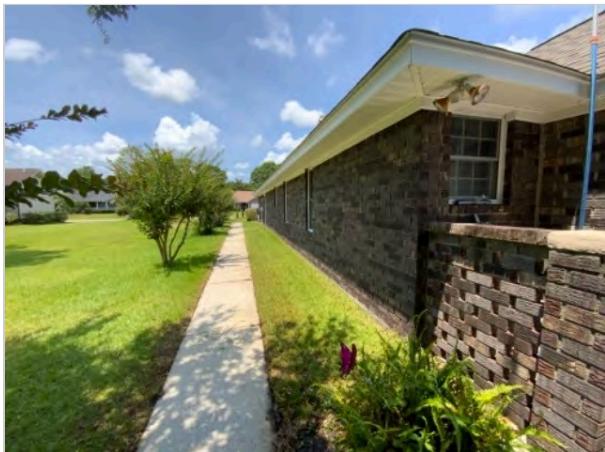
The structure was situated on a level lot. The general grade around the structure appeared to be adequate to direct rain water away from the foundation, assuming normal drainage and downspout, gutter, and other systems are functioning properly.

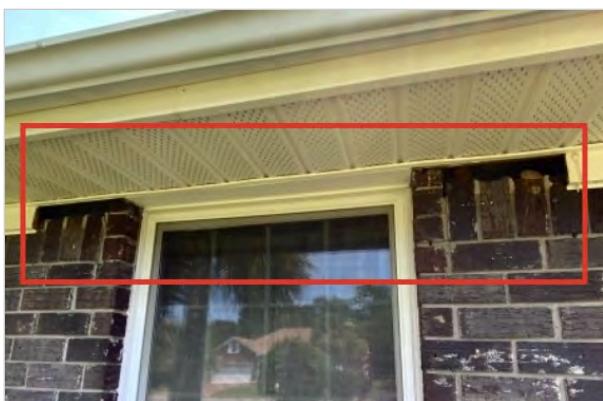
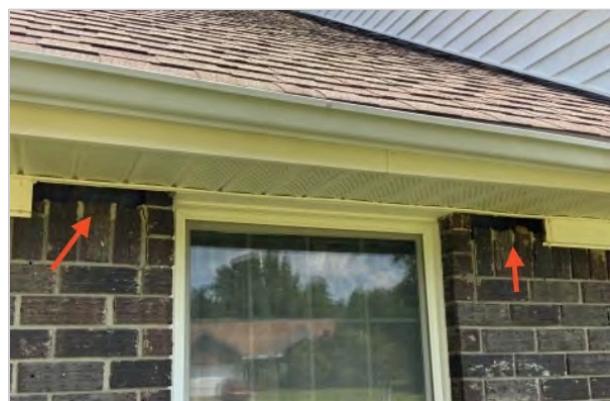
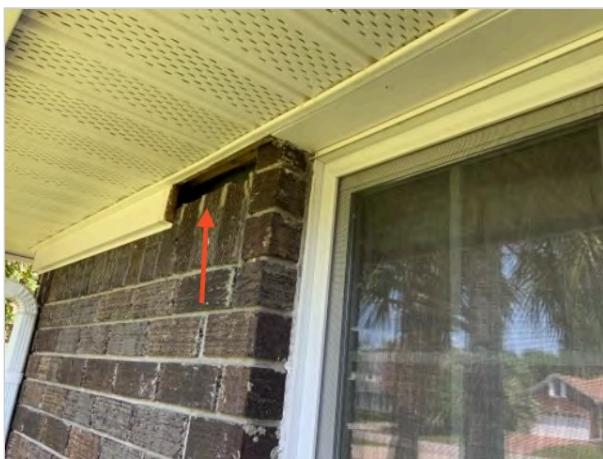
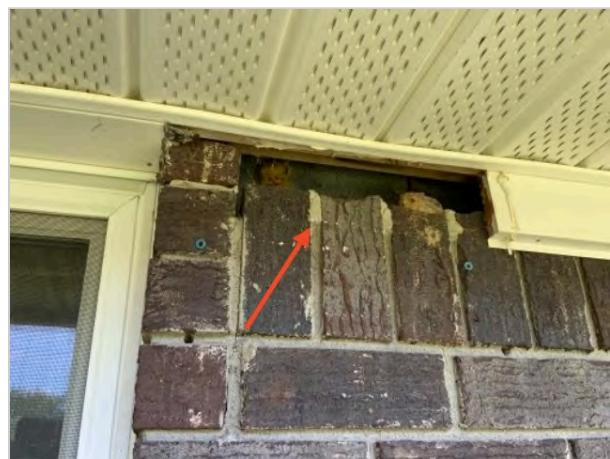
**Damaged siding was noted on the front of the structure's exterior.** This condition does not have any effect on the structural integrity of the building. The areas should be repaired to prevent water intrusion.

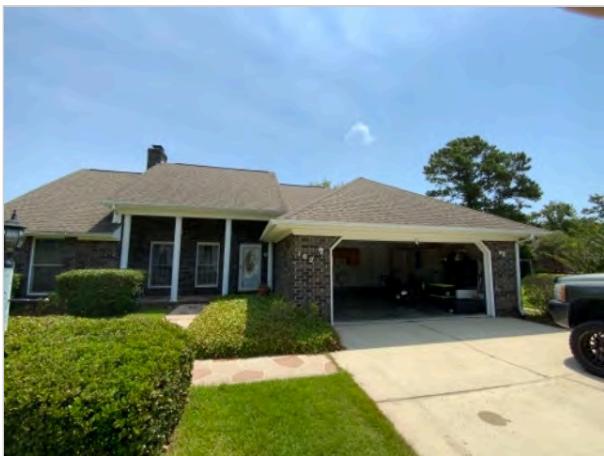
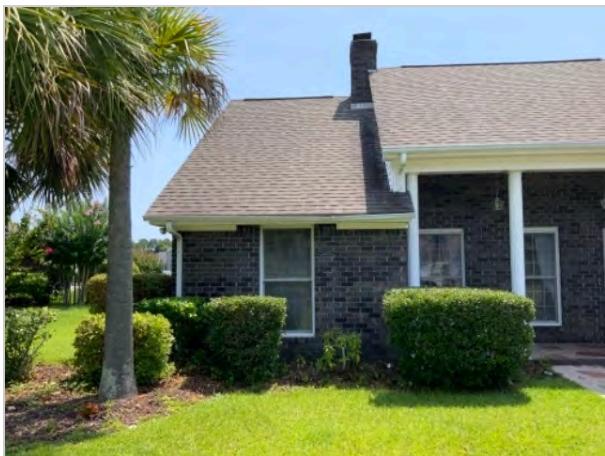
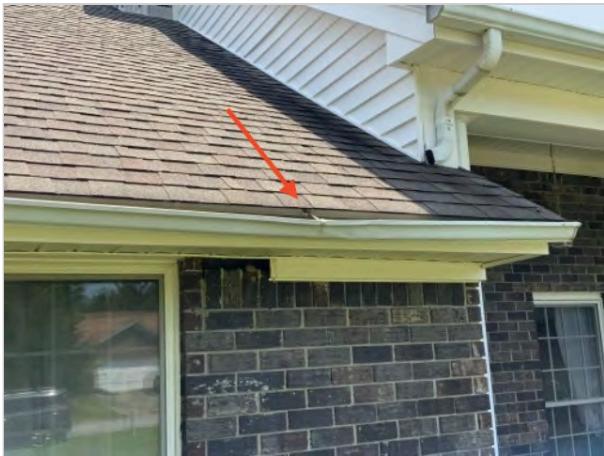
The roof drainage system consisted of aluminum gutters and downspouts which appeared to be functional but in need of repair at the time of the inspection. Gutters and downspouts should receive routine maintenance to prevent premature failure and drainage problems that may lead to water intrusion. Observation of fascia behind the gutters is obscured by the gutters. Keeping the gutters clean will help reduce the likelihood of overflows and resulting damage to fascia. Homeowners should be aware that gutters that have been dirty or clogged for an extended time may have led to unobservable damage to fascia or roofing components.

**Downspouts were draining at or too close to the base of the foundation.** To reduce the likelihood of water problems at the base of the structure, all roof drainage should be directed at least six feet from the base of the foundation.

A downspout has separated from the gutter. Damaged gutters can cause roof drainage water to drain at the base of the foundation. The gutters should be repaired.

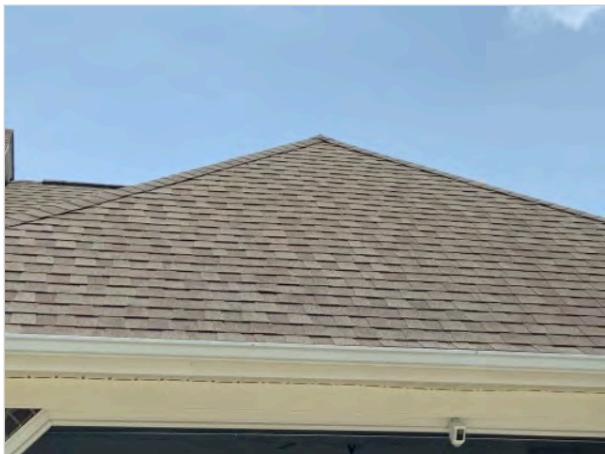
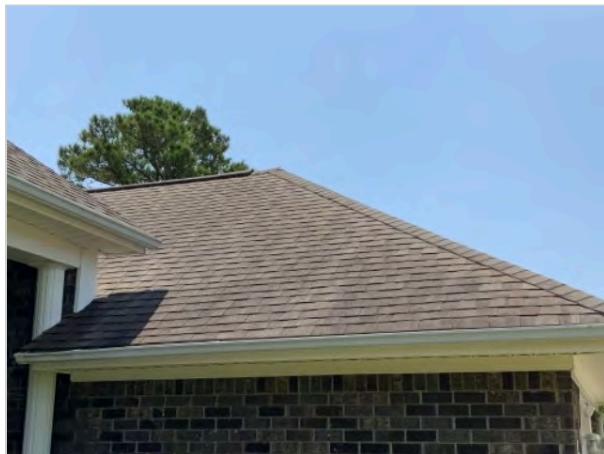
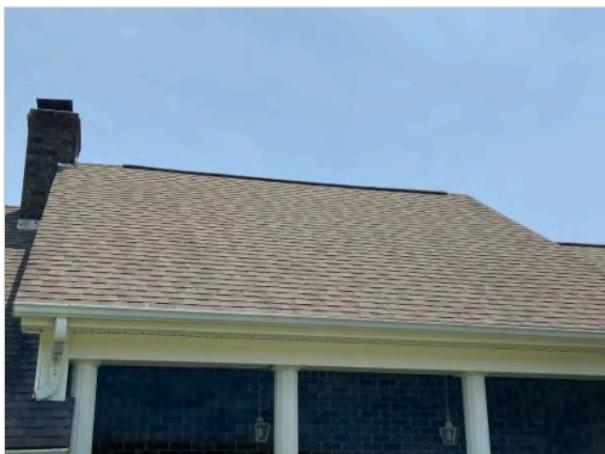
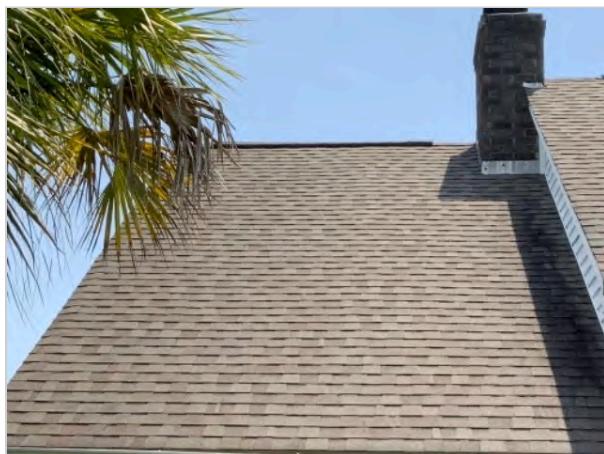
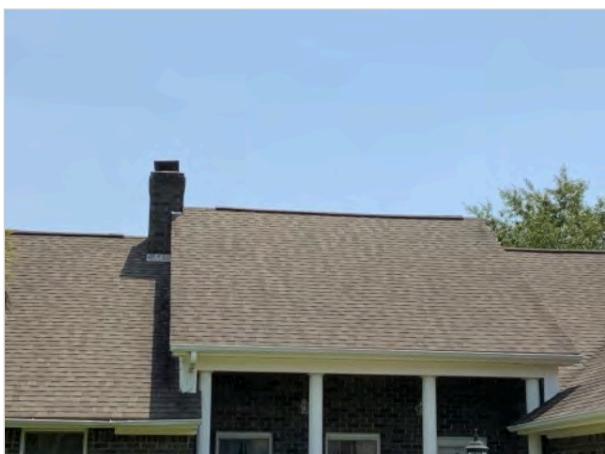
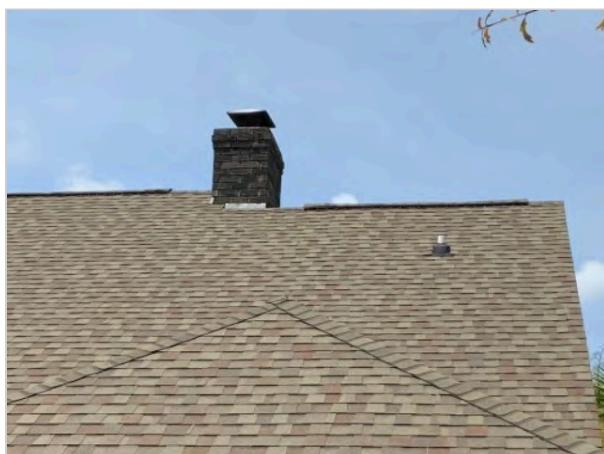
The roof shingles exhibited no curling and light surface wear. Several areas were tested for lifted edges, and lifted edges were not observed. Nail pops were not observed. Evidence of a hail event was not observed.

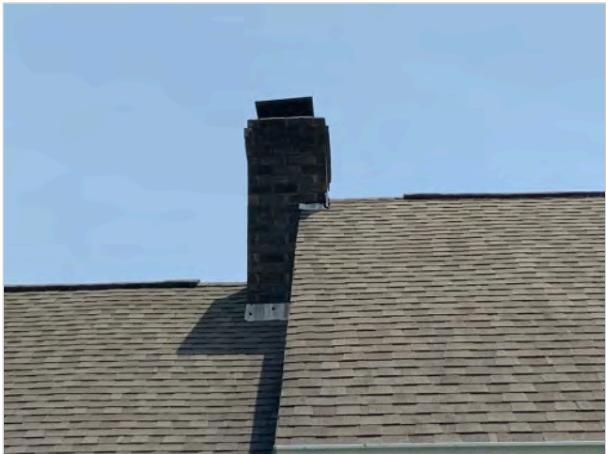
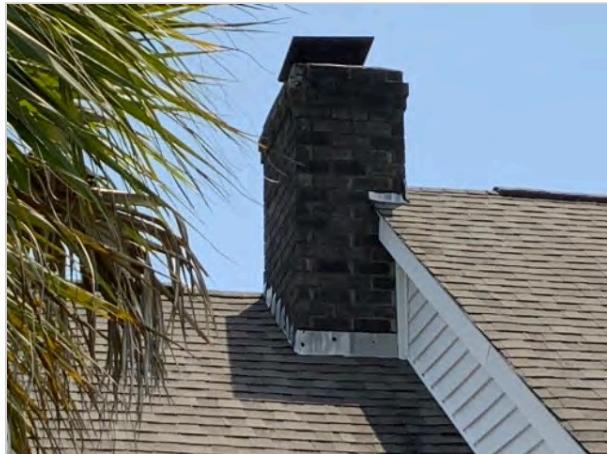
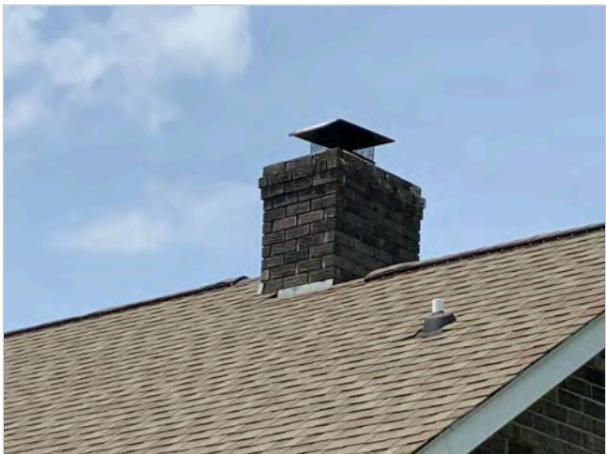
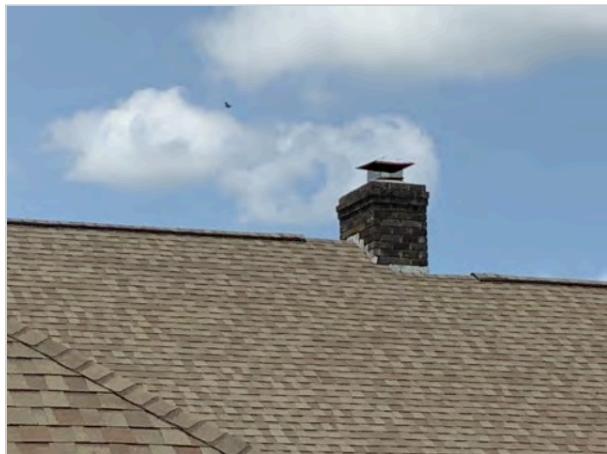
The structure had one chimney. Observation of the chimney was made from the ground with the aid of binoculars. The flashing around the roof penetration point appeared to be adequate.

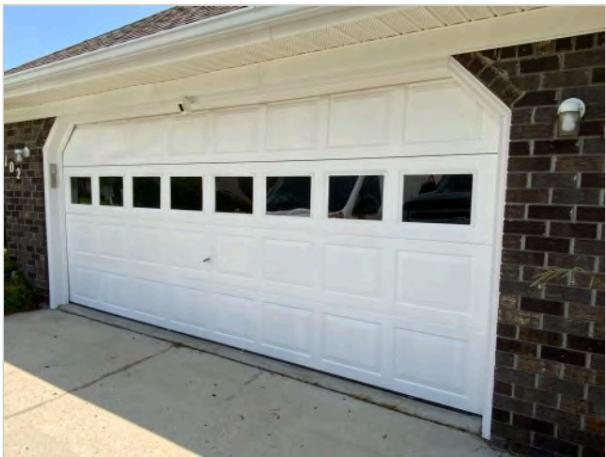
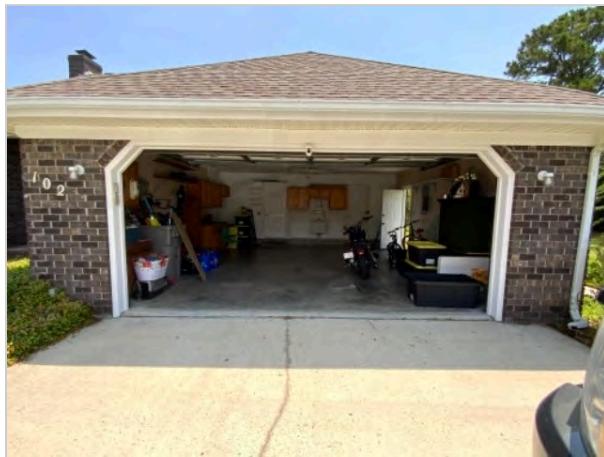
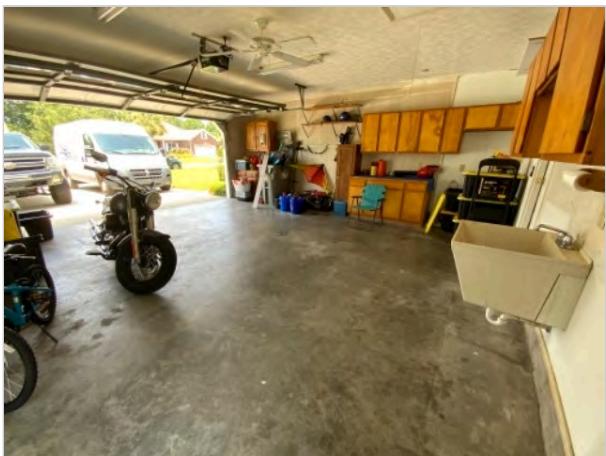
A concrete driveway is present in the front of the structure. Cracks and spalling were observed on the driveway. Surface defects in driveways develop and progress with age and are considered normal as long as they do not create a safety hazard. Sealing defects may help slow the rate of deterioration.

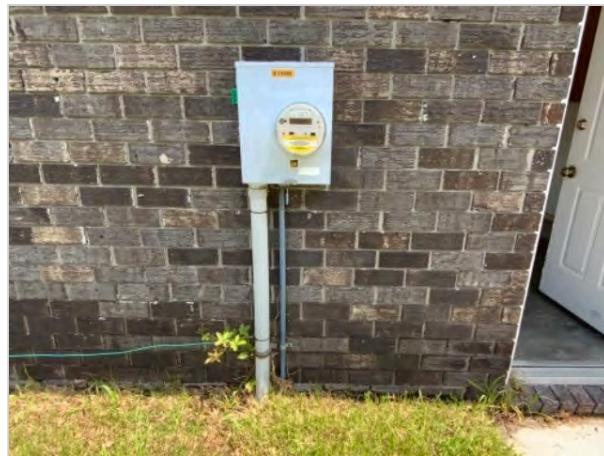
**Photo 52**

The underground electric service wire entered the structure on the right wall. The electric meter was located on the exterior wall.

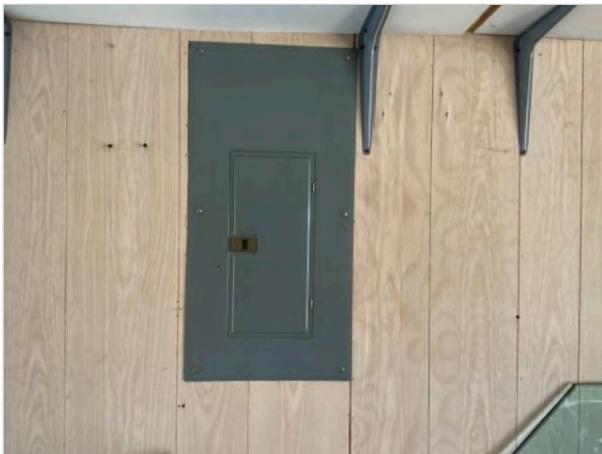
**Photo 53**

The service wire appeared to be 120/240 volt and 200 amp and entered a Square D service panel, located on the right garage wall. The main service disconnect was 200-amp rated and was located in the main panel. The branch circuits within the panel were copper and aluminum. These branch circuits and the circuit breaker to which they were attached appeared to be appropriately matched. The internal components of the service panel, i.e. main lugs, bus bars, etc were in good condition.

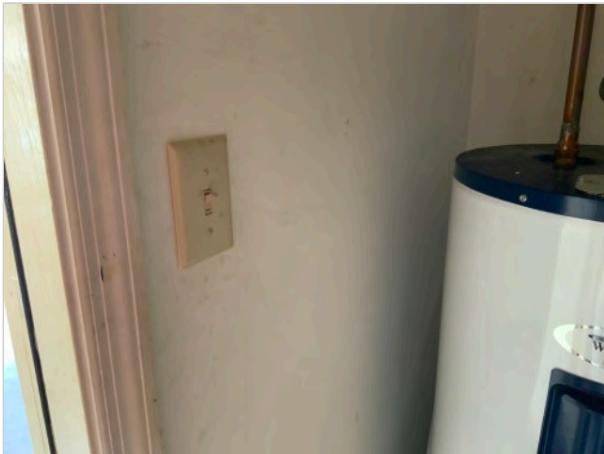
**Photo 74**

The overhead light in the garage utility room was not operable at the time of inspection.

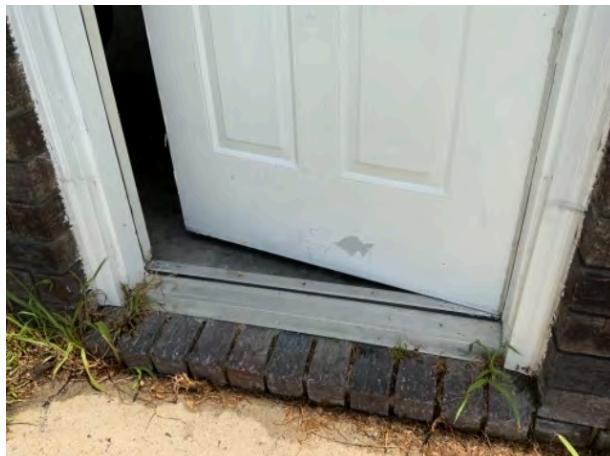
**Photo 84**

**The base of the door frame to the garage was damaged from apparent moisture exposure.** The door frame should be repaired and the surrounding area should be further assessed at the time of repair for any additional damage.

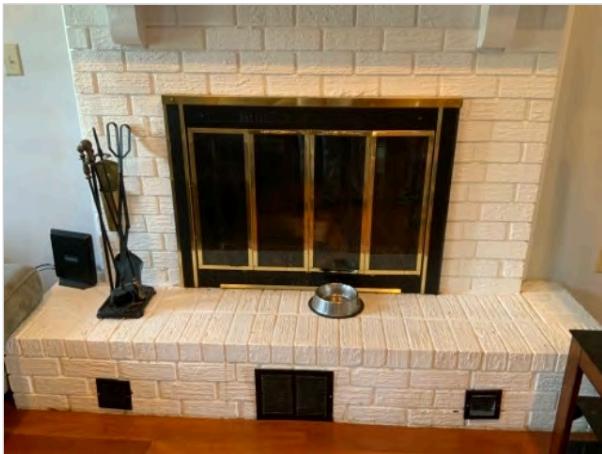
**Photo 91**

A wood burning masonry fireplace was located in the living room. The damper did appear to be functional. The chimney flue was masonry. There was no visual evidence of creosote buildup in the firebox and/or chimney.

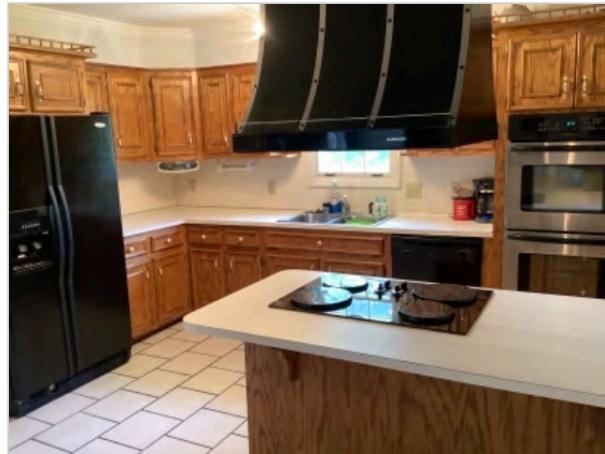
**Photo 95**

The visible portions of the kitchen cabinets and counter tops were in good condition. The appliances were operated to check basic operational function only. No consideration is given regarding the age or components that may be worn or otherwise affected by wear and tear or use. The kitchen contained the following appliances:

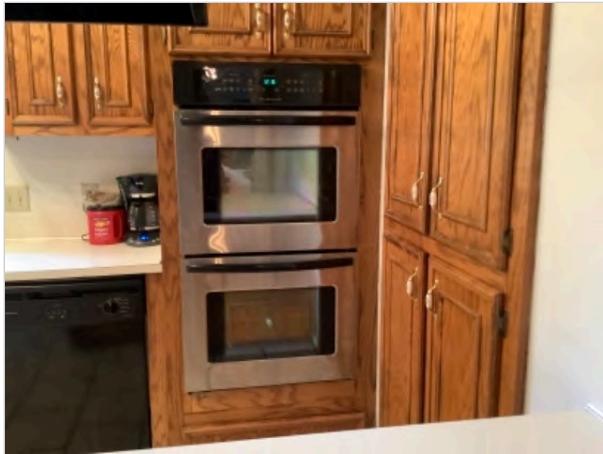
**Photo 96**

The electric double oven was inspected and did appear to be functional. The accuracy of the clock, timers and settings on ovens are not within the scope of this inspection.

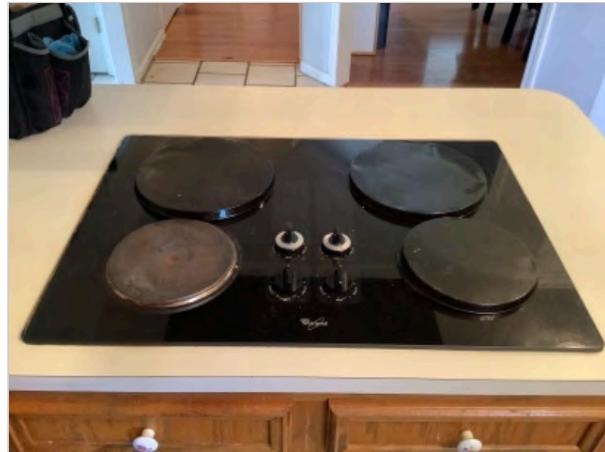
**Photo 98**

The built in cooktop was tested and found to be functional.

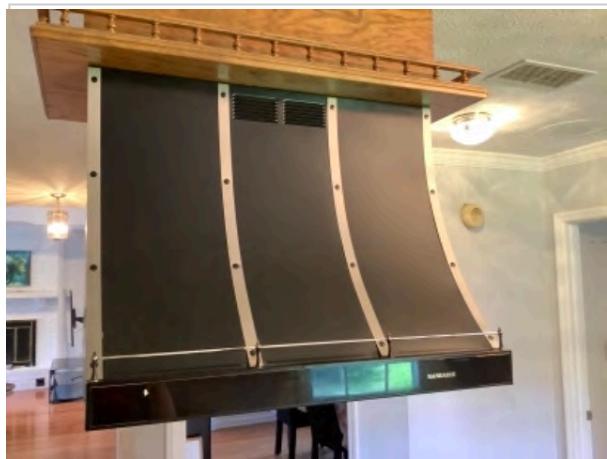
**Photo 99**

The range hood was inspected and did appear to be functional. The exhaust capacity is not within the scope of this inspection. Cleaning the fan and filter may increase the exhaust capability.

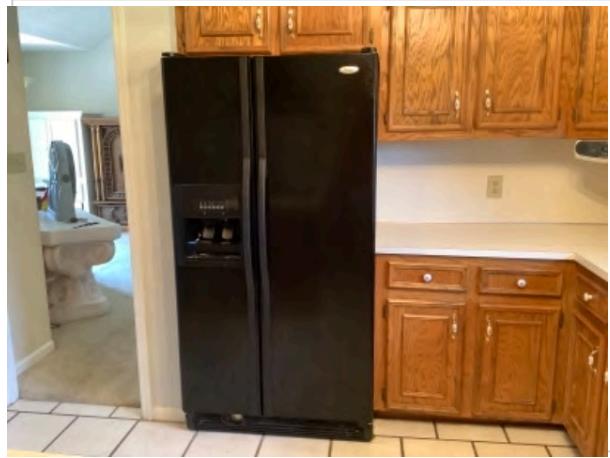
**Photo 100**

The refrigerator was inspected and did appear to be functional . The ice maker operation and hookups, if present, are not within the scope of the inspection.

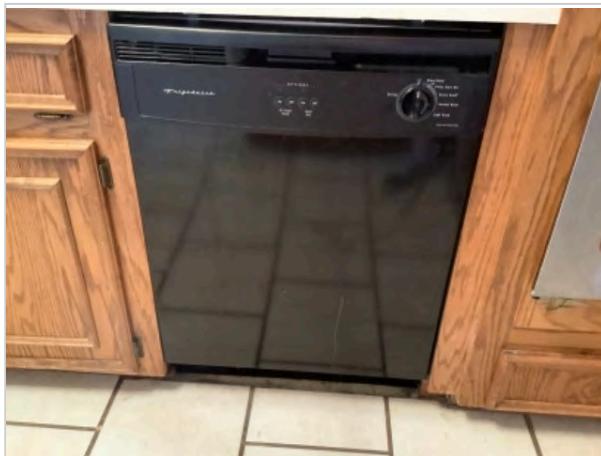
**Photo 101**

The dishwasher was tested and did appear to be functional.

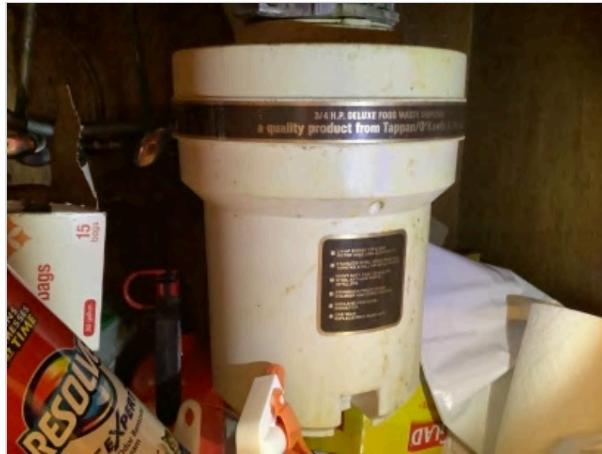
**Photo 102**

The disposal was inspected and did appear to be functional. The efficiency rating and chopping / grinding ability of the unit is not within the scope of the inspection.

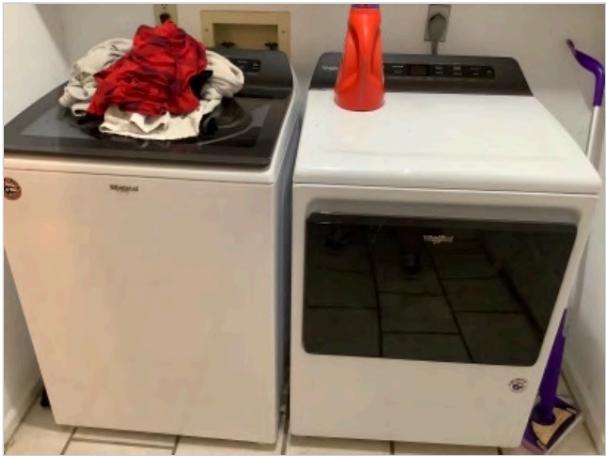
**Photo 103**

A drain for a washing machine was present.

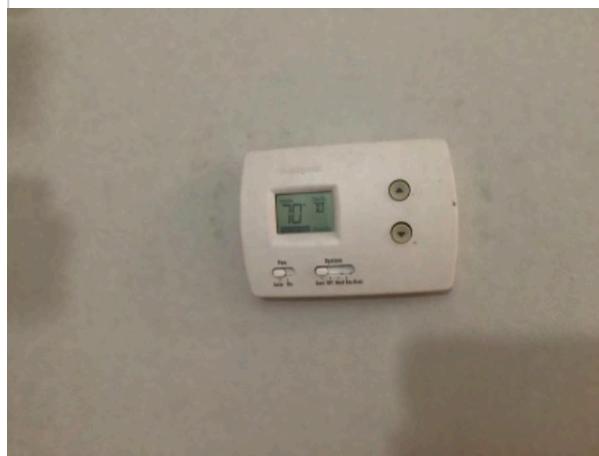
**Photo 110**

The control for the heating and air conditioning system was a 24 volt digital thermostat located on the hallway wall of the home. The thermostat was manufactured by Honeywell and was found to be in working order.

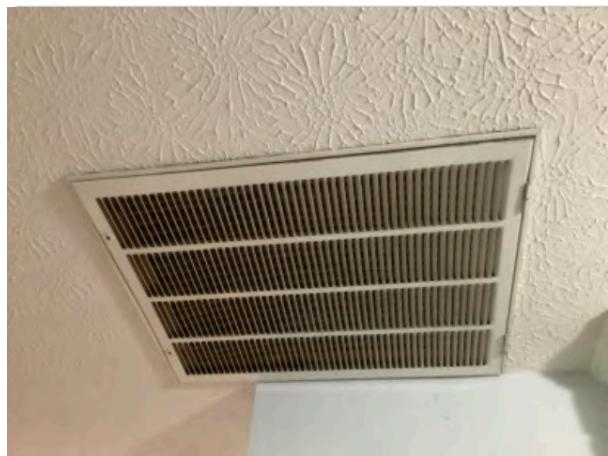
**Photo 111**

The disposable/washable filter should be replaced/cleaned on a regular basis to maintain the efficiency of the system. The efficiency rating is not within the scope of this inspection. A 20x25x1 filter(s) was installed in a hallway filter grille.

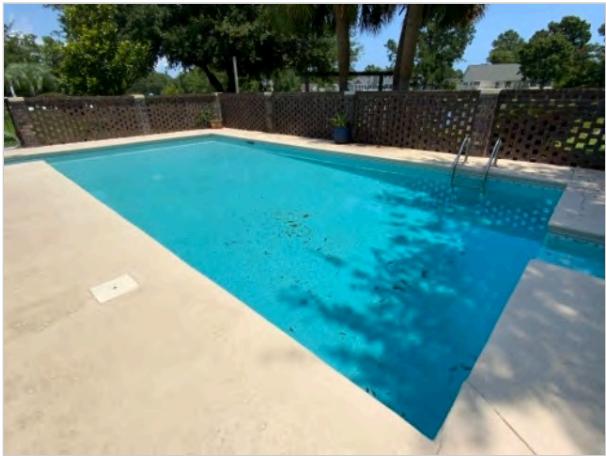
Photo 114

The in-ground pool was constructed of concrete. The water level around the perimeter of the pool was uniform. There was a light installed in the pool. The light was functional. The coping around the top of the pool was in good condition. There was not a diving board installed. The deck surrounding the pool was constructed of concrete. There were some chipping or spalling in the pool decking. There were no material defects observed in the pool.

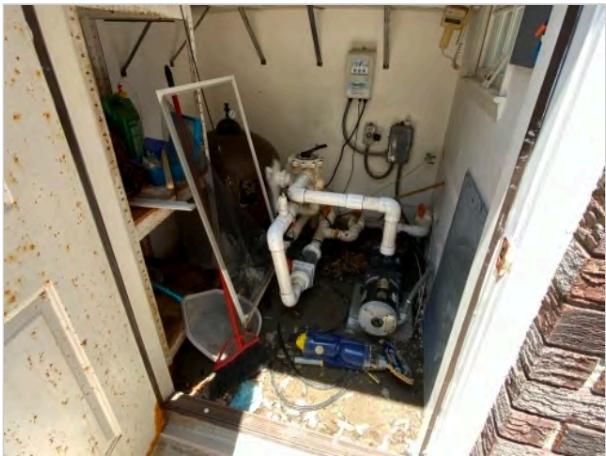
Photo 116

The Triton pool sand filter was operational at the time of the inspection. All pool filters require cleaning and routine maintenance in order to properly clean the water. Consult with the manufacturers documentation for maintenance procedures.

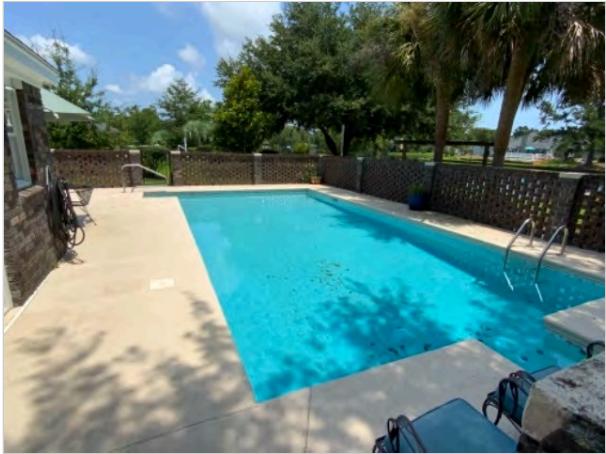
**Photo 122**

The fencing was in good condition and the self-closing gate was not functional at the time of the inspection. Homeowner stated that he plans to repair.

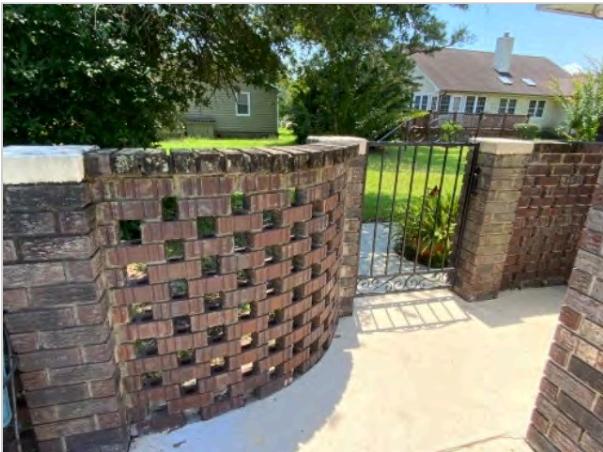
**Photo 125**

Left gate not attached.
