HOME INSPECTION REPORT

**123 Anywhere St.
Topeka, KS 66605
Inspection #: 1234 - 567890**

2718 SE Illinois Ave, Topeka, KS 66605

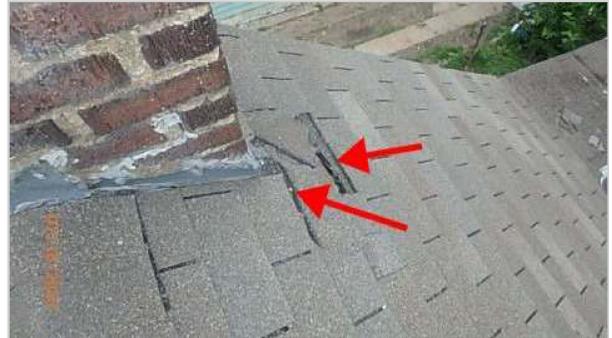
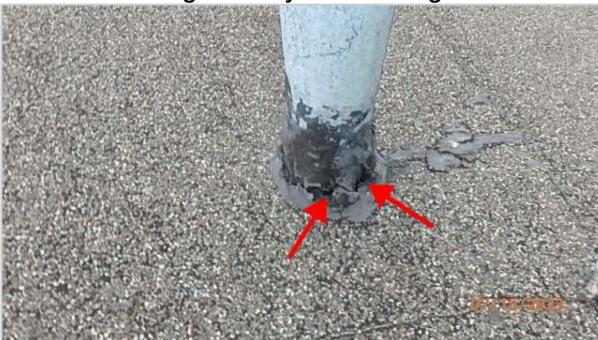
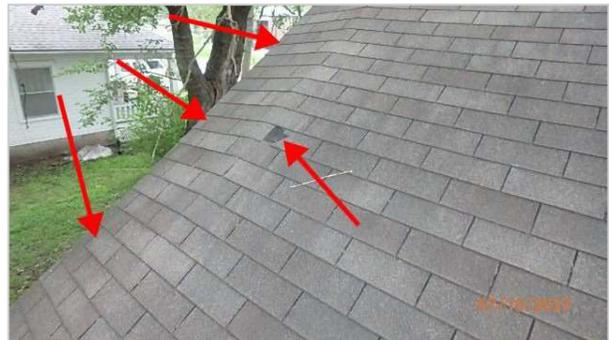
We observed several issues with the roof covering/structure including but not limited to: damaged shingles; significant wear on the asphaltic roll roofing over the low slope areas; damaged/deteriorated flashings; settled and soft areas of sheathing indicating damage to the roof decking. Further evaluation of the roof covering above the roof and to the roof structure in several areas (including in the attic) is recommended to determine the scope and cost of needed repairs/reinforcement.

Significantly soft decking

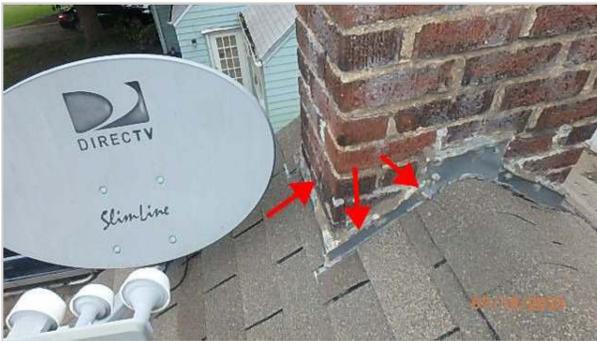
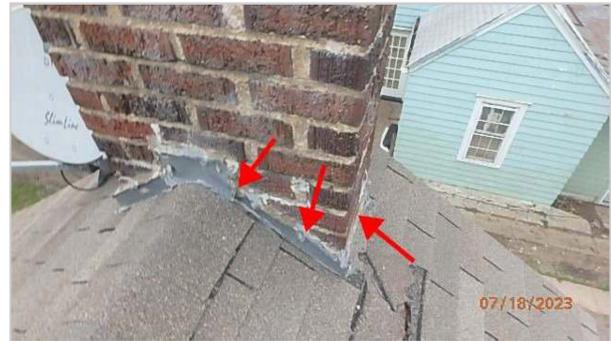
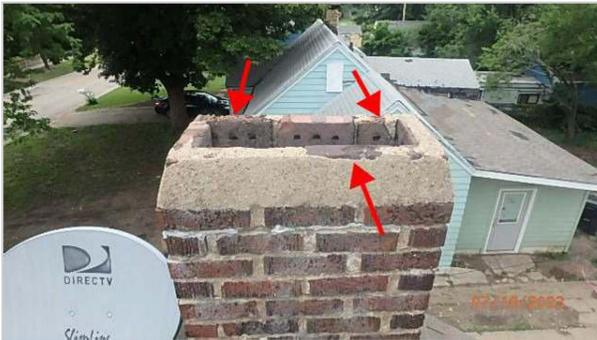
The chimney is in need of service to seal up the flashing around the base, repair the crown, and install a rain cap.

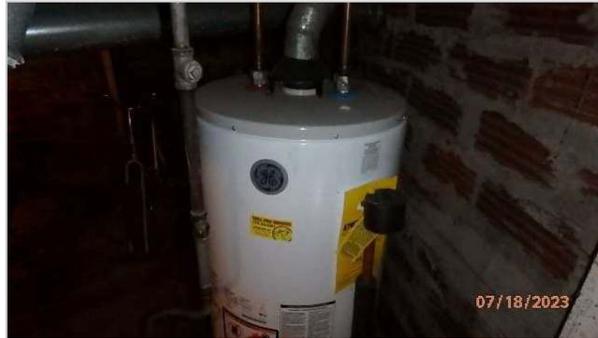
There was a 40 gallon capacity, natural gas water heater located in the basement. The water heater was manufactured by GE model number GG40S06AVJ00 and serial number GELN0412509740. Information on the water heater indicated that it was manufactured in 2012. A temperature and pressure relief valve (T&P) was present. Because of the lime

build-up typical of T&P valves, we do not test them. A drip leg was installed on the T&P valve. It did terminate close to the floor. Your safety depends on the presence of a T&P valve and a drip leg terminating close to the floor. The water heater was functional.

The flue pipe to the water heater was inspected and found to be in need of some adjustment.

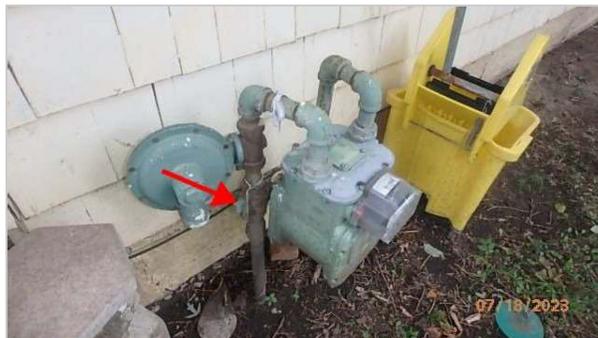
Main gas shut off

The gas meter was located on the right exterior wall. Although no actual testing was performed to detect the presence of gas fumes, there was no noticeable odor of gas detected at the time of the inspection. It should be noted that the main shut off valve for the gas supply to the home is located at the meter and that it requires a crescent wrench or similar tool to operate.

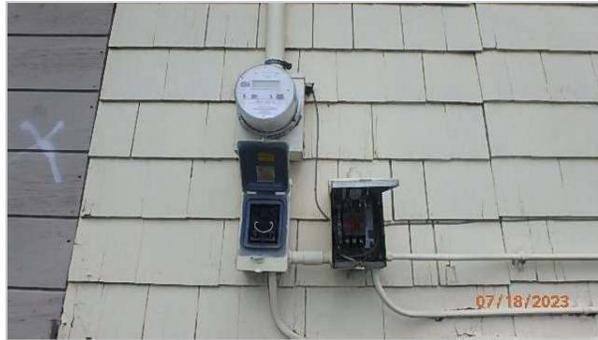
The electrical service wires located just outside the weather head have damage to the insulating jacket caused by age. These wires are in need of replacement from the overhead connection to the meter to eliminate potential short circuiting or accidental contact.

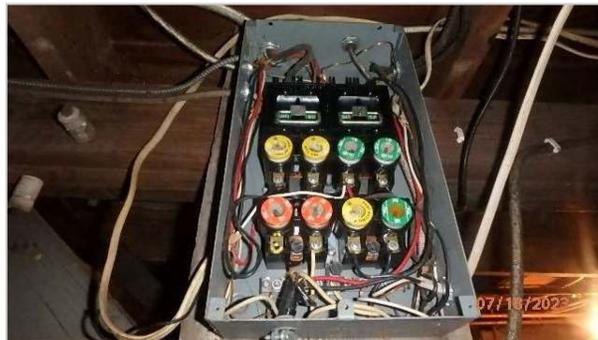
The basement sub-panel is aging and obsolete by modern standards. Although older, the capacity of the service panel is adequate for the connected load as currently configured. Older equipment such as this can develop issues due to aging and repair and replacement parts are often expensive or unavailable. The service capacity is limited to 60 amps which should be adequate as long as gas fired appliances continue to be used for cooking and central AC is not installed. If these are changed, the sub panel will need to be upgraded to 100 amps.
