HomeTeam[®]
INSPECTION SERVICE

Joe Client
1313 Mockingbird Lane
Mayberry, NC 12345

On 6/30/2021, HomeTeam Inspection Service made a visual Pre-drywall inspection of the property referenced above. Enclosed please find a written, narrative report of our findings in accordance with the terms of our agreement.

PDW - PHASE II - PRE-DRYWALL

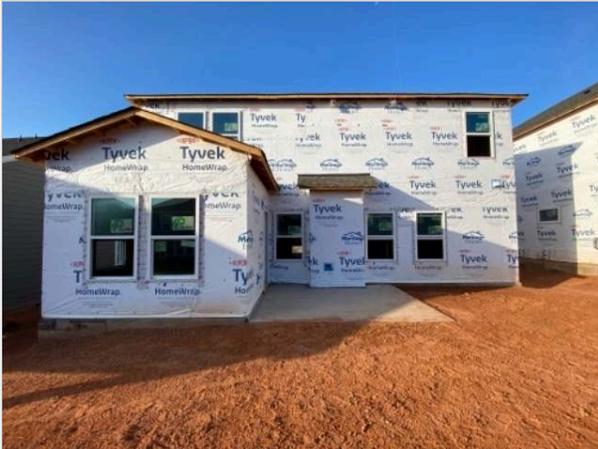
At the roof, the two plumbing vents have no boots installed. This allows water penetration to the interior. Have the builder complete this work prior to insulation and drywall work.

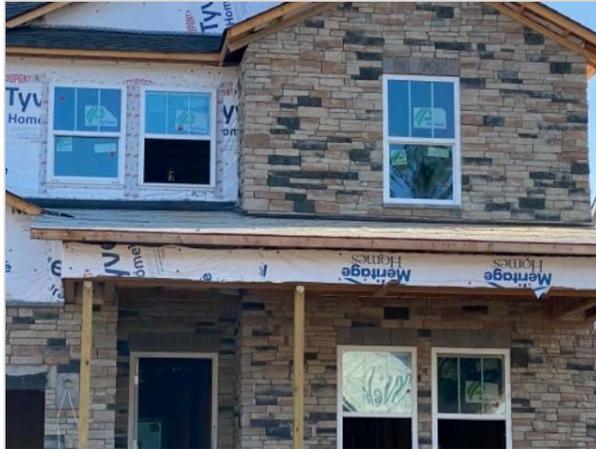
The stone veneer does not appear to be installed to industry standards. The transitions from stone veneer to structural framing components do not have an expansion joint. This condition may cause the stone veneer to fail prematurely due to differential expansion/contraction at extreme temperatures. Refer to <https://ncma.org/resource/msv-installation-guide/> then click "Download Guide" to review the current edition of the Installation Guide. Have the builder's engineer certify this is not required in the North Carolina climate zone or prescribe the necessary rework.

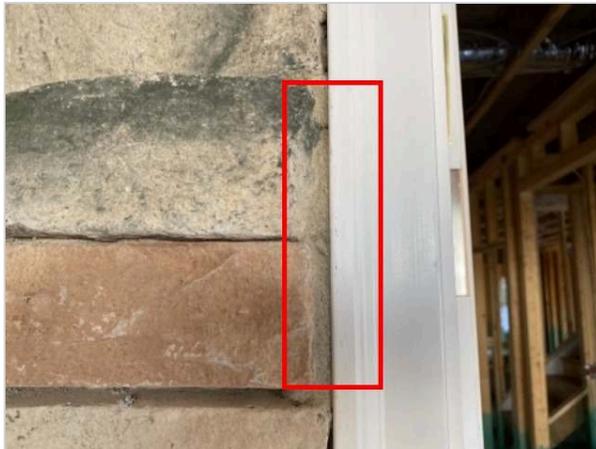
At the stone veneer around the home, there is at least one area where the mortar is incomplete. This can allow moisture and pest intrusion. Have the builder repair everywhere needed.

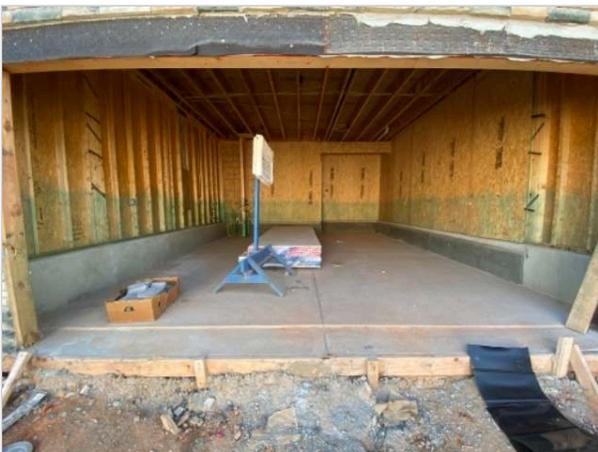
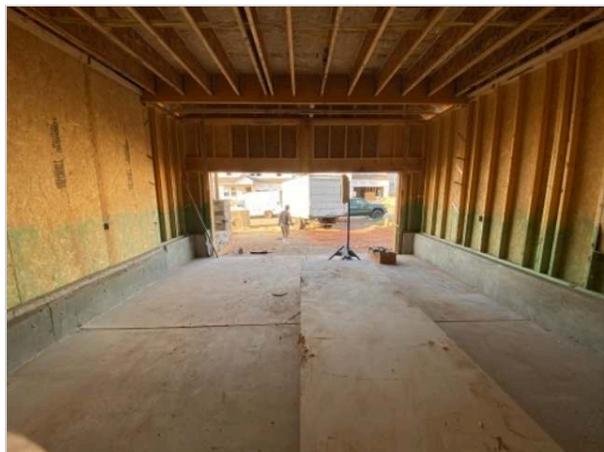
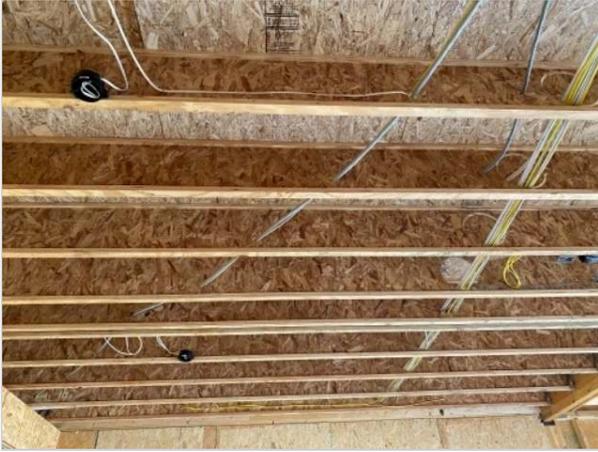
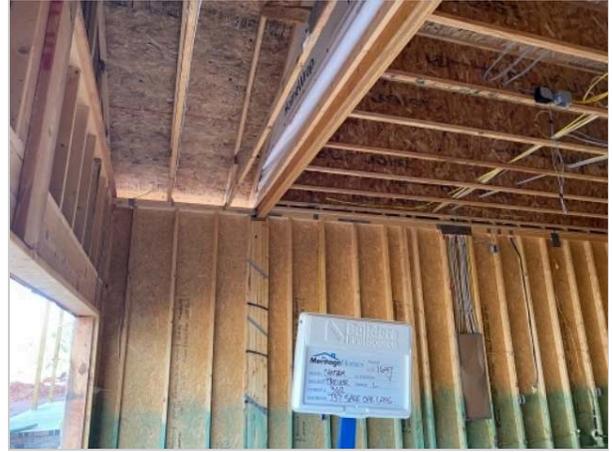
At the garage door, the framing on the left side is defective. Have the builder rework/repair as needed.

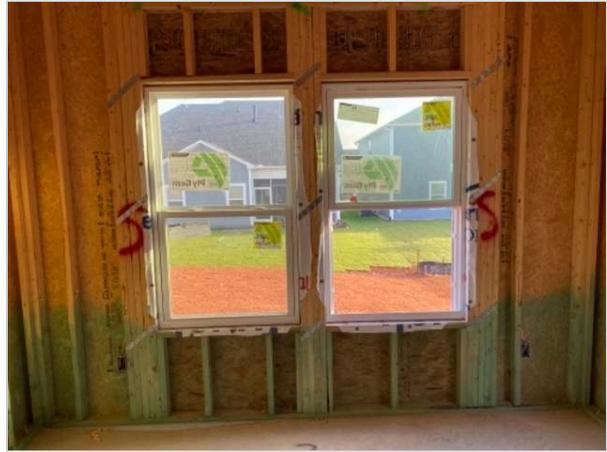
Example strapping present

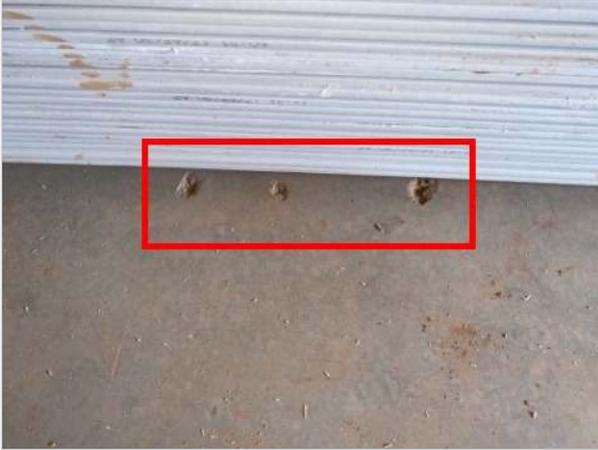
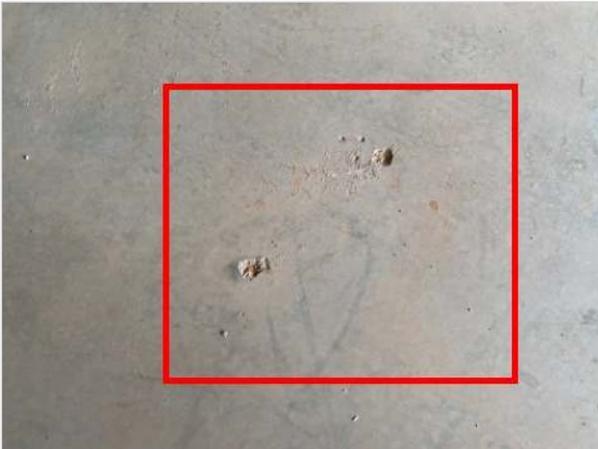
At several places, the concrete slab is damaged. Have the builder repair the slab as needed prior to interior finish work

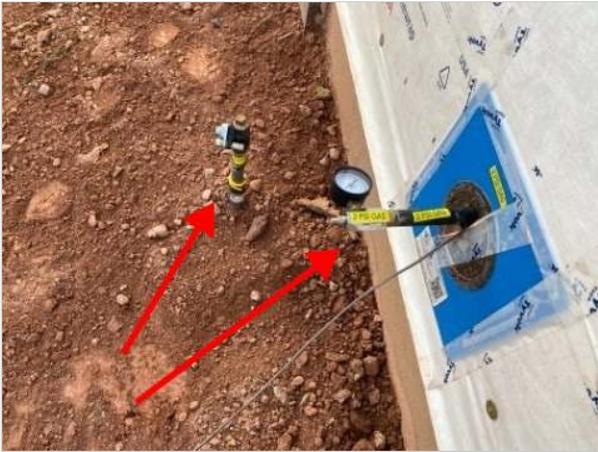
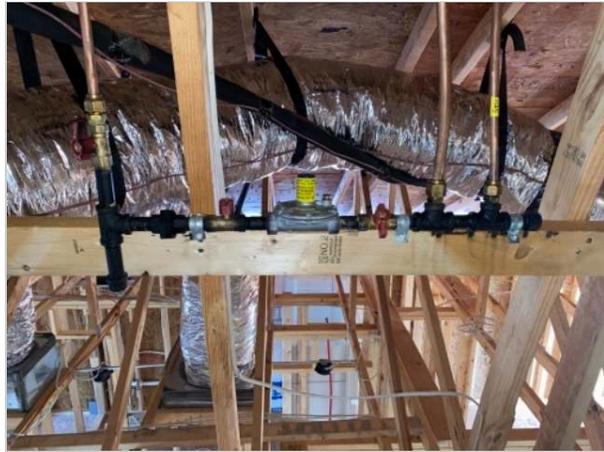
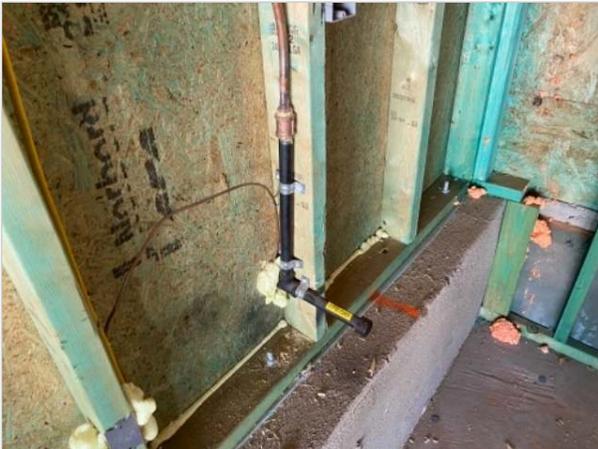
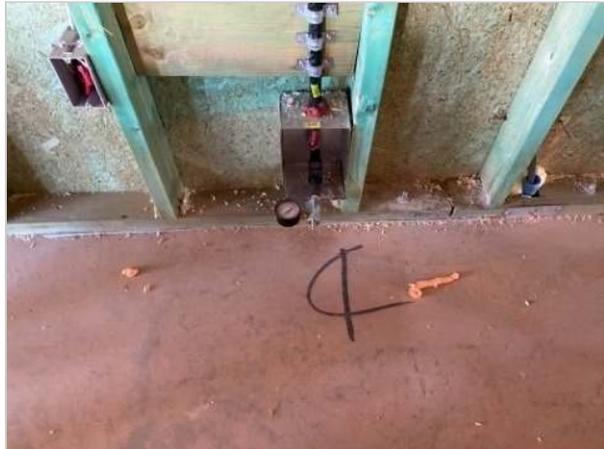
At the incoming gas line, the test gauge is reading 0 psi. This may mean the static pressure test has failed, indicating a leak in the system. Also, the gauge at the kitchen gas pipe reads 5 psi. Both gauges cannot be correct, but either reading indicates a possible test failure. Prior to insulation and drywall work, have the builder ensure the gas piping is properly installed and passes the static pressure test.
