HOME INSPECTION REPORT

The HomeTeam Inspection Service made a visual inspection of 123 Anywhere St., City, ST 12345. Enclosed please find a written, narrative report of our findings in accordance with the terms of our Inspection Agreement.

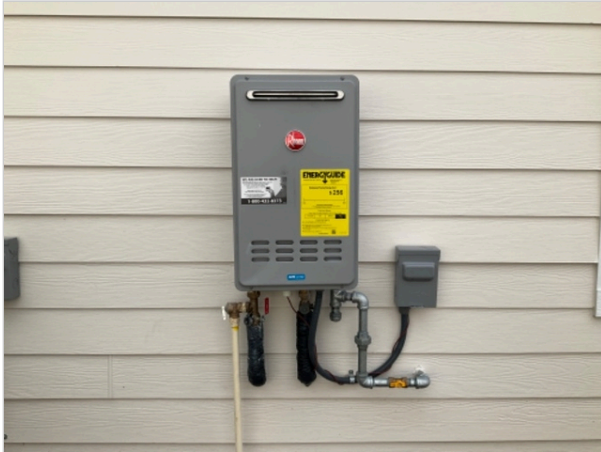
Photo 53

Left side

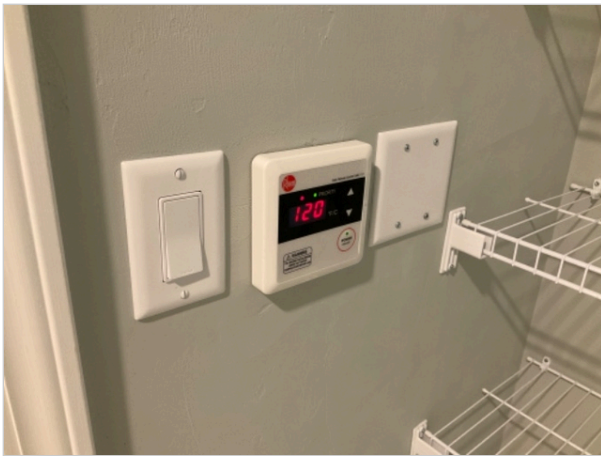
Photo 55

Master closet

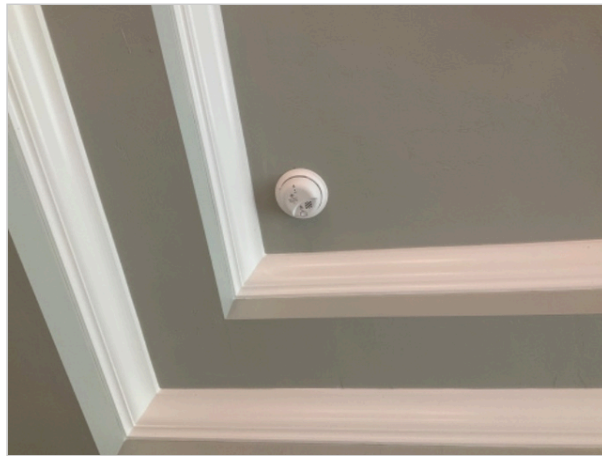
Photo 56

Living

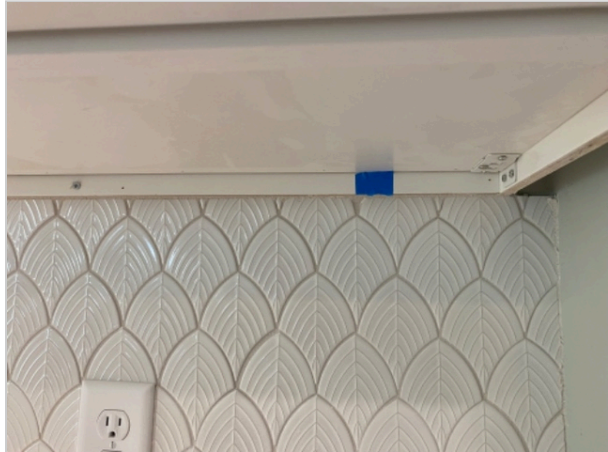
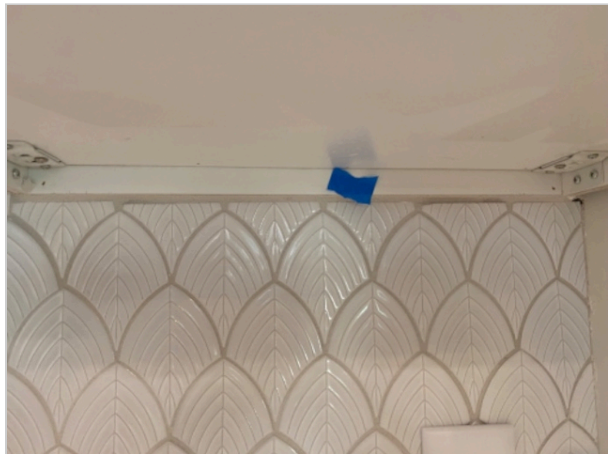
Portions of the kitchens cabinets were not completely secure to the wall. The cabinets should be secured to prevent them from falling.
