On Thursday, August 3, 2017 The HomeTeam Inspection Service made a visual inspection of 123 Sample Drive Anytown, MN 55555. Enclosed please find a written, narrative report of our findings in accordance with the terms of our Inspection Agreement.

HOME INSPECTION REPORT

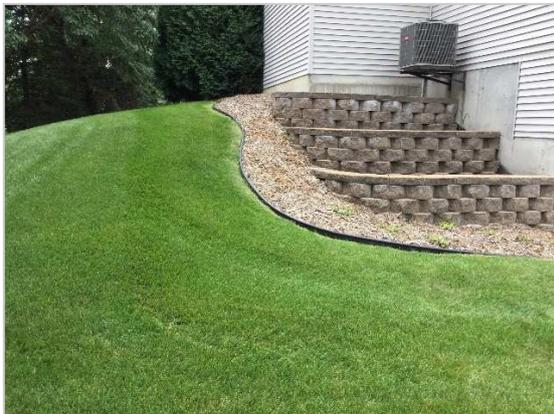
Photo 1

The structure was situated on a lightly sloped lot. The general grade around the structure appeared to be adequate to direct rain water away from the foundation, assuming normal drainage and downspout, gutter, and other systems are functioning properly.

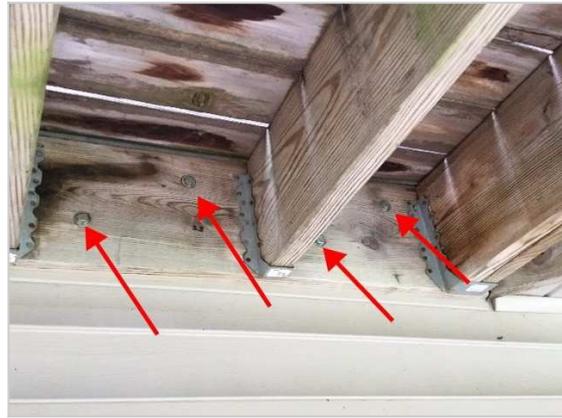
Photo 8

Showing proper bolts into house.

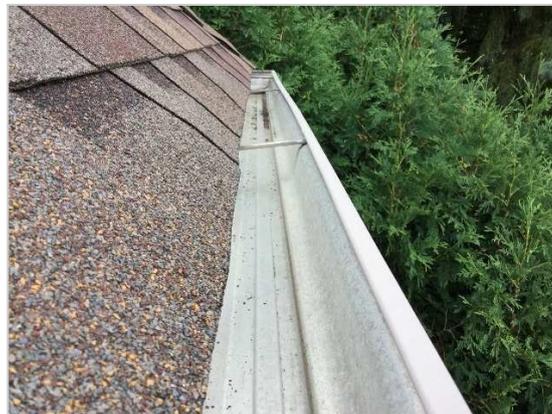
Photo 13

Gutter above the garage.

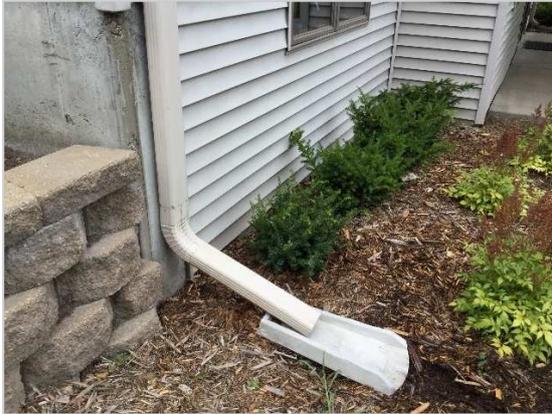
Photo 16

Right rear downspout.

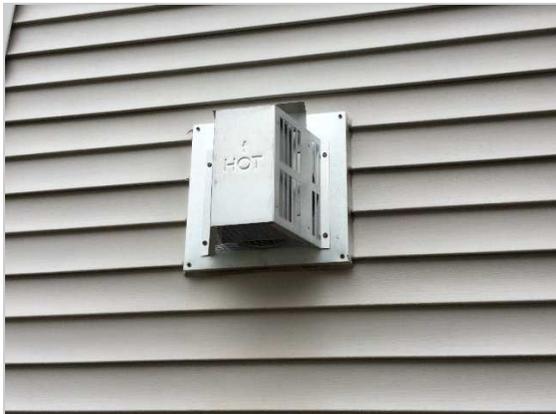
Photo 22

Main floor fireplace flue on left side of home.

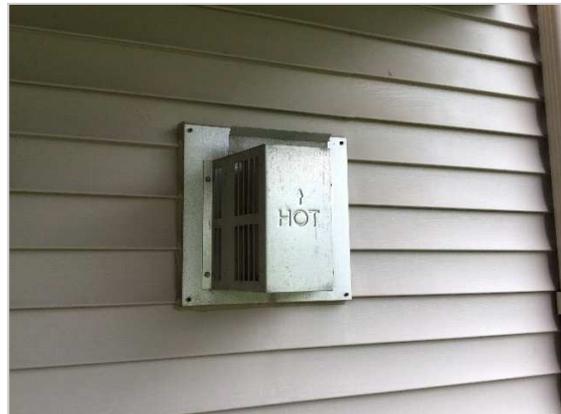
Photo 23

Basement fireplace flue, on lower rear of home.

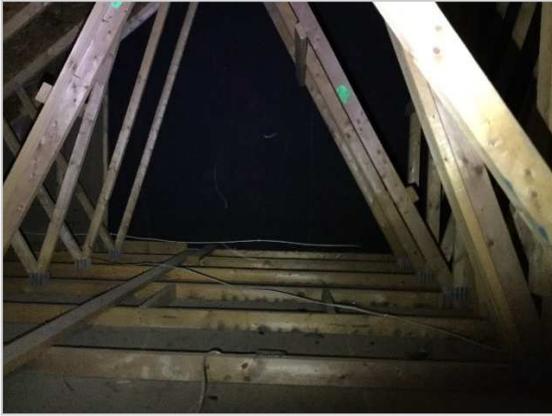
Photo 29

Garage attic has no insulation.

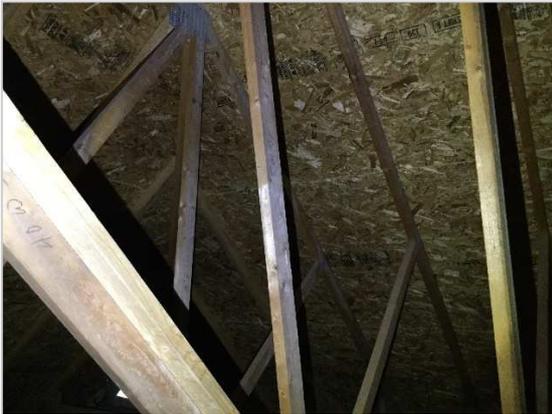
Photo 31

Garage attic.

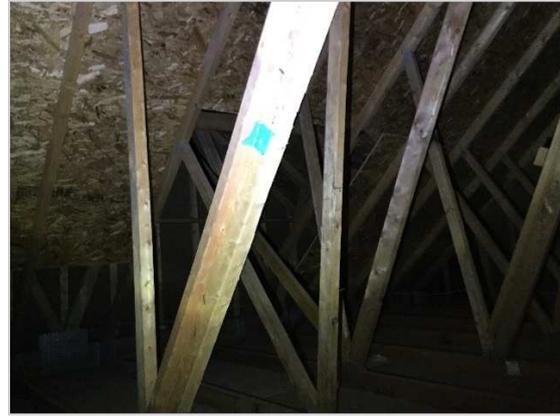
Photo 30

Garage attic.

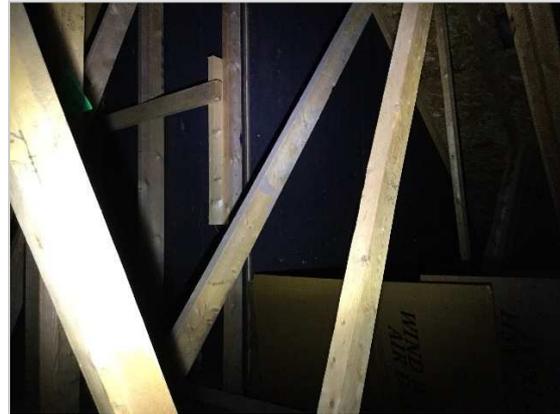
Photo 32

Garage attic.

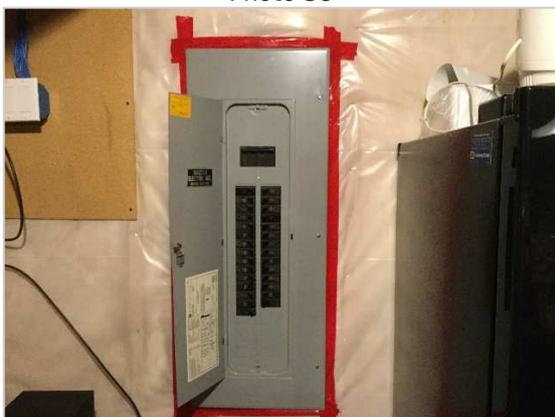
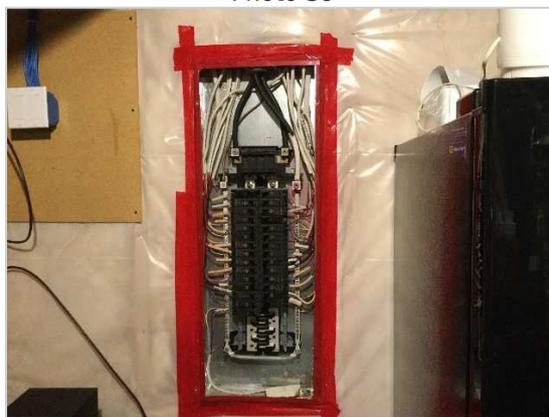
Corrosion was observed on components in the electric panel. Corrosion on terminal screws and wires can result in overheating of terminals and possible arcing problems in the panel. HomeTeam recommends that a licensed electrician repair and further evaluate the condition of the electrical panel.

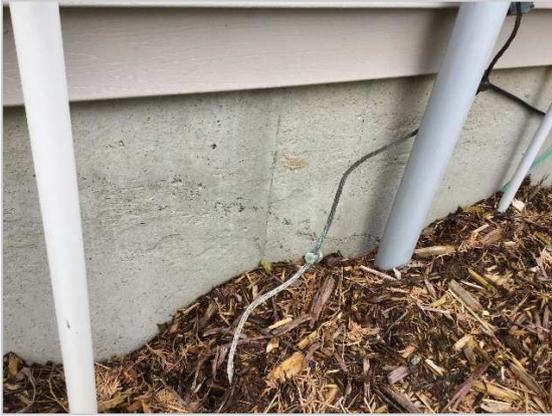
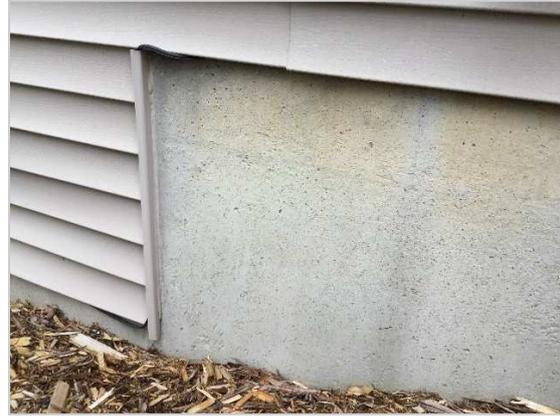
Small cracks were observed on the foundation. The cracks were 1/16th-inch or less in width. The homeowner should monitor these cracks for any changes, and if changes are noted, should contact a structural repair company for further analysis. Below-grade cracks are highly susceptible to water intrusion during times of heavy rain. Water staining from previous water intrusion was not visible. HomeTeam recommends sealing these cracks if a watertight basement is desired.

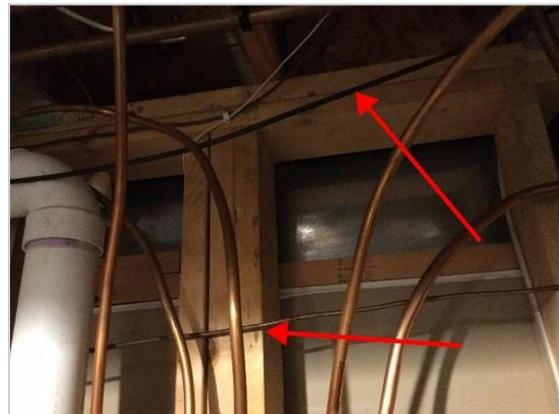
Photo 49

Built up post and support.

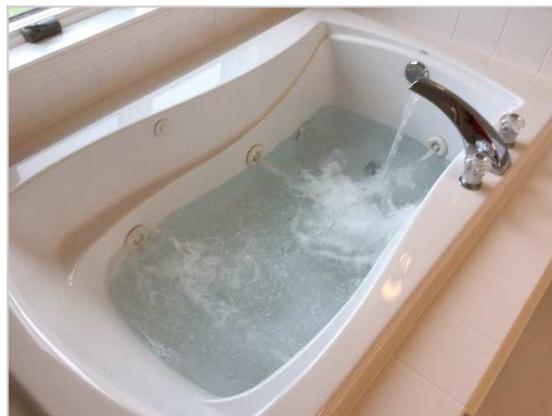
Photo 56

The jetted tub was tested by filling the tub above the jets and engaging the on/off switch. The operation of the tub was done by verifying that water was coming out of each of the jets. The jets were run for approximately 1 minute. The tub did appear to be operable. Leaks were not observed from the jetted tub.

Appears to function correctly.

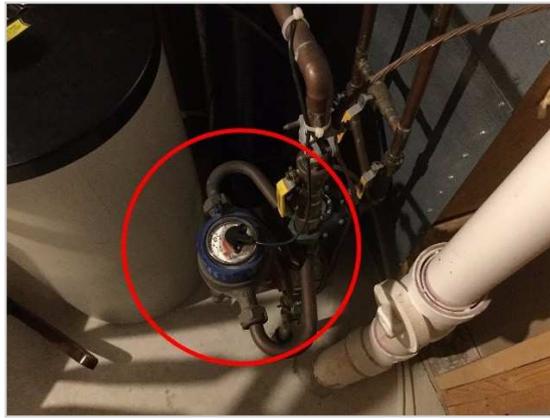
Photo 57

The main water shutoff valve for the structure was located adjacent to the water service entry point near the base of the water heater in the basement. Water shutoff valves are visually inspected only. No attempt is made to operate the main or any other water supply shutoff valves during the inspection. These valves are infrequently used and could leak after being operated.

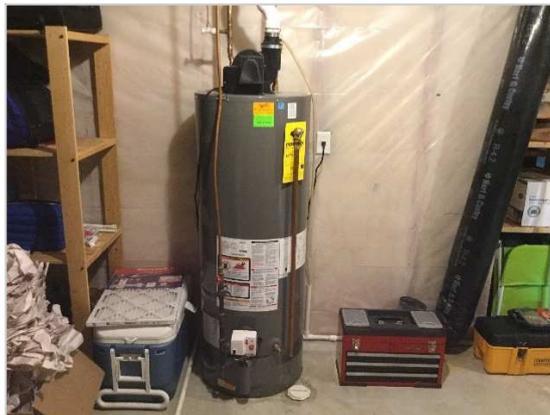
Photo 58

A 50 gallon capacity, natural gas water heater was located in the basement. The water heater was manufactured by Rheem, model number 43VP50E2 and serial number RHLNQ521221838. Information on the water heater indicated that it was manufactured 15 years ago. Hot water temperature was approximately 112 degrees F.

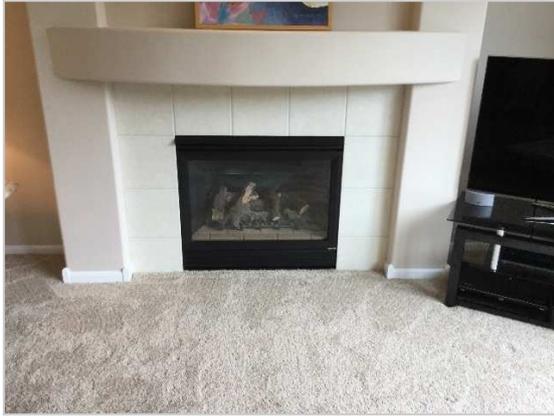
Photo 68

Main floor fireplace.

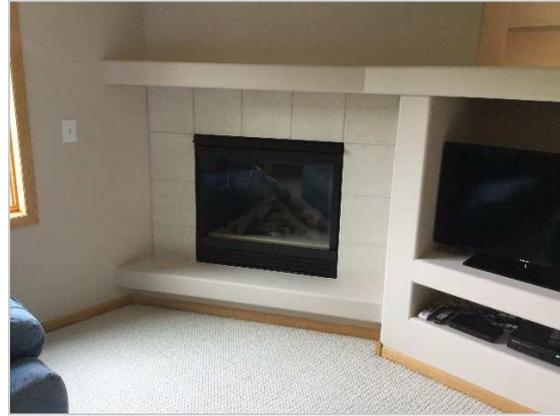
Photo 69

Basement fireplace.

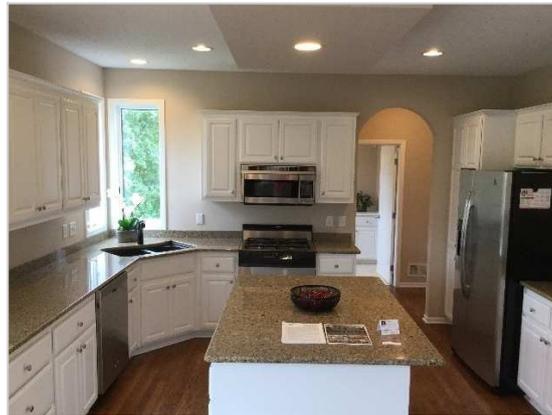
Photo 70

The natural gas oven and range combo was inspected and did appear to be functional. The accuracy of the clock, timers and settings on ovens are not within the scope of this inspection.

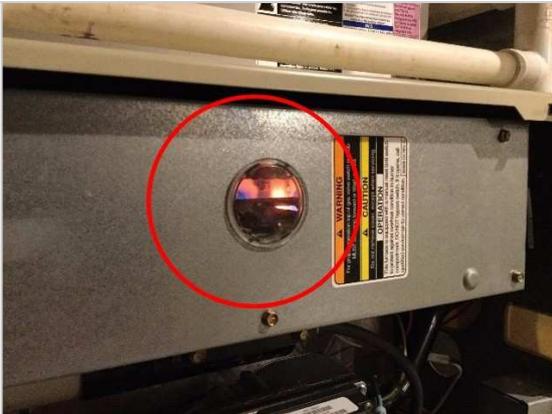
Photo 79

Furnace tested and worked at time of inspection.

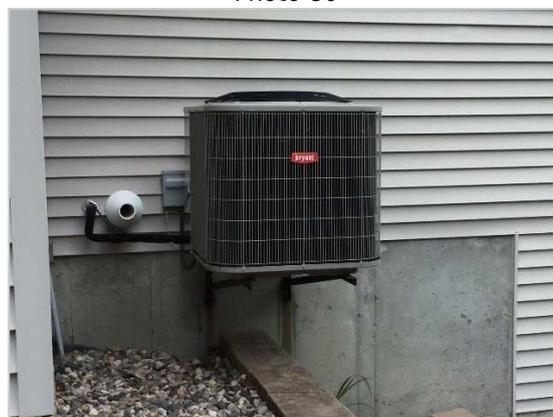
Photo 80

The electric outdoor air conditioner condensing unit was a Bryant, Model Number 113ANA042-C and Serial Number 2910E20624. The unit is located on the right side of the structure. This unit is approximately 17 years old. Periodic preventive maintenance is recommended to keep this unit in good working condition, and HomeTeam strongly recommends partnering with a reputable HVAC company for routine maintenance for the heating and cooling systems in the fall and spring. The air conditioning system was tested and found to be functional. As a reminder, this is functionality test and visual inspection only; we do not check suction pressures, contactor amps, or refrigerant levels. If a more detailed inspection is required, please consult with an HVAC company.
