HOME INSPECTION REPORT

File Number: **SAMPLE REPORT**

Address of Inspection: **1670 Moultrie**

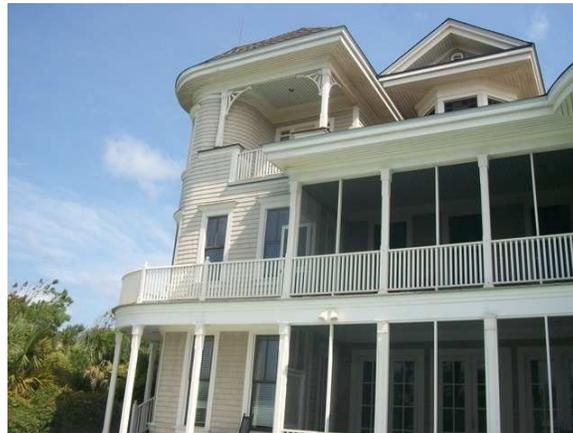
Exterior of home needs several areas of moisture damage repaired and total exterior re-painted to prevent further damage. Consult Contractor for further complete evaluation of the total exterior. Some areas of moisture damage visible are listed under maintenance concerns, Latent damage to areas of exterior are likely and may not be listed in this report.

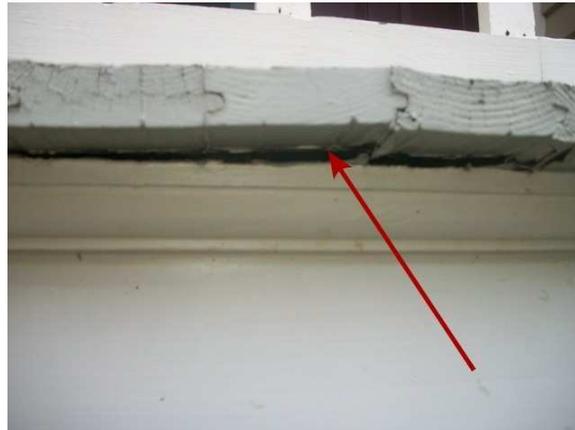
Some areas of right side porch 1st floor has moisture damage to railing/lattice work. Consult Contractor for further evaluation.

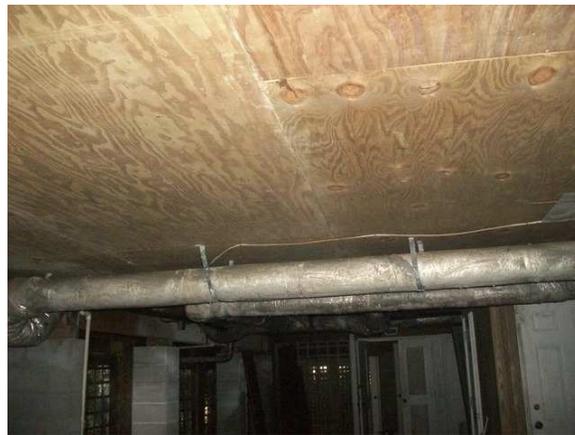
There is debris in crawl space which needs removal to prevent rodents and moisture issues.

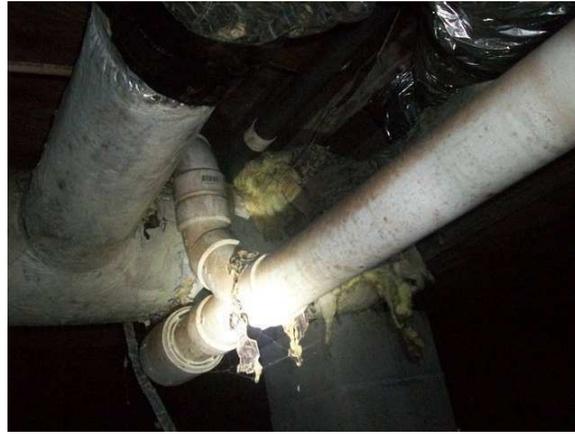
There are several areas of plywood /insulation under home covering floor structure missing. Areas should be repaired to prevent rodent entry into floor structure.

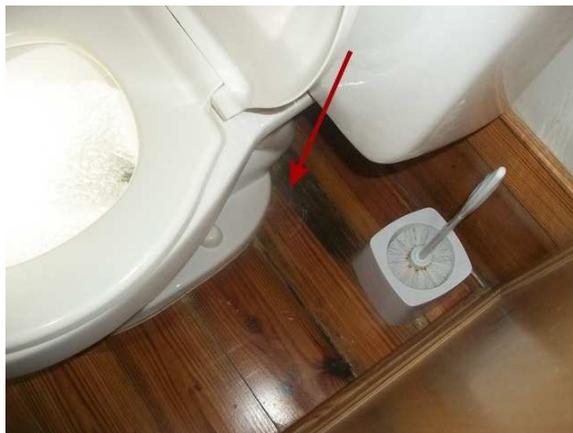
Moisture damage to wood flooring behind toilet in 1/2 bathroom. No moisture present at time of inspection

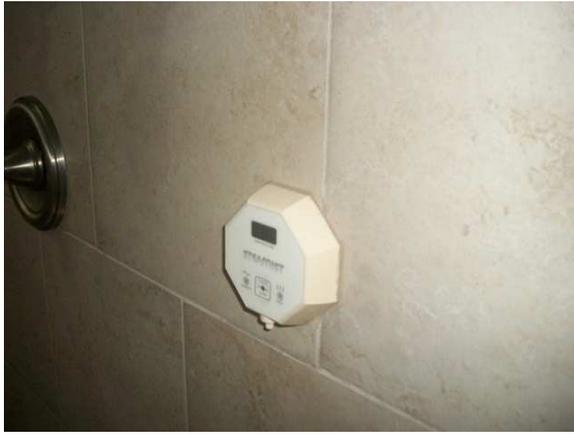
Master shower Steamist not functioning. Consult Plumber for further evaluation

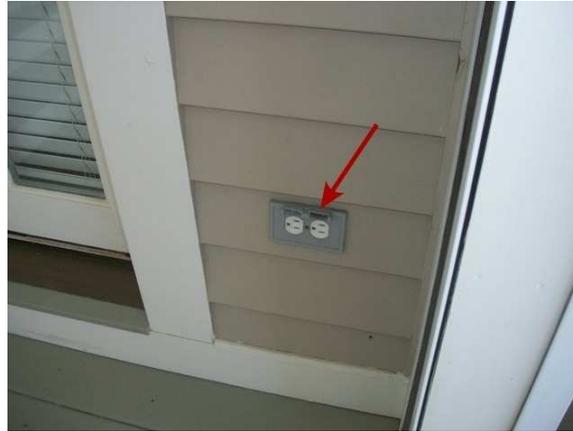
Exterior electrical outlet(s) have broken weather proof cover plates.

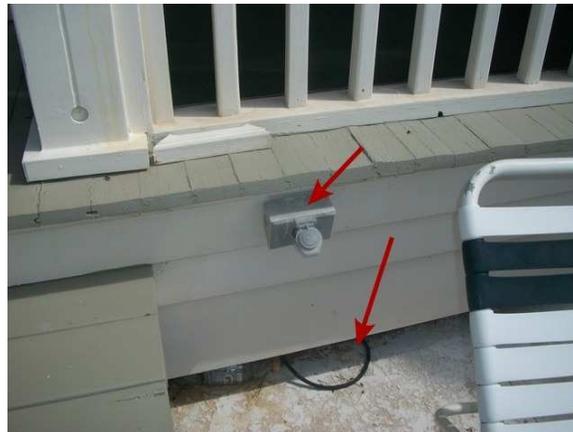
Pool electrical light switch mounted on face of rear porch loose and needs to be re-secured

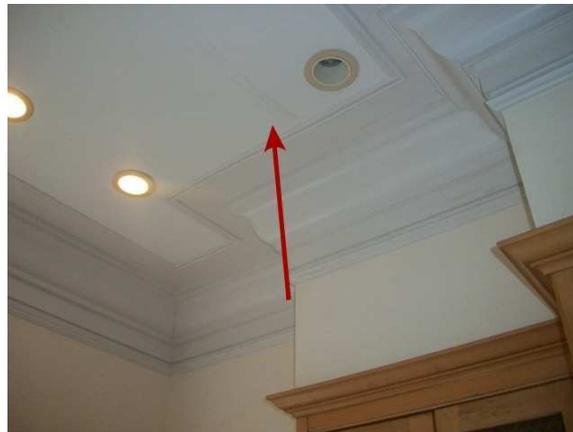
Moisture stain /damage kitchen ceiling. No moisture present at time of inspection. Consult Contractor for further evaluation.

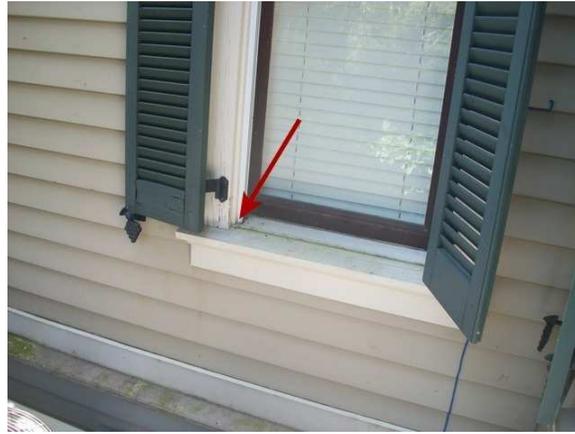
Several windows have moisture damage to casing /trim. Consult Contractor to further evaluate all windows/casing/trim

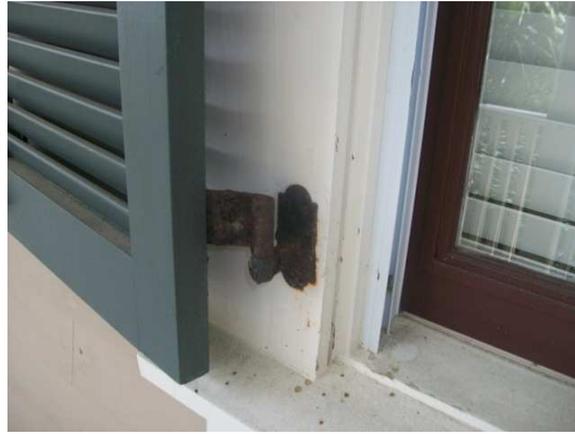
Moisture damage to exterior shutters and shutter hardware

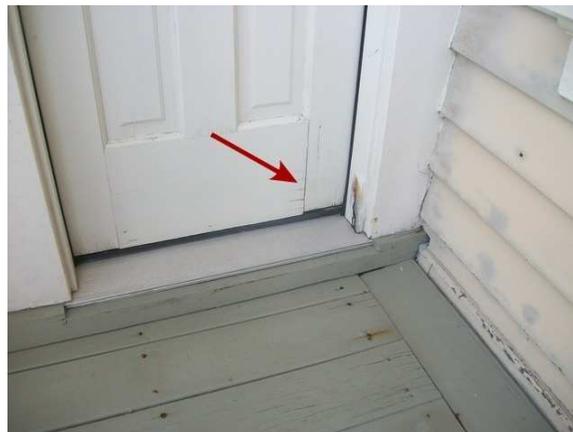
Moisture damage right side 2nd floor entry door/casing/trim

- Moisture damage right side 2nd floor entry door/casing/trim

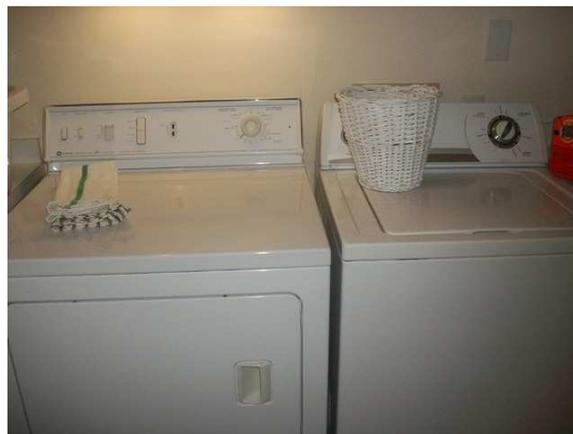
Dryer vent pipe broken loose in crawl space and needs repairs

- Dryer vent pipe broken loose in crawl space and needs repairs
- Moisture stain in 2nd floor front bedroom ceilings. No moisture present at time of inspection

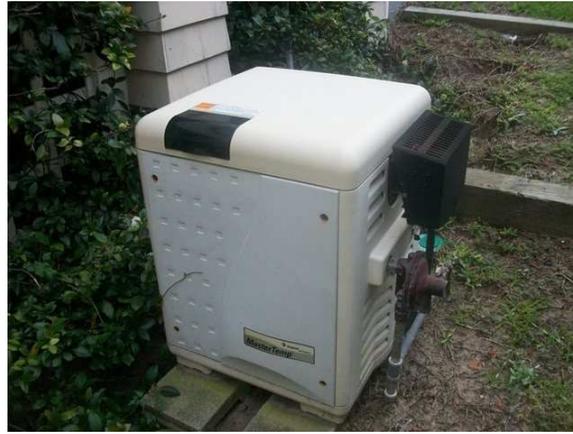
The Pentair pool LP gas heater was not operational at the time of the inspection.
