PROPERTY INSPECTION REPORT

Concerning: 123 Sample Drive, Anytown, TX 12345

By: Jerimy Schiewe (# 21015) Dale Lockamy (# 22446) Bobby McDonald (# 8094) 12-12-2019

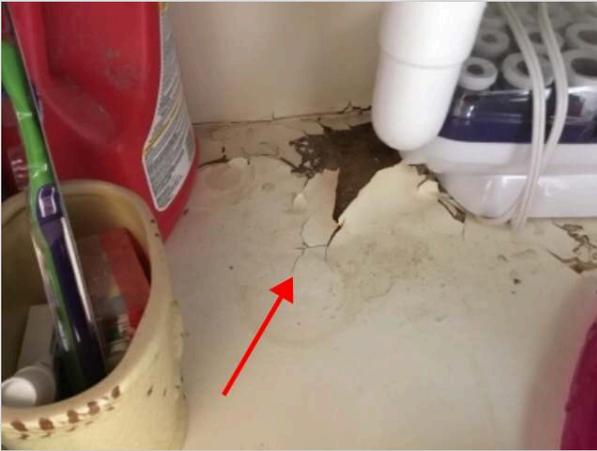
1B

Sheetrock crack(s) were observed on interior wall surfaces at rear right in rear living room (PIC 1A) and front right at door entry in upstairs rear left bedroom (PIC 1B).

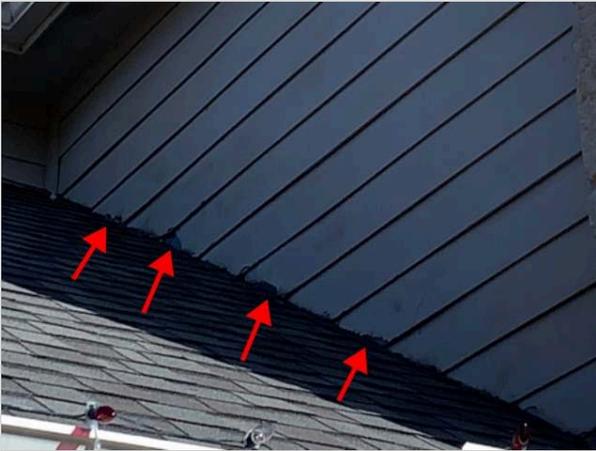
2G

Damaged trim was observed at left side front window (PIC 2G).

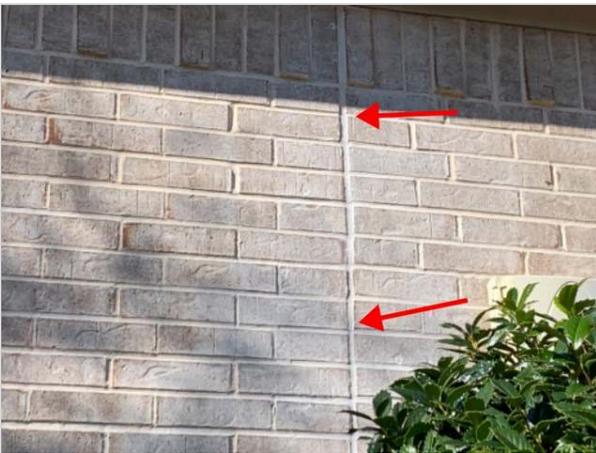
2I

Separation was observed at front right between garage doors (PIC 2I).

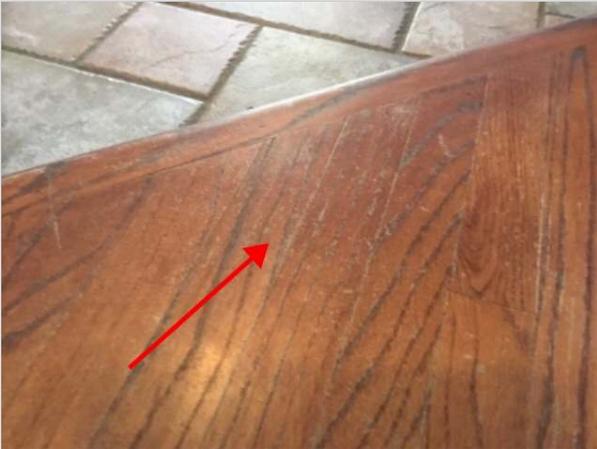
F

Significant wear was observed on wood flooring at multiple locations in study (PIC F,G).
