### HOME INSPECTION REPORT

# PROPERTY INSPECTION REPORT

**Concerning:** \_\_\_\_\_ 123 Main St Anywhere, TX 55555

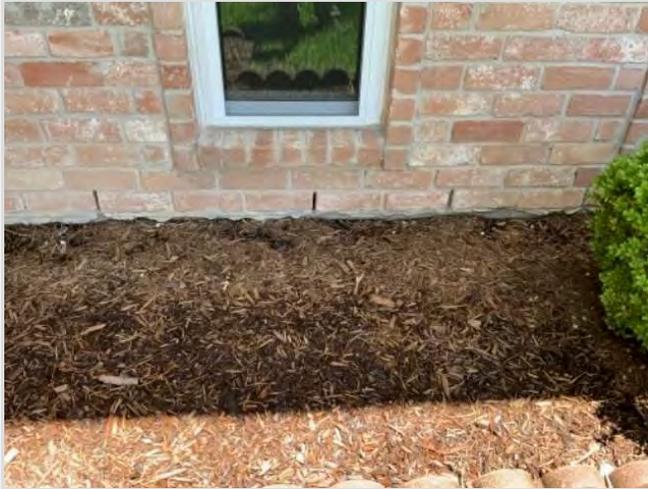
High soil (front)

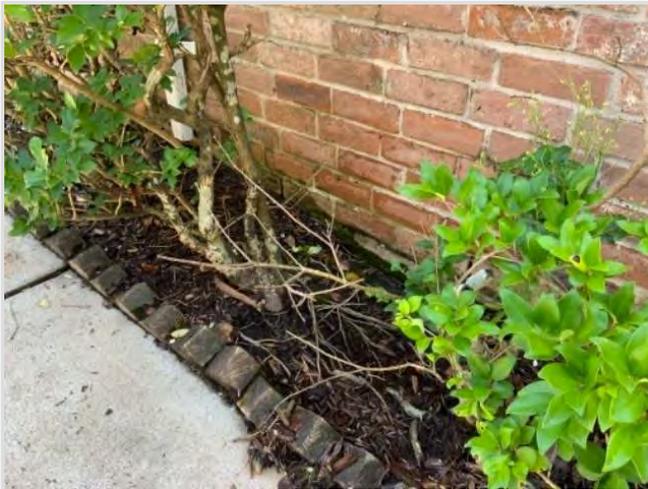
High soil (left side)

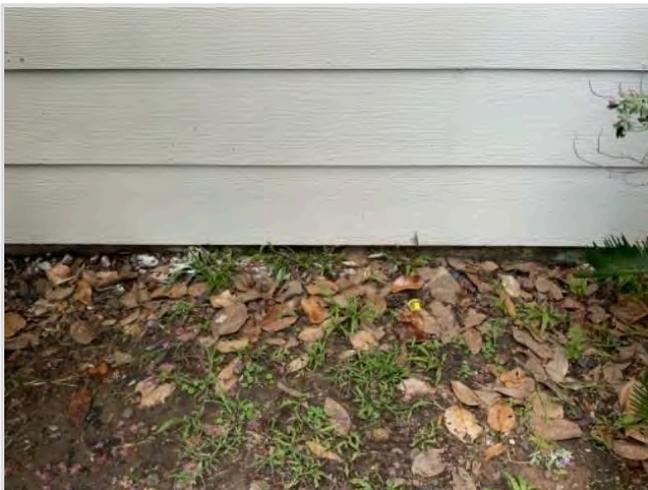
High soil (garage)

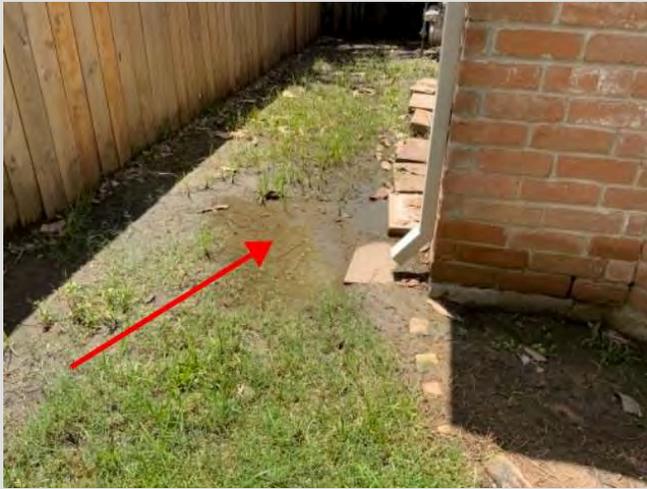
Low area (right side)

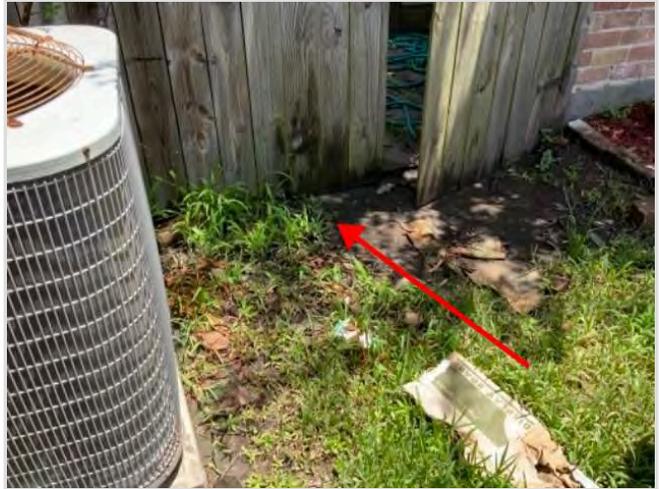
Low area (right side)

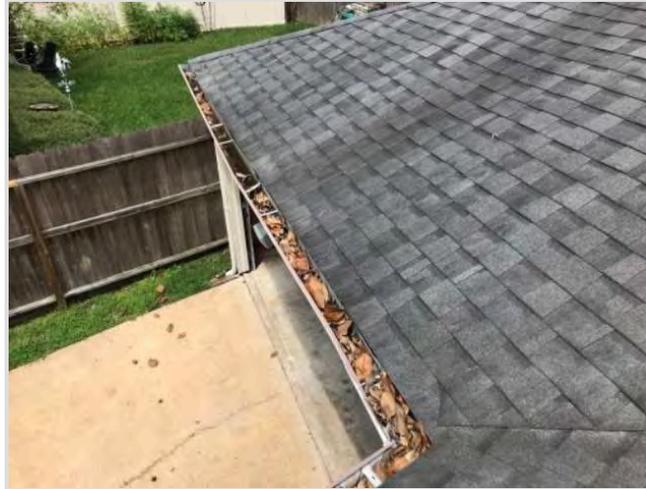
Portions of the gutters needed to be cleaned out. Keeping gutters clear and free of debris is a maintenance requirement for homeowners.

Debris in gutters (garage)

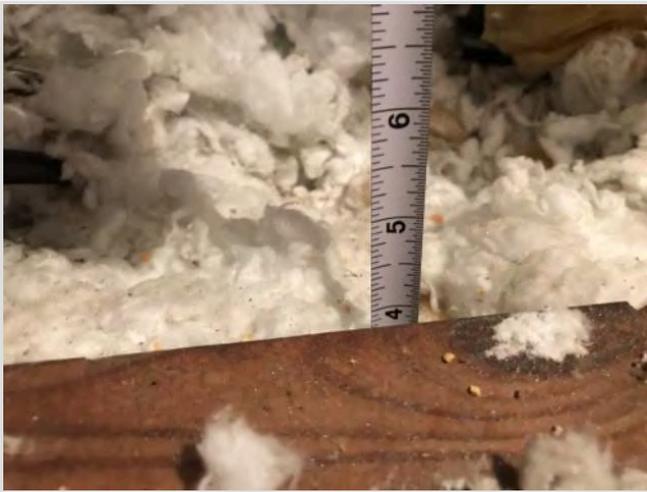
Average attic insulation depth was 4 inches or less

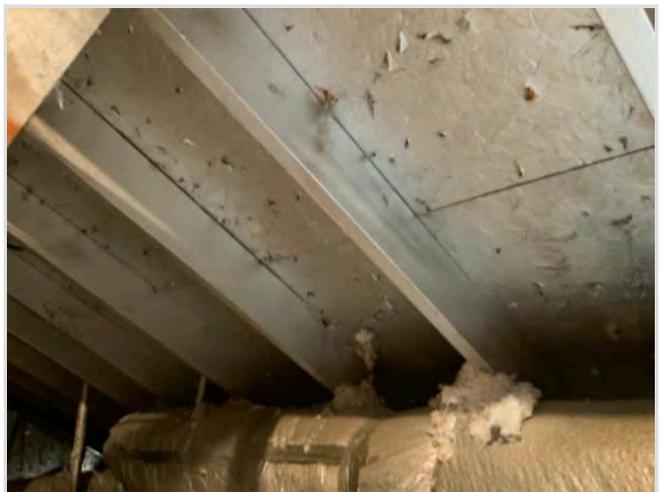
Note: There was a sprayed-on radiant barrier installed at the underside of the roof decking. As a result, we were unable to fully inspect the roof decking and areas around the roof penetrations for signs of water penetration.

Radiant barrier was sprayed on rafters and bottom of roof decking

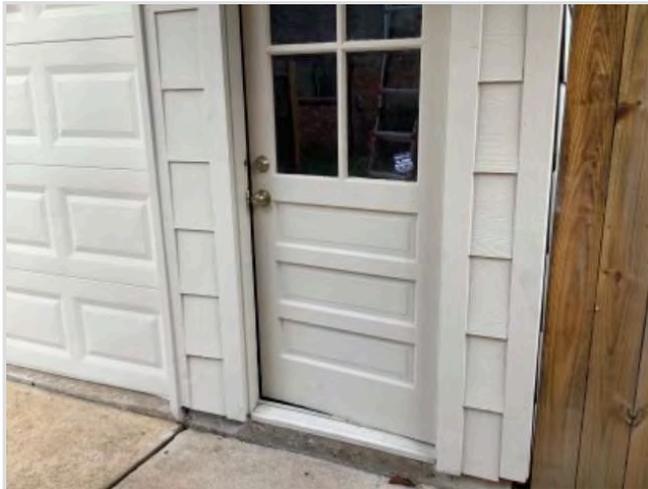
Would not latch in the closed position (garage access door)

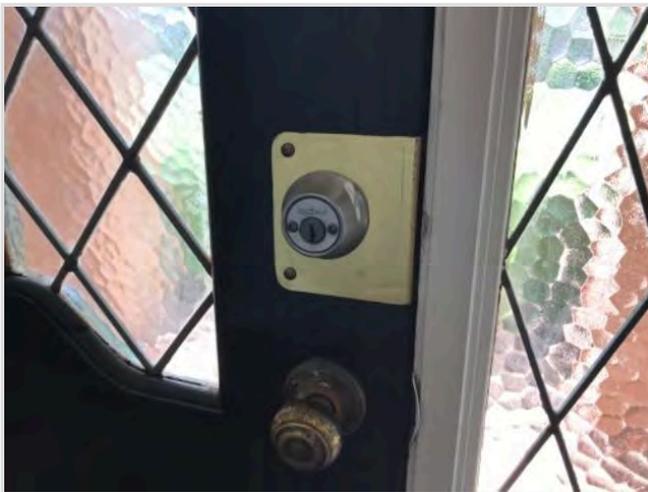
Note: Front and rear exterior doors were keyed on the inside, which can hinder emergency egress.

Lock keyed on the inside (front door)

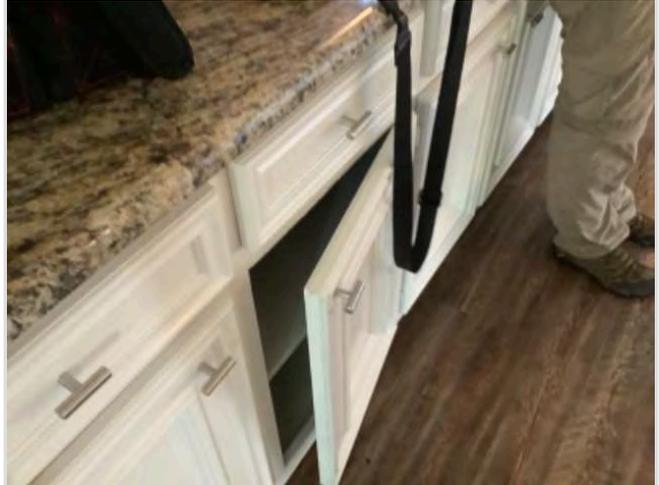
Cabinet door would not stay closed (kitchen)

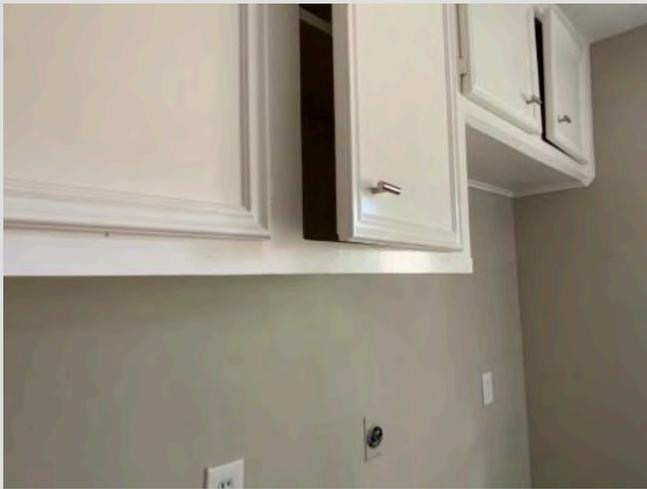
Cabinet door would not stay closed (utility room)

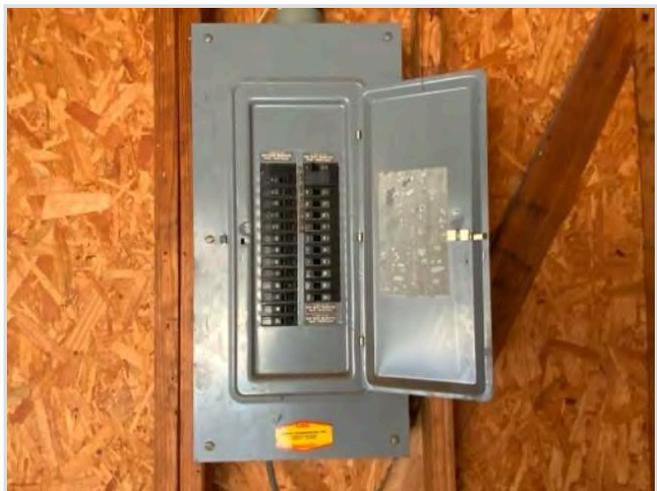
Note: The panel box does not meet current electrical code. When the house was constructed, the distribution panel was compliant and updating to current code is not required (grandfathered). If there is a desire to bring the panel up to current code, consultation with an electrician is recommended.

Electrical service panel

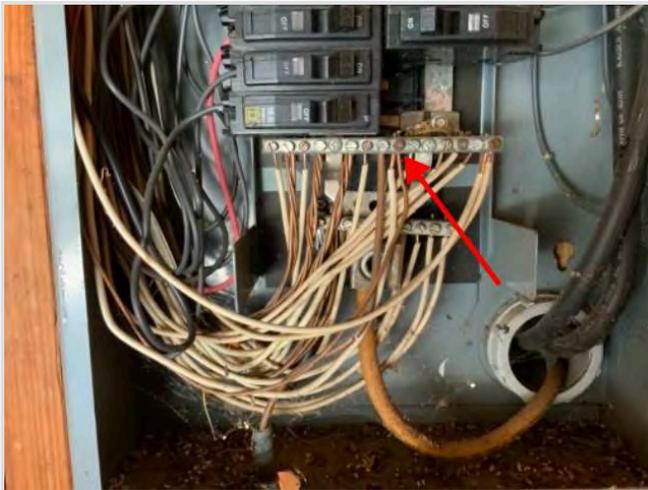
Neutral and ground under shared set screw

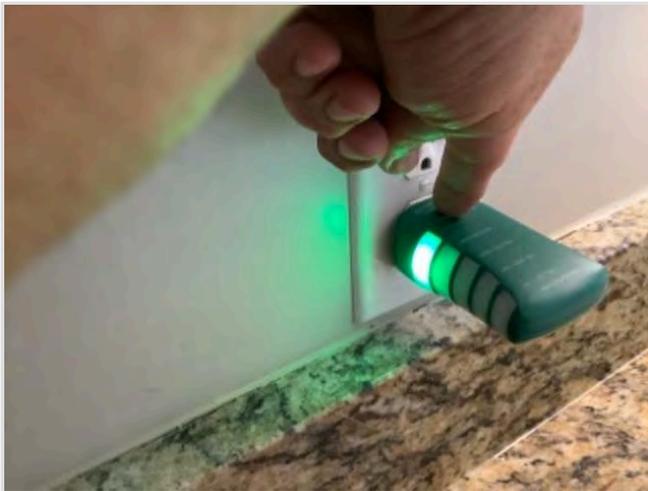
No GFCI protection (kitchen countertop)

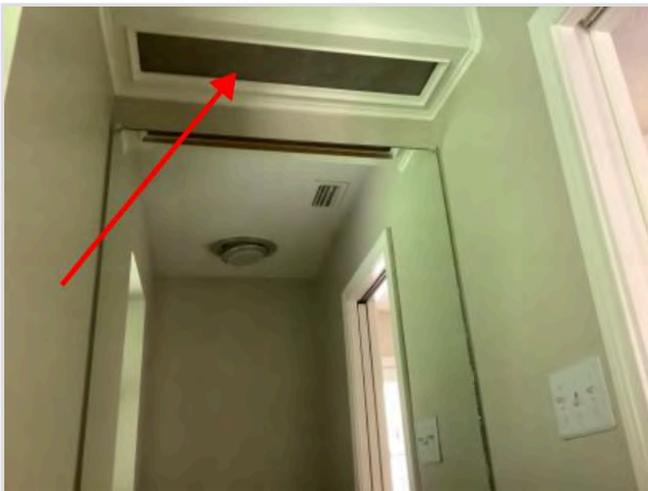
Would not illuminate (powder bath)

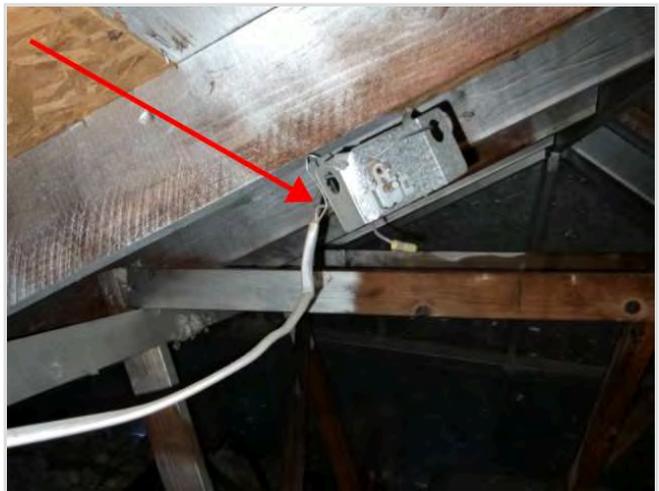
Wires outside of junction box (attic)

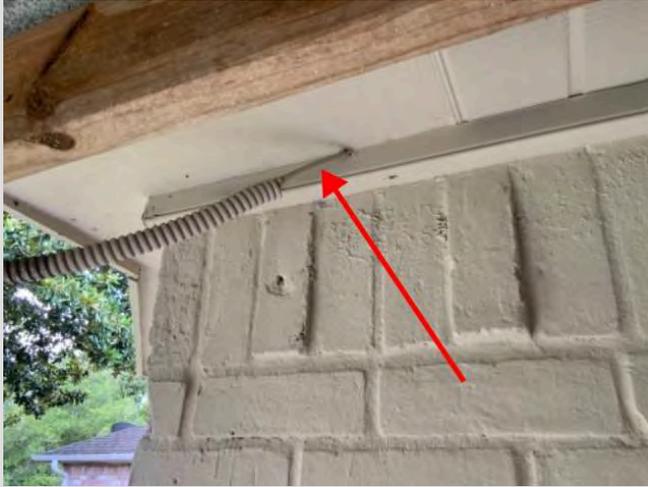
Wire outside of conduit (back porch)

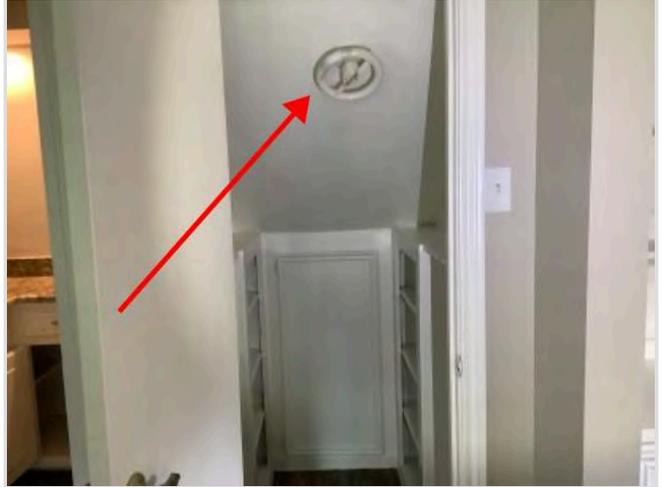
Light not protected (kitchen pantry)

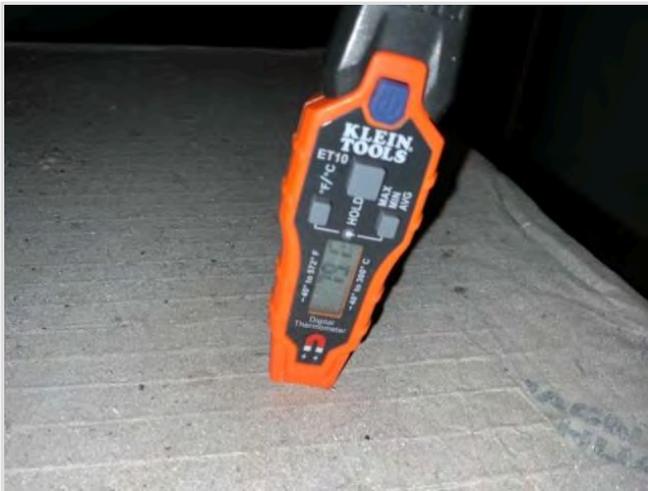
Return air temperature 79.1 degrees

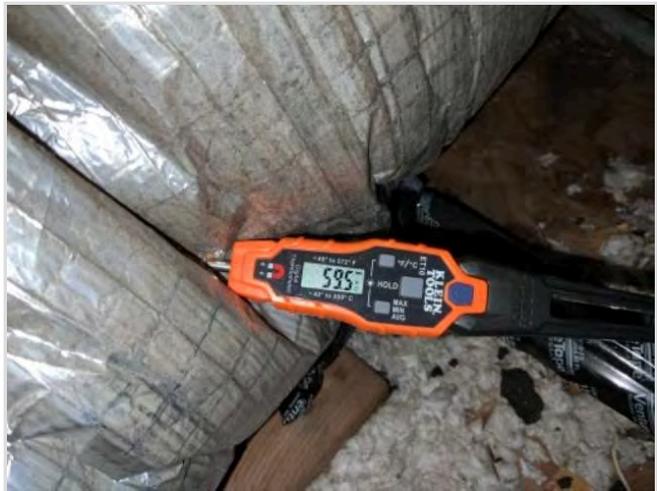
Supply air temperature 59.5 degrees

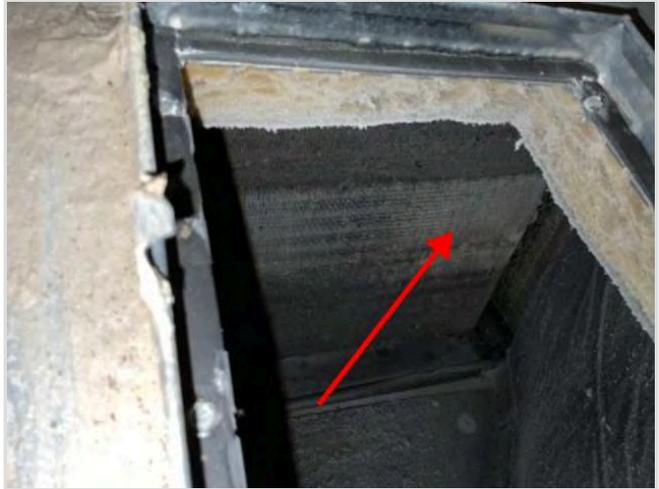
The cooling unit was performing as intended at the time of the inspection with a 19.6 degree temperature differential. Note: The evaporator coil was viewed, found to be dirty and was in need of a cleaning/servicing.

Coil was dirty

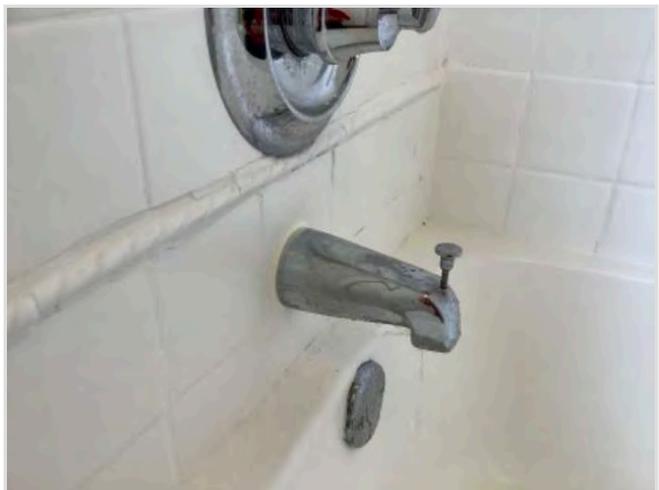
Diminished functional flow was observed during operation of multiple fixtures/faucets.

Diminished water flow (second floor bathtub)

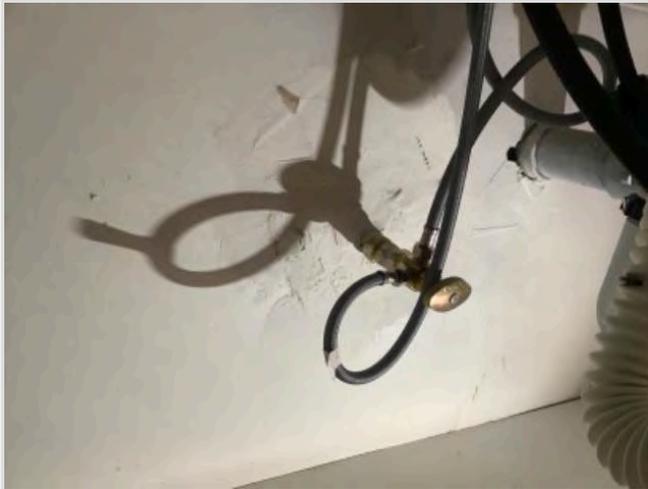
There was no hot water line run to the bar sink.

No hot water line (bar sink)

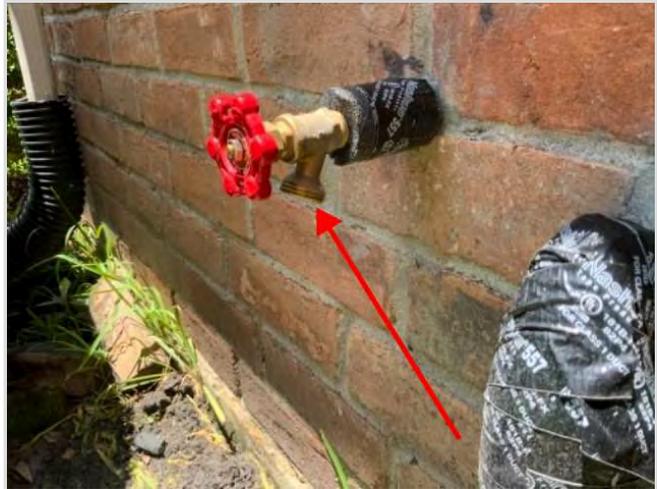
There were no check valves/anti-siphon/back-flow prevention present on the exterior faucets. Check valves allow unobstructed water flow to exit the water fixture as intended while preventing back flow or reverse siphoning to occur. This function prevents non-potable water from being introduced into the potable/drinking water system.

No back-flow prevention (right side)

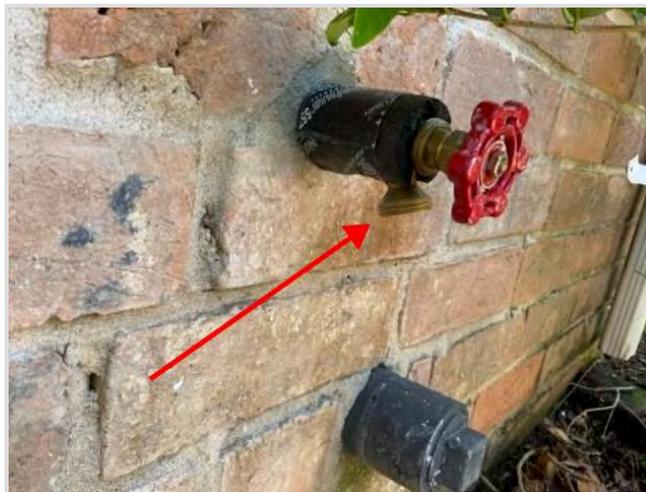
No back-flow prevention (left side)

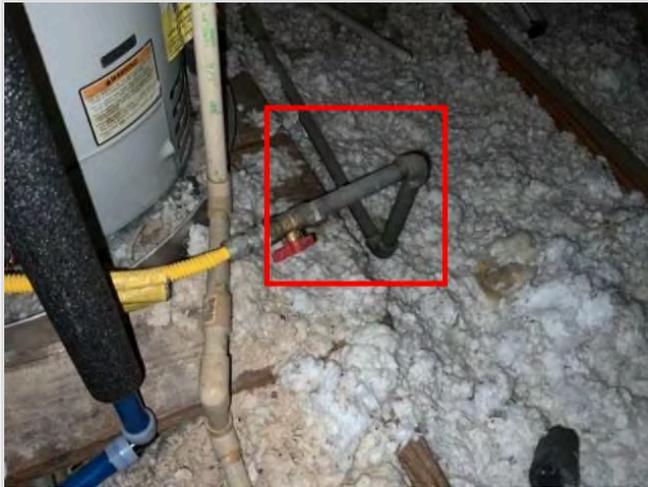
No sediment trap at water heater

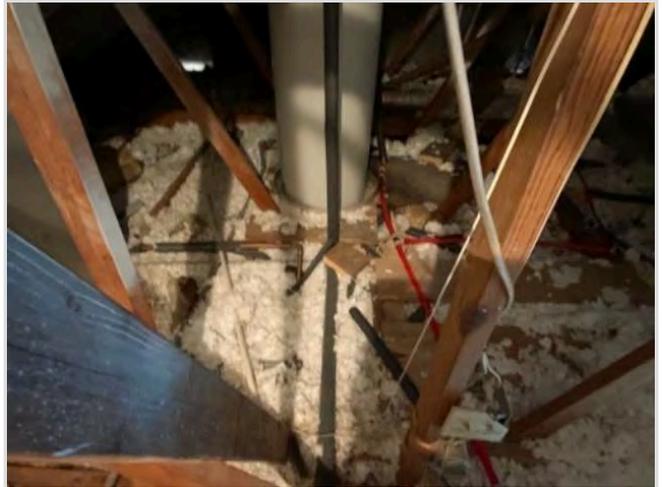
There was no "floored passageway / service platform" to the water heater in the attic (required per TREC).

No floored passageway to water heater

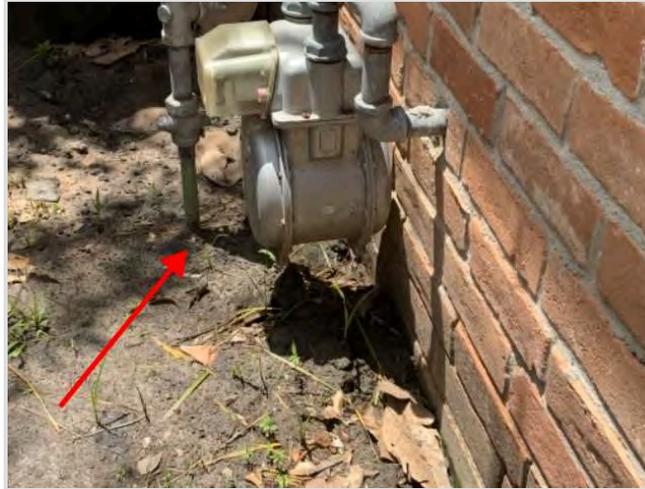
Unable to verify if the gas piping system was properly bonded / grounded (no visible clamp with wire at meter).

No visible bonding clamp or wire

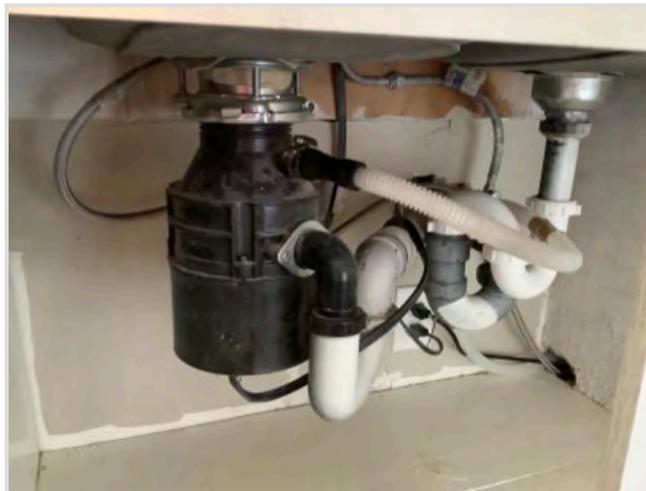
There was no visible air gap in the dishwasher drain line to prevent potential back-flow into the clean water supply.

No air gap or high loop

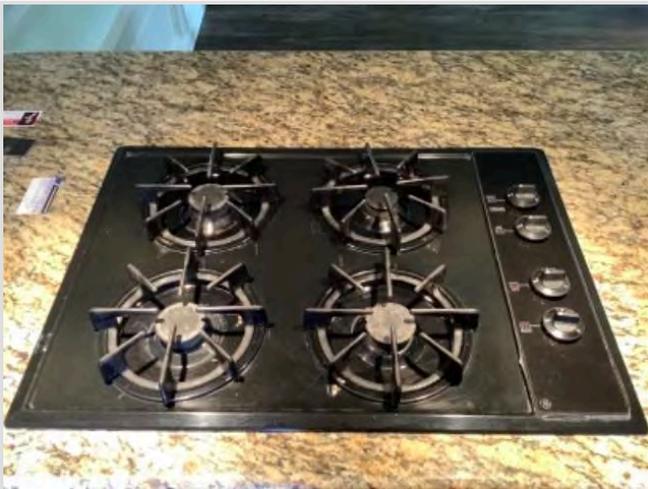
The Cooktop unit was nonfunctional at the time of the inspection. The gas line was disconnected, and the electrical cord was unplugged.

Cooktop was non-functional

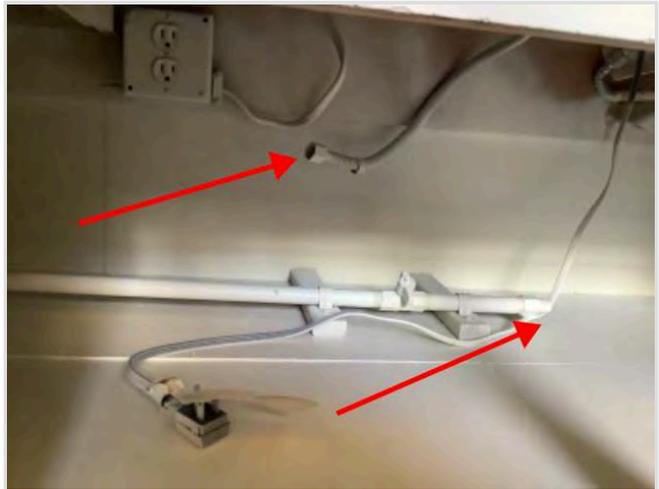
Gas line to cooktop was disconnected

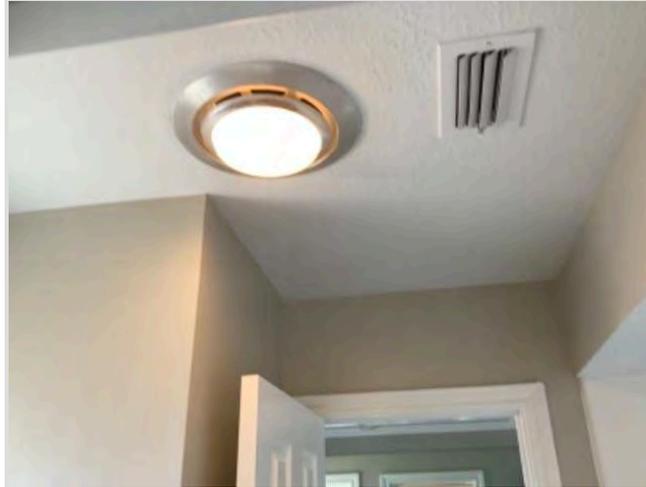
Mechanical exhaust vent fan in the second floor bathroom was not working.

Exhaust fan was not working (second floor bathroom)

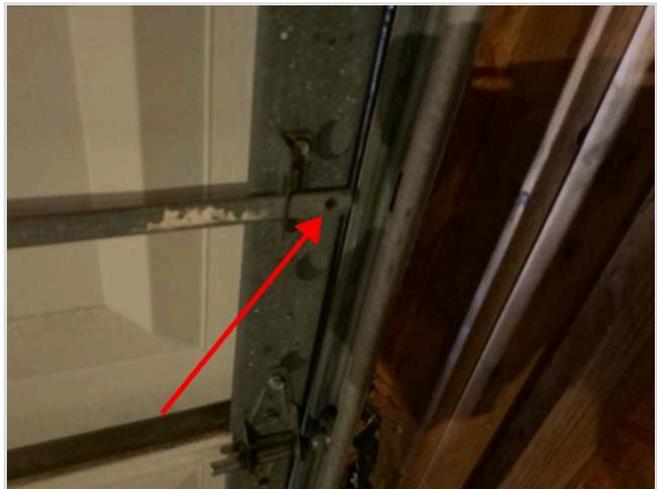
Garage door lock was not disabled

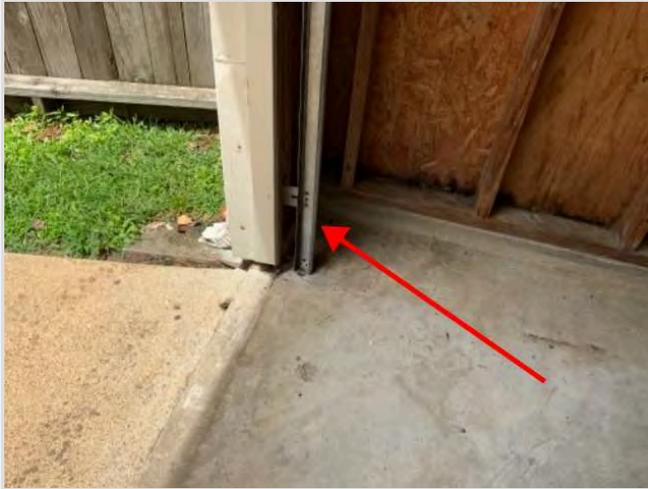
Reverse sensors were not installed at the time of inspection.

No garage door sensors

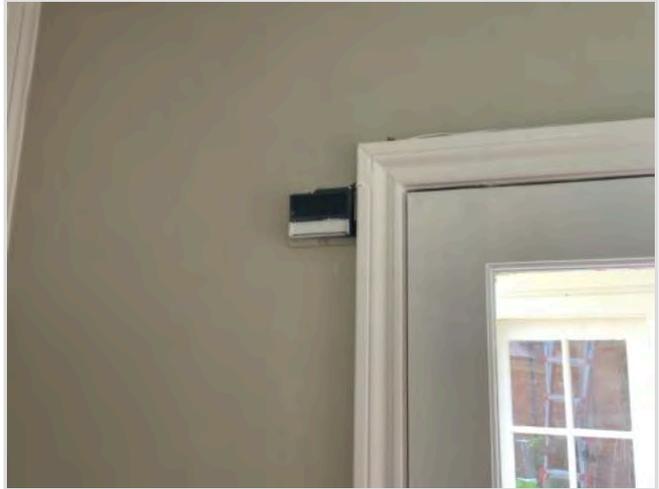
Note: The garage door operator button was installed in the utility room, rather than in the detached garage.

Garage door operator button (utility room)

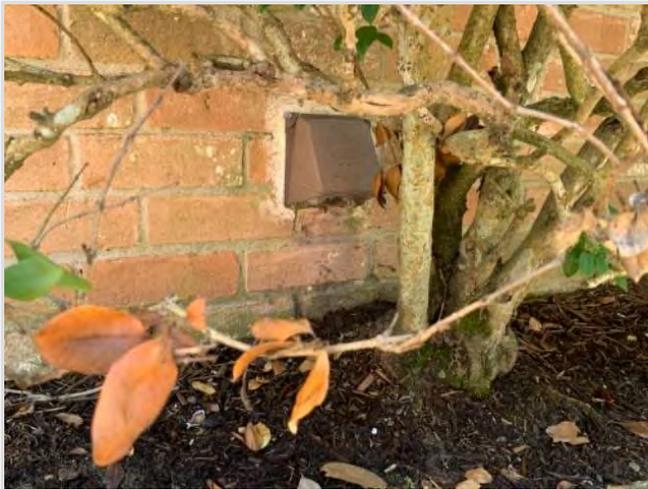
Dryer exhaust vent (left side)

Dryer vent was missing its damper/exclusion cover, which could allow rodent/pest entry into the house.

Dryer exhaust had excessive lint buildup and needed to be cleaned.
